Test installation of a Marker-based Framework for Structural Health Monitoring of Bridges

Abstract. Regular health monitoring of bridges is a vital process to prevent serious structural damage. Marker-based systems, which follow the trajectory of objects by placing a well-characterized pattern on their surface and identify them on photos or videos taken of these objects, have proven to be a cheap and flexible alternative for such tasks. In this work, we extend our previous laboratory implementation with a low-cost, fully automatic on-site installation at the bridge at Arosa Island, Galicia, Spain. Preliminary results presented in this paper show that our system is highly robust for the harsh climate of the installation site.

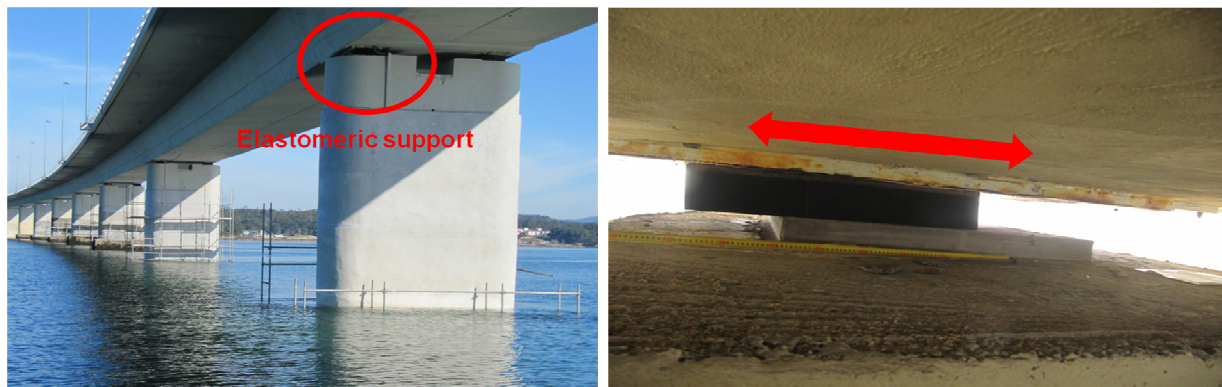
Figure 2: Elastomeric support. The left image shows its location on the bridge, while the right image shows how the bridge is sliding on the support. Note that at the time of construction, the support was placed at the middle, while when the photo was taken it was shifted by around 30 cm.

Our system was installed at the bridge connecting the Arosa island with the mainland at the Atlantic Coast of Galicia in Spain. The bridge was constructed using elastomeric supports that connect pillars with the deck. When the deck expands or shrinks due to fluctuation of the temperature, it can slide on the support, preventing the structure to be damaged by the changes in its volume (Fig. 2). The high forces arisen during sliding cause damage in the elastomeric support making it less and less capable of sliding, i.e. losing its functionality. The health of the elastomeric support can be characterized by the total distance it has moved so far, if this reaches a certain threshold, the support has to be replaced. Thus, by tracking the trajectory we can minimize the frequency of costly reparations while maintaining safety of the structure.

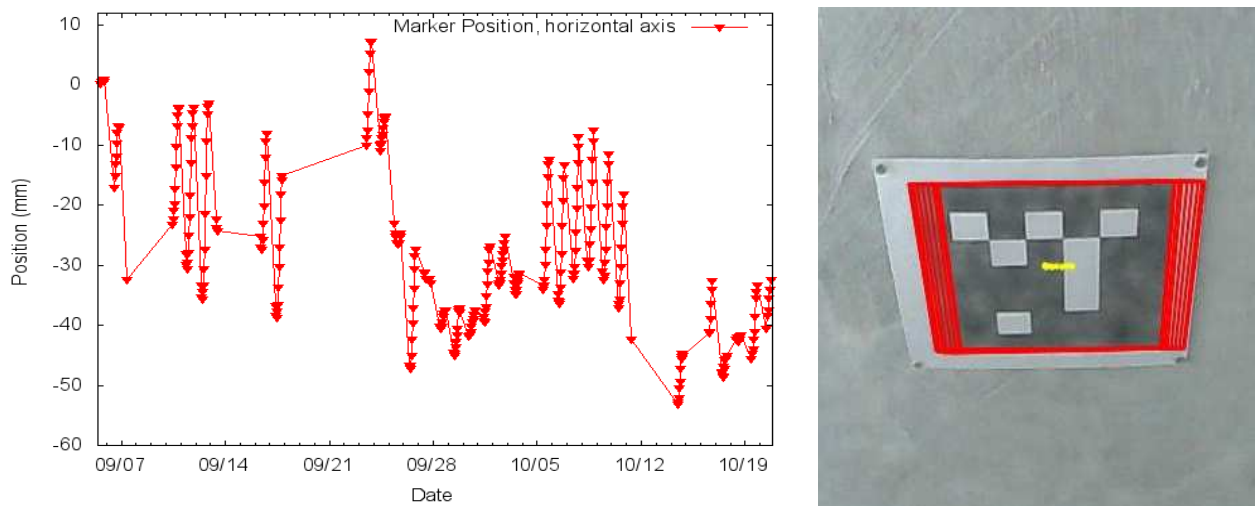
Figure 4: Dilations along the horizontal axis of the camera by time (left) and the evolution of marker positions during a single day (right)

Measurements were collected for 6 weeks, with a photo taken at every daylight hour. Fig. 4 (left) shows the measured dilations of the marker along the horizontal axis of the camera in millimeters. Since movement along the vertical axis were at most 1 pixel (approx. 2 mm) and in depth no movement was detected, the depicted values well approximate the 3D trajectory. Note that in certain days, the deck moved almost 4 cm. However, we expect higher values during summer when the daily temperature fluctuations are much higher. The lack of measurements between September 18 and 22 was due to system maintenance of our database server. The rest of the outages were due to network and electricity issues, discussed in the next section. In order to illustrate how the marker moves during a single day, Fig. 4, right shows the border and center of the detected markers.

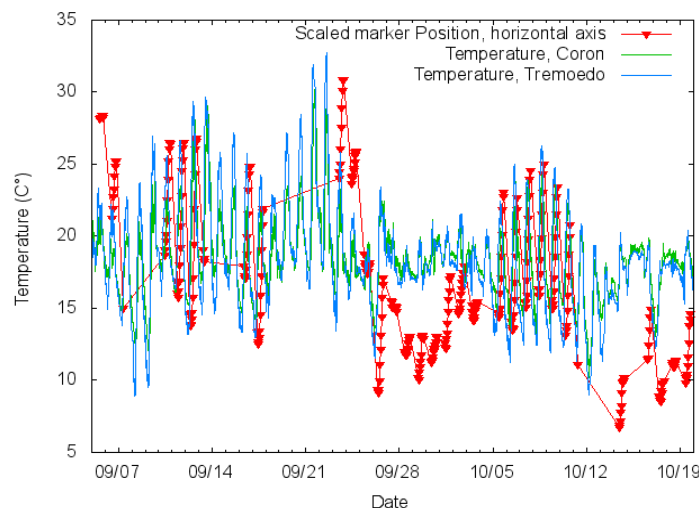
Figure 5: Correlation between the temperature curves measured at nearby meteorological stations and the dilation of the structure. The dilation was scaled to match the temperature curves.

We also compared the dilations of the support to the daily temperature fluctuations measured by nearby meteorological stations at Tremoedo and Corón, which lie approximately 4 and 10 km away from the bridge, respectively. As Fig. 5 shows, there is a noticeable correlation between the temperature and the dilation (note that we scaled the dilation curve to match the scales of the temperature curves), however, since the bridge was built over a reach and the stations are located in the mainland we cannot expect perfect correlation. Still, it is obvious that the larger the daily fluctuation in temperature, the higher the structure position oscillates and additionally, the daily mean of the position tends to follow the mean temperature.
