# Appendix A - Issues

## 1.0 GFE Integration

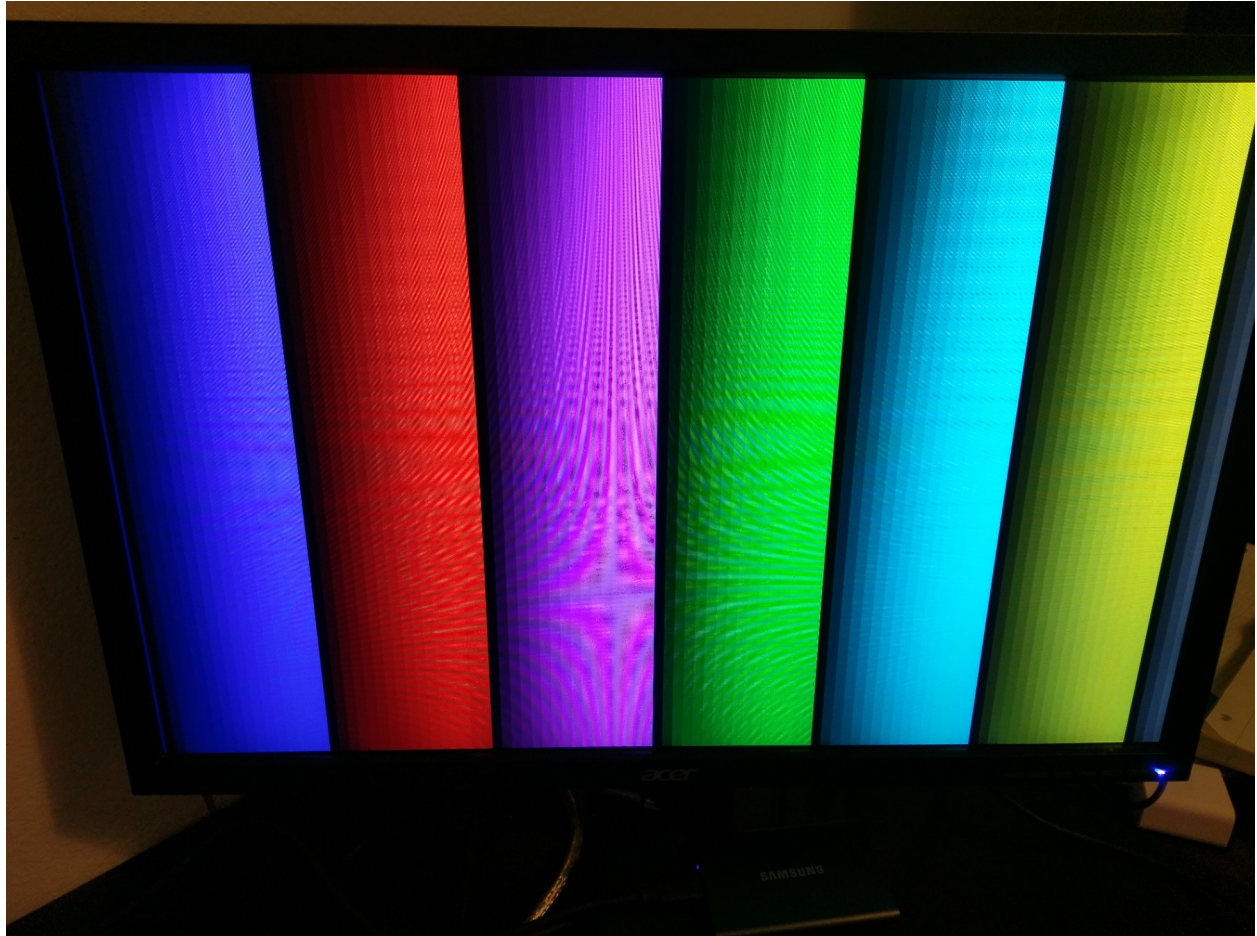
Color palette test pattern from example Vivado project

As part of our initial test of the hardware, we took an RTL model from [an example repository for our PMOD to DVI adapter<sup>3</sup>](#), generated a bitstream, and examined any issues that would show up on our local FPGA development boards and monitors. Upon examination, our tests appeared to work properly; expected test patterns were shown on our local monitors over a DVI-D (aka HDMI) cable.
