5GHOUL : Unleashing Chaos on 5G Edge Devices

VULNERABILITY DISCLOSURE REPORT

December 07, 2023, UTC -12

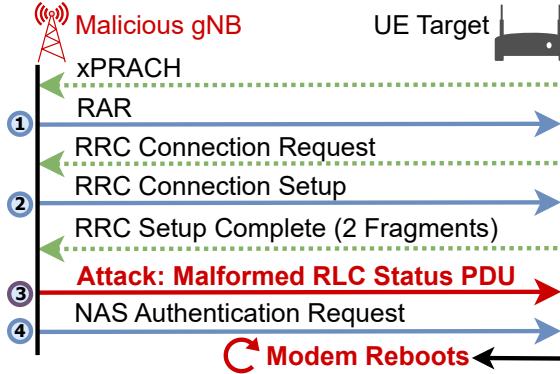
Figure 3: Illustration V5 - "Invalid MAC/RLC PDU"

To test the impact of 5G vulnerabilities on mobile devices and hence user experience, we exploit vulnerabilities V5 to V10 against *Asus ROG Phone 5S (ARP5s)*, which uses Qualcomm Modem and *OnePlus Nord CE 2 (OnePlus)*, which uses MediaTek Modem (see Table 1). First, when vulnerability V5 (see Figure 3) or V6 is triggered on ARP5s, its 5G modem immediately reboots and automatically recovers connection to gNB in few seconds (temporary DoS). Hence, an attacker exploiting V5 and V6 must continuously launch the attacks if the intention is to completely disrupt mobile network connectivity of the user. Additionally, 3G and 4G communication are also disrupted upon modem reboot since the modem handles

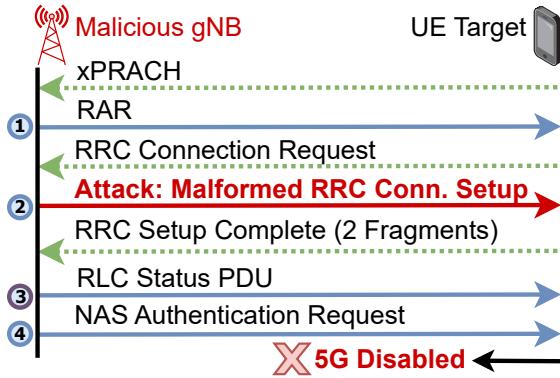
Figure 4: Illustration V7 - "RRC Invalid pdcch-Config"

More surprisingly, vulnerability V7 (see Figure 4) can prevent ARP5s to connect to any 5G network, while keeping 4G/3G connectivity intact (*i.e., downgrade attack*). Nevertheless, such behavior of V7 highlights that the mobile device modem enters an erratic state such that the user needs to manually reboot the phone, thus power cycling the modem to fully restore 5G connectivity. As illustrated in the Video 1, the impact of this attack (*i.e., freezing 5G connectivity*) persists even after the attack stops. Moreover, in certain cases, manually rebooting the phone does not restore the connectivity either, instead, the SIM card requires to be taken out manually and then re-inserted to ensure a hard reset on the modem.

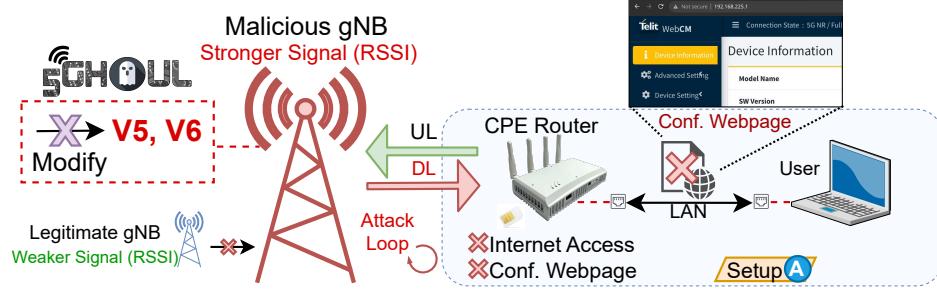
Figure 5: Impact of exploiting **V5, V6** on *Telit FT980m* operating as CPE Router (**Setup A**)

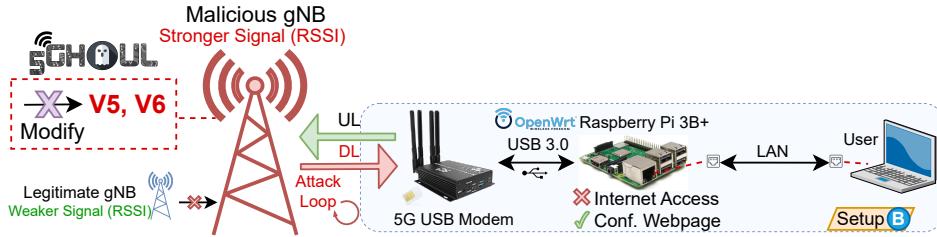
Figure 6: Impact of exploiting **V5, V6** on *RM500Q-GL* modem operating as CPE Router (**Setup B**)

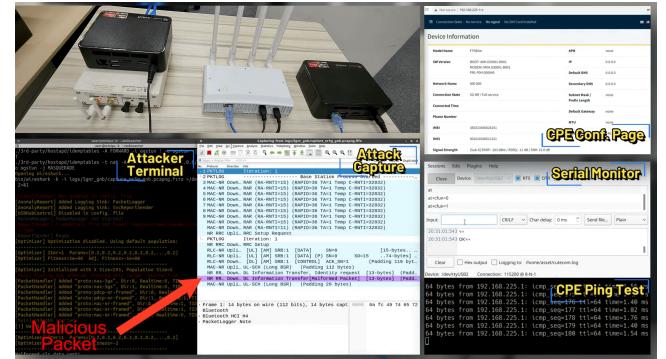
In **Setup B** (shown in Figure 6), a Raspberry Pi 3B+ with OpenWRT 22.03.4 [12] and RM500Q-GL 5G USB Modem (see Table 1) were used. This setup offered better isolation against attacks exploiting **V5** and **V6** since the *Configuration*

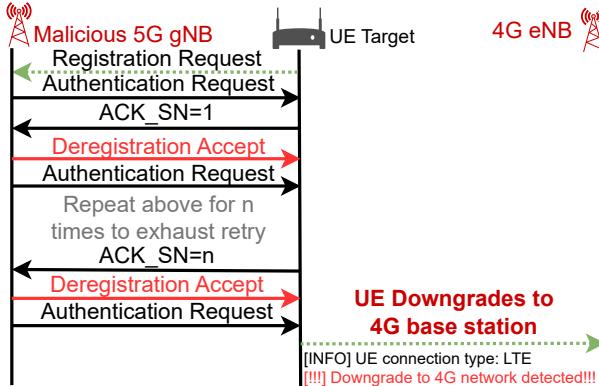
Figure 7: Downgrade via *NAS flooding*.

Our downgrade attack vector **DA1** is illustrated in Figure 7 and in Video 3. In this attack, the target device is kept in a *NAS Authentication procedure* loop by receiving many (i.e., flooding) *NAS Authentication Request*, followed by *NAS Deregistration Accept* many times. After the target device goes through an arbitrary number of retries in this scenario, it falls back to connect to the nearest 4G base station. Notably, *the UE cannot re-establish the 5G connection by merely toggling the airplane mode; it necessitates initiating a new connection process with the base station*. Such downgrade attack highlights the capability of 5GOUL exploitation to be used as a valuable tool for 5G NR security testing beyond DoS vulnerabilities. Such tooling capabilities of launching both attacks and test cases are detailed in Section 5.

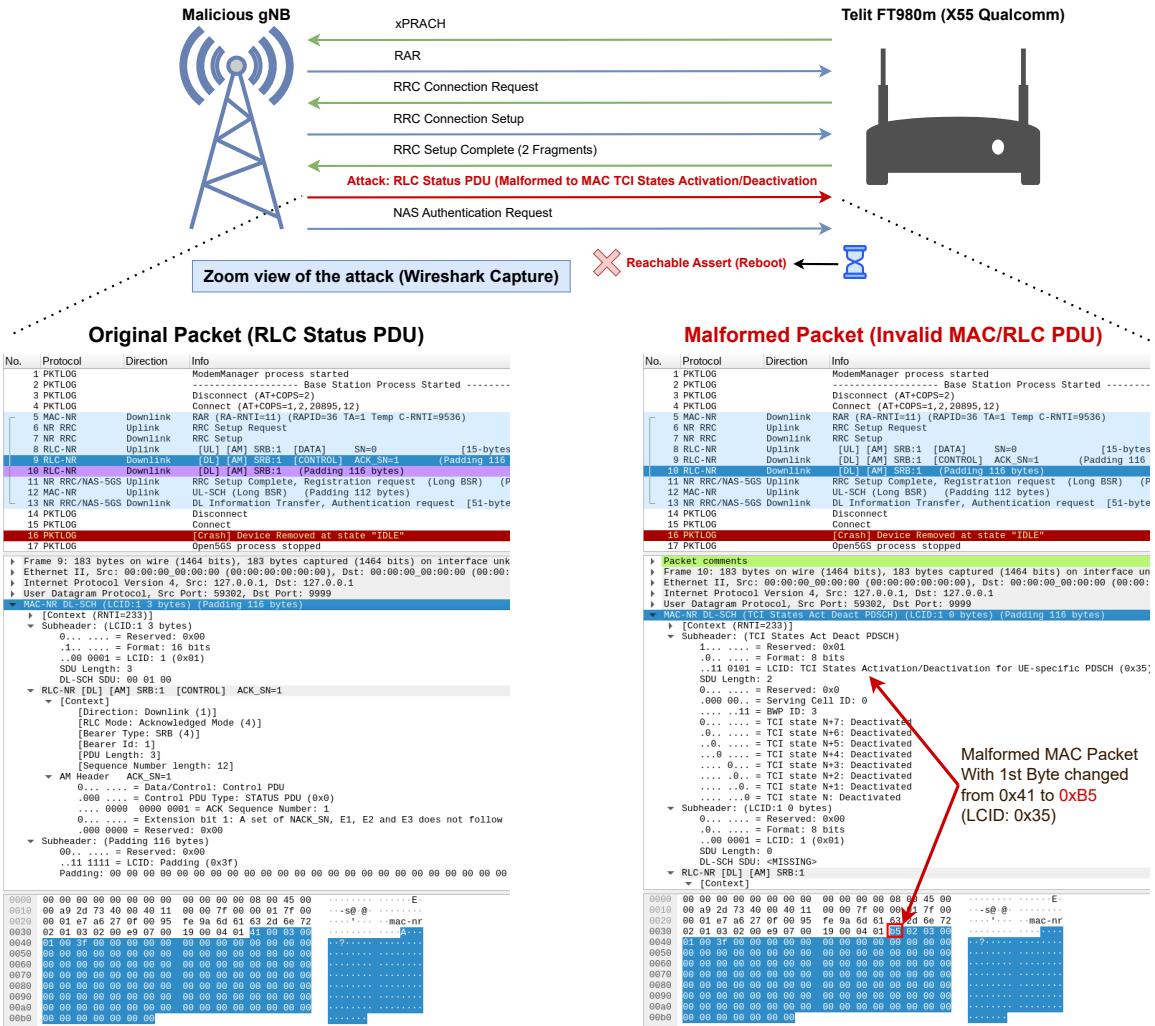
[ASSERT] nr5g_ml1_mdb.c:12636 Assert serving_cell_ptr->cell_data.nr5g.configured_bwp_bmask & (1< <bwp_idx)
failed: gNB beam update for BWP not configured 0x1

Impact: An attacker within X55/X60 modem-based UE radio range can block 3GPP Modem connectivity by continuously sending an invalid packet. Furthermore, this vulnerability is fairly easy to trigger since no information about the target's SIM card information is required to launch the attack. This is because the invalid downlink frame is sent during the RRC attach procedure, which happens before any NAS authentication procedure.

Figure 11: Invalid MAC/RLC PDU.

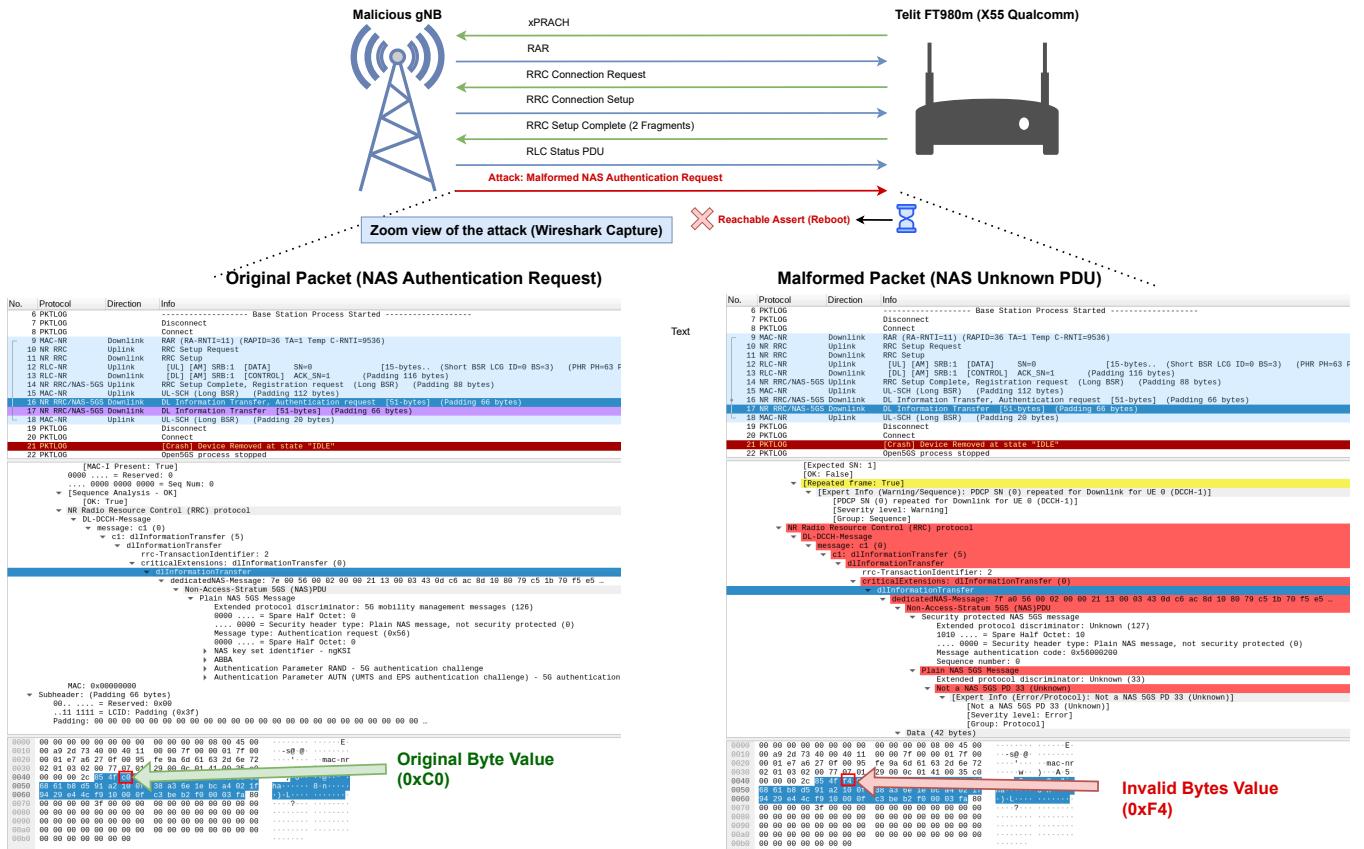
[ASSERT] ds_3gpp_tlb_ctrl.c:2088 Assertion msg_size == 1 failed

Impact: An attacker within X55/X60 UE radio range can block 3GPP Modem connectivity by continuously sending an invalid packet. Furthermore, this vulnerability is fairly easy to trigger since no information about the target's SIM card information is required to launch the attack. This is because the invalid downlink frame is sent *early* in the NAS registration procedure, which happens before any NAS authentication procedure completes.

Figure 12: NAS Unknown PDU.

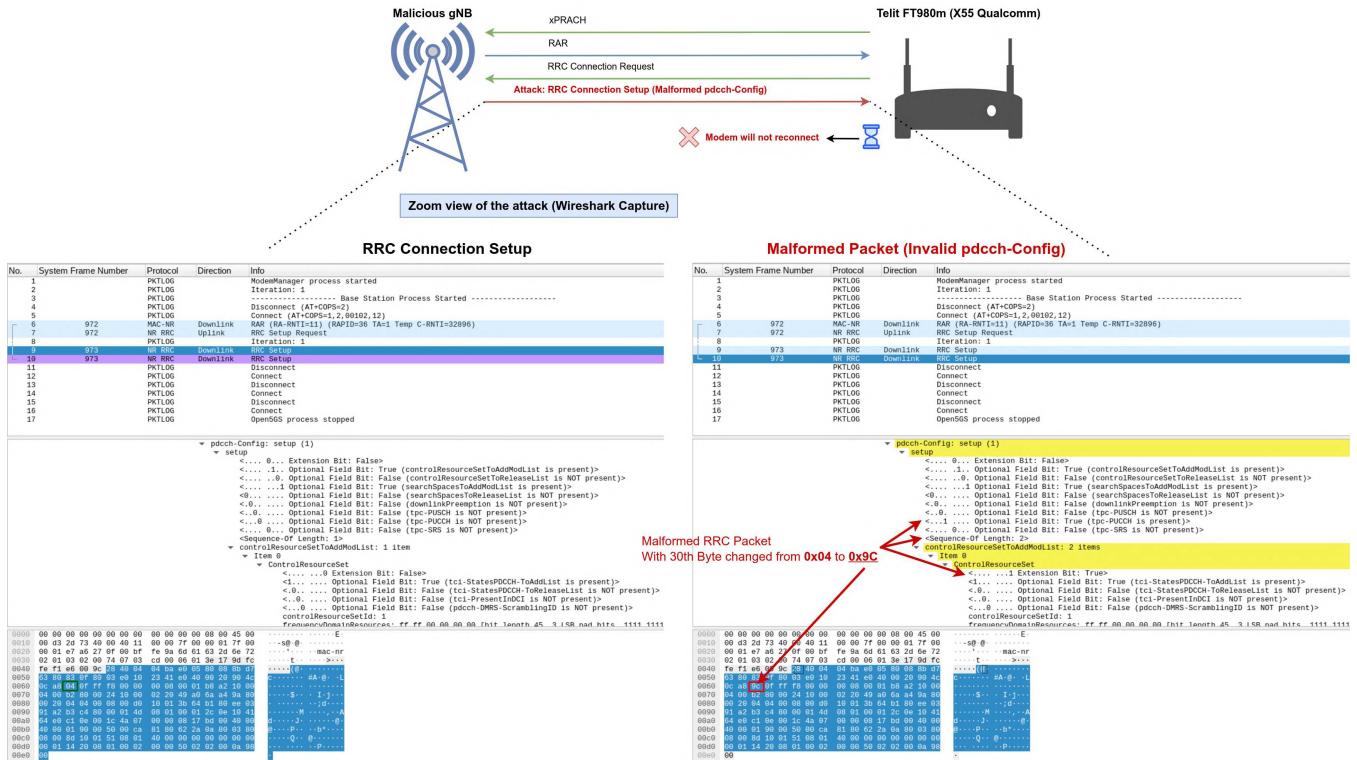
7.3 V7: Disabling 5G / Downgrade via Invalid RRC pdcce-Config (CVE-2023-33042)

An attacker within radio range can trigger a 5G connectivity downgrade or denial of service within the **Qualcomm's X55/X60** modem firmware by means of sending malformed RRC frame to the target 5G UE (smartphone, CPE router) from a nearby malicious gNB. During the *RRC Attach Procedure*, the attacker (malicious gNB) sends a malformed NAS PDU, changing the 30th byte of the **RRC dInformationTransfer** payload from **0x04** to **0x9C**. This modifies optional bits of the **pdce-Config** such as **tpc-PUCCH** and **Sequence-Of Length** (See these bytes highlighted in red in the Figure 12). After the malformed message is sent to the 5G UE, connection to any 5G network fails. For example, USB Modems or CPE Routers are often not able to scan 5G networks via the serial command **AT+COPS=?** and hence connection to any gNB (including legitimate ones) fails. Moreover, attempting to connect to any listed 5G network does not succeed either. This behavior was verified to occur in all of our 5G-capable Qualcomm devices such as *Asus Rog Phone 5S*, *Quectel RM500Q-GL* etc (see Table 2). Once the attack is launched, the X55/X60 modem remains affected until the user reboots the phone. Simply switching airplane mode on and off does not restore 5G communication.

Impact: An attacker within Qualcomm X55/X60 UE radio range can deny or downgrade 5G connectivity by sending a single malformed packet. The user needs to manually reboot the phone to recover 5G connectivity. Furthermore, this vulnerability is fairly easy to trigger since no information about the target's SIM card information is required to launch the attack. This is because the invalid downlink frame is sent during the RRC attach procedure, which happens before any NAS authentication procedure.

Figure 13: Disabling 5G / Downgrade via Invalid RRC pdcce-Config.

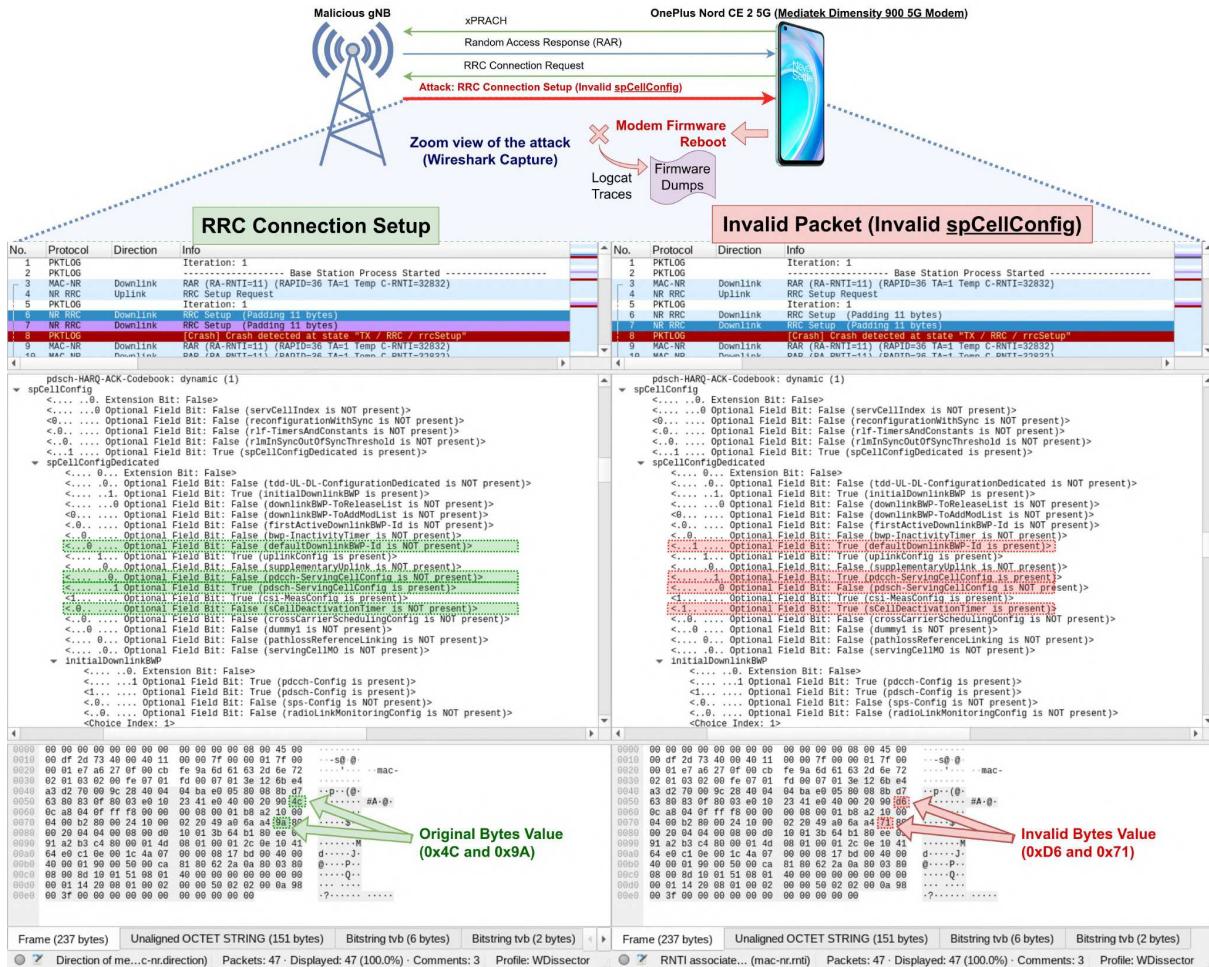
[ASSERT] file:mcu/l1/mml1/mml1_endc/src/mml1_endc_db_hdlr.c line:524 p1:0x91920c70

Impact: *The attacker can block 3GPP Modem connectivity by continuously sending such invalid packet.* Furthermore, this vulnerability is fairly easy to trigger since no information about the target's SIM card information is required to launch the attack. This is because the invalid downlink frame is sent *during* the RRC attach procedure, which happens before any NAS authentication procedure.

Figure 14: Invalid RRC Setup spCellConfig.

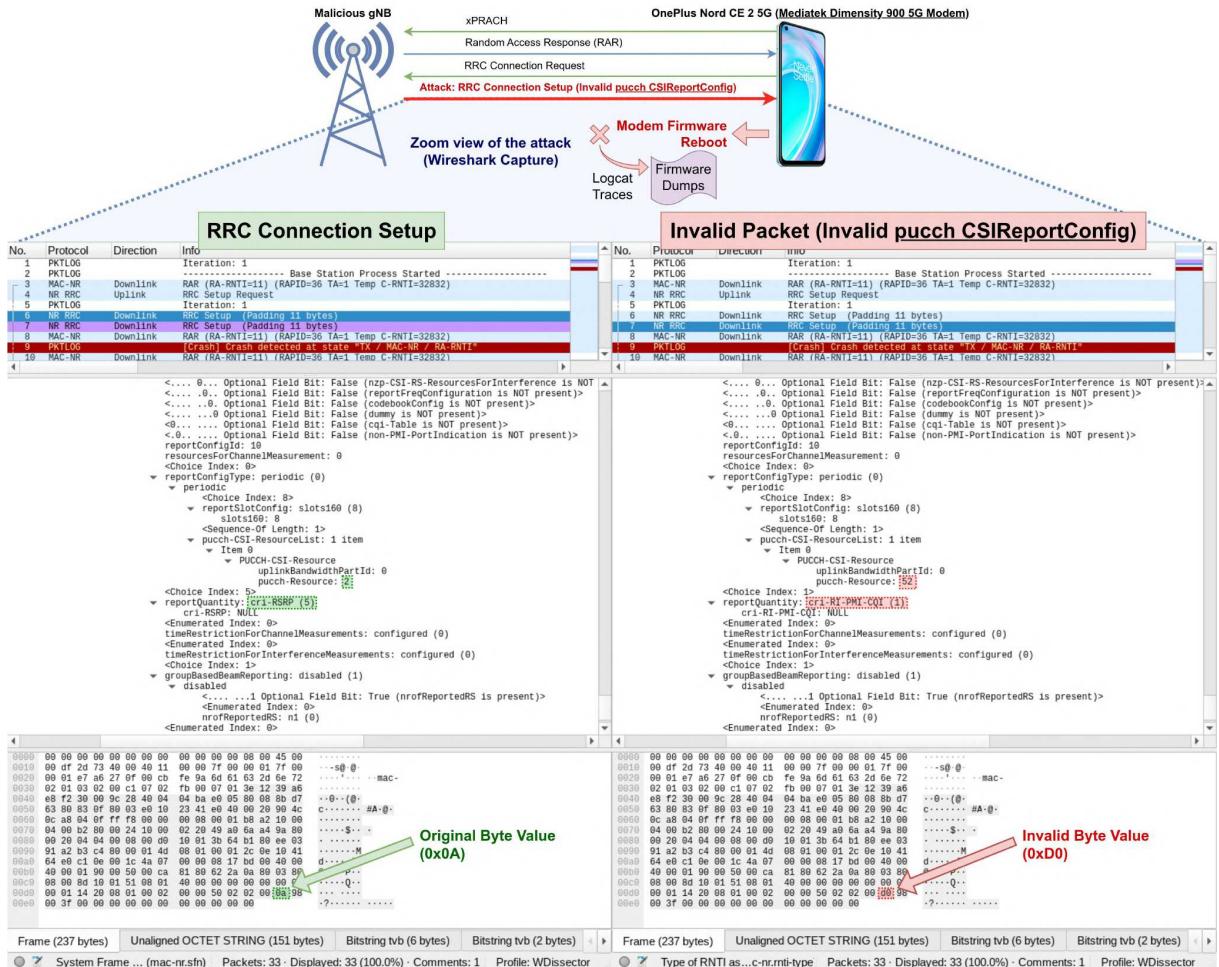
[ASSERT] file:mcu/l1/nl1/internal/md97/src/rx/nr_rx_dspcmd_ext_csiif_csi.c line:2657 p1:0x00000000

Impact: *The attacker can block 3GPP Modem connectivity by continuously sending such invalid packet.* Furthermore, this vulnerability is fairly easy to trigger since no information about the target's SIM card information is required to launch the attack. This is because the invalid downlink frame is sent *during the RRC attach procedure*, which happens before any NAS authentication procedure.

Figure 15: Invalid RRC pucch CSIReportConfig.

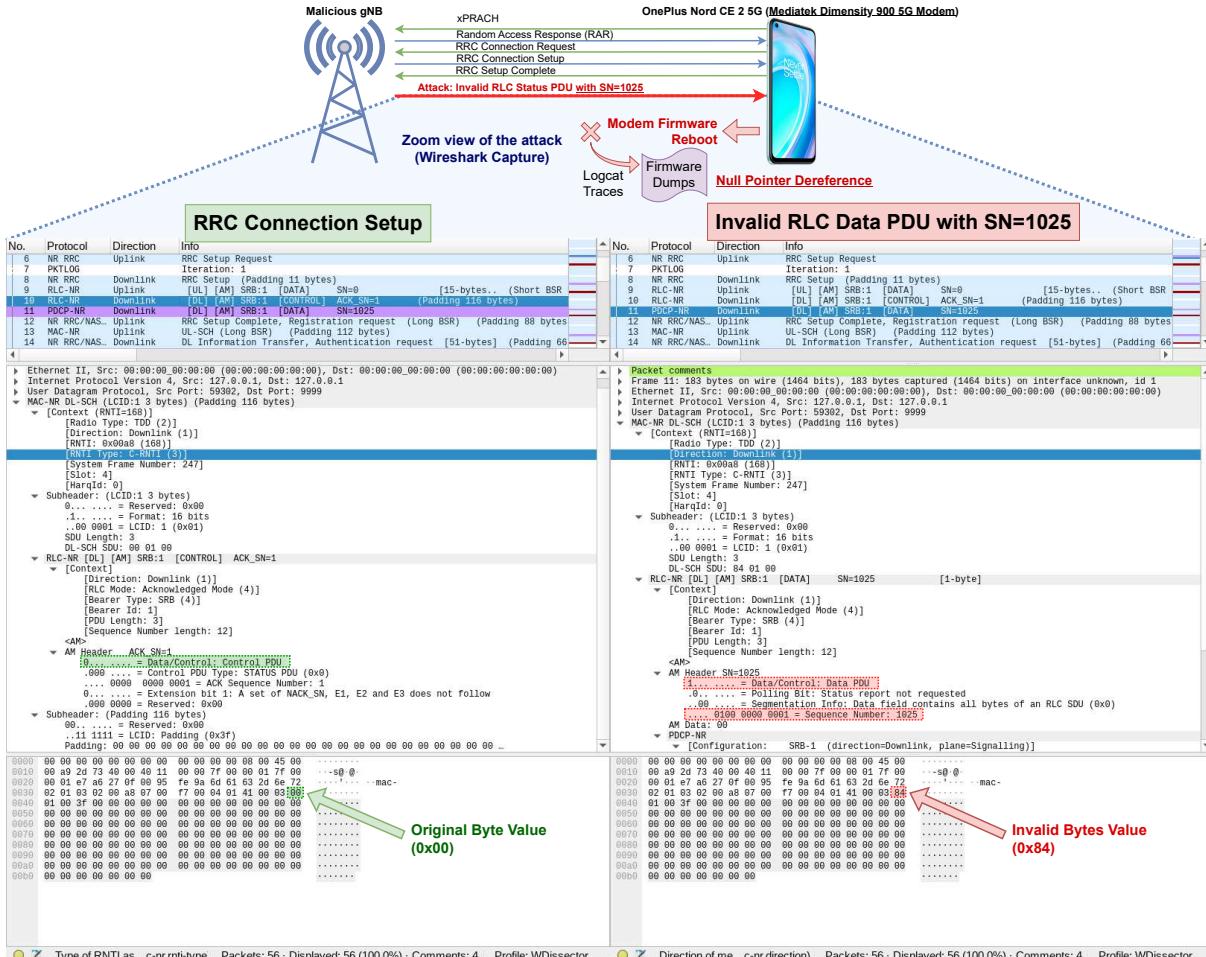
[Fatal error(MPU_NOT_ALLOW)] err_code1:0x0000001D err_code2:0x910D66F6 err_code3:0x910D66E2

Impact: The attacker can block 3GPP Modem connectivity by continuously sending such invalid packet. Furthermore, this vulnerability is fairly easy to trigger since no information about the target's SIM card information is required to launch the attack. This is because the invalid downlink frame is sent *after* the RRC attach procedure, which happens before any NAS authentication procedure.

Figure 16: Invalid RLC Data Sequence.

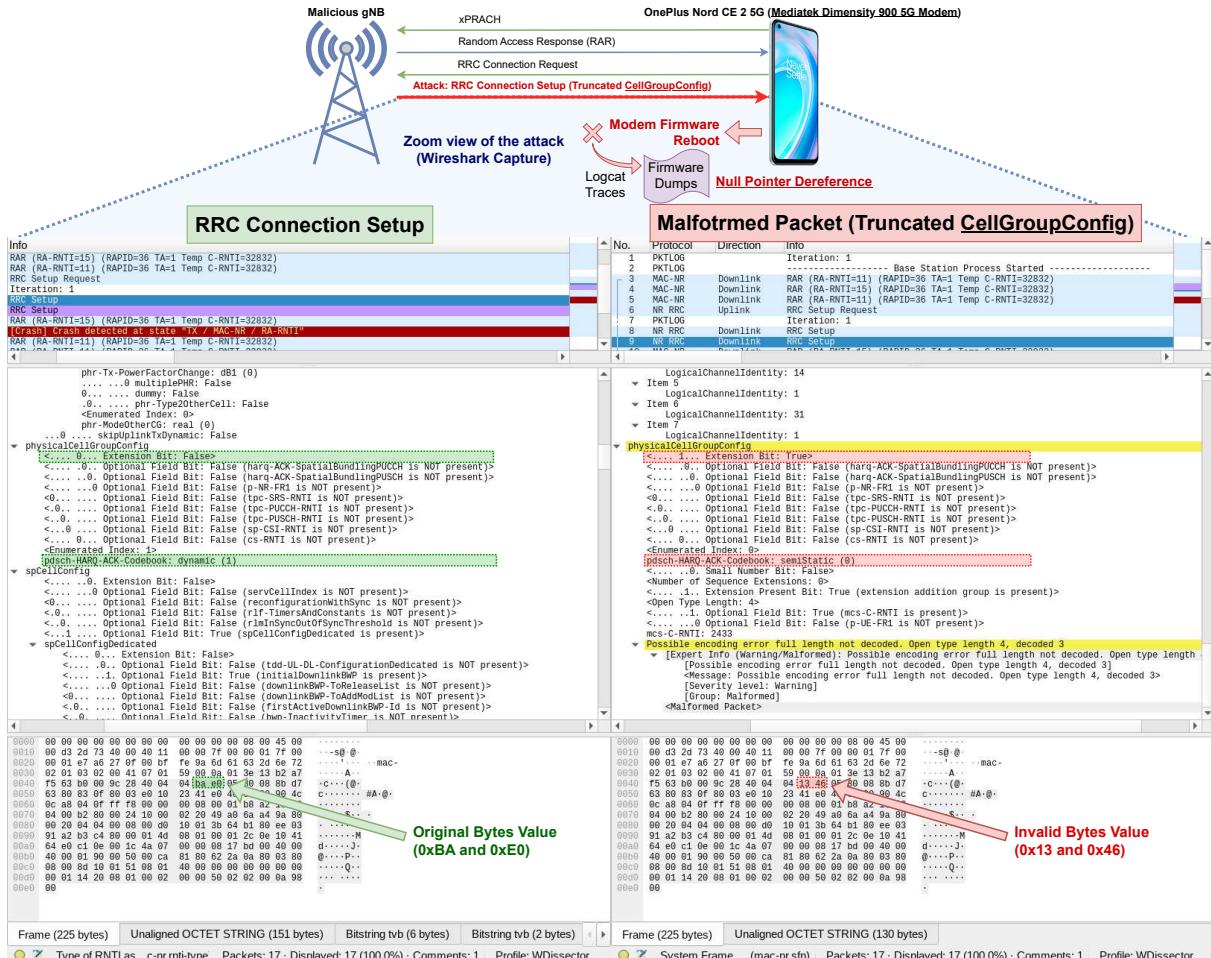
[Fatal error(MPU_NOT_ALLOW)] err_code1:0x0000001D err_code2:0x90F5D83A err_code3:0x90F5D836

Impact: *The attacker can block 3GPP Modem connectivity by continuously sending such malformed packet.* Furthermore, this vulnerability is fairly easy to trigger since no information about the target's SIM card information is required to launch the attack. This is because the invalid downlink frame is sent *during the RRC attach procedure*, which happens before any NAS authentication procedure.

Figure 17: Truncated RRC physicalCellGroupConfig.

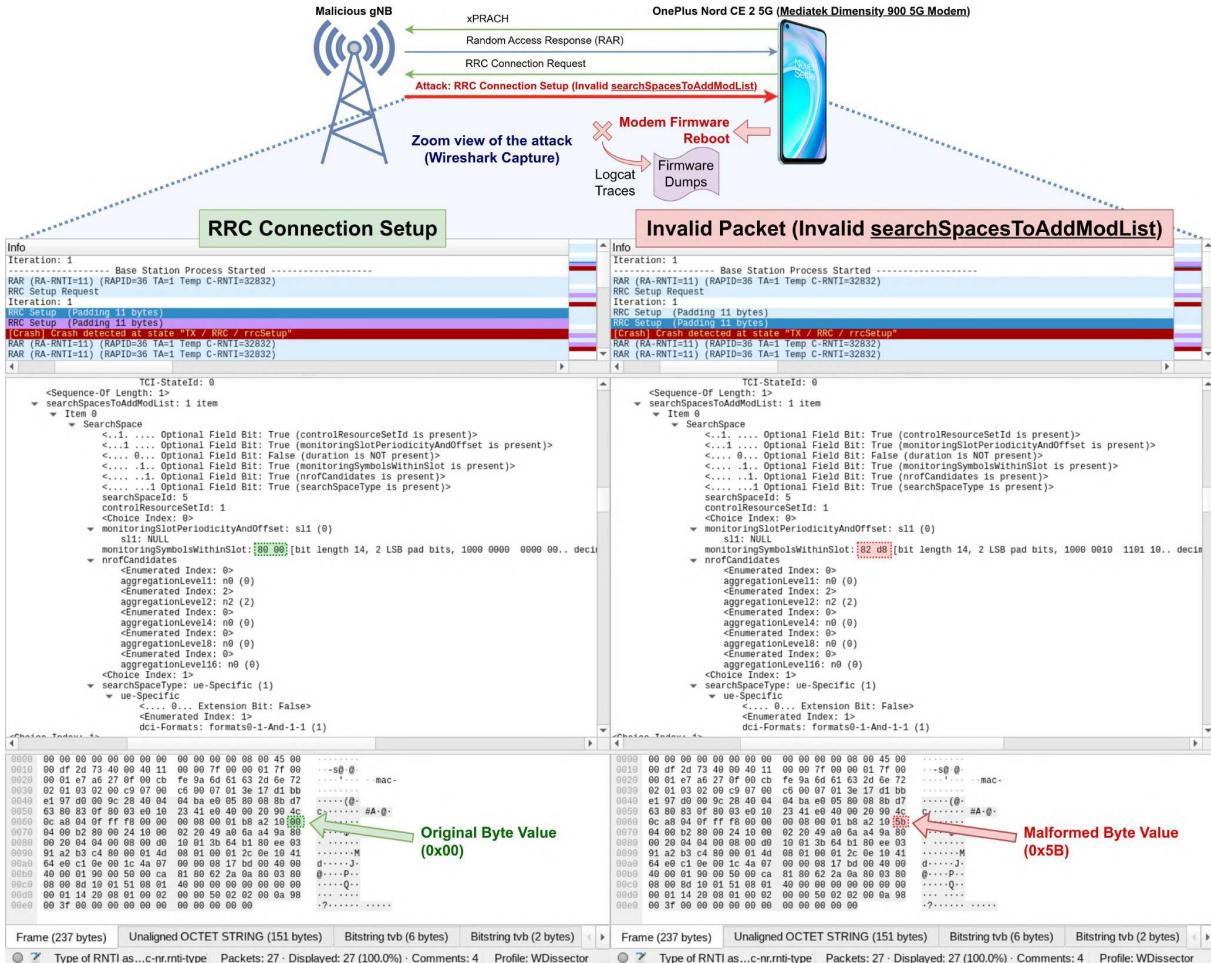
[ASSERT] file:dsp3/coresonic/msonic/modem/slm/nr_post_proc/src/nr_slm_rpt_hdlr.c line:9302

Impact: The attacker can block 3GPP Modem connectivity by continuously sending such invalid packet. Furthermore, this vulnerability is fairly easy to trigger since no information about the target's SIM card information is required to launch the attack. This is because the invalid downlink frame is sent *during* the RRC attach procedure, which happens before any NAS authentication procedure.

Figure 18: Invalid RRC searchSpacesToAddModList.

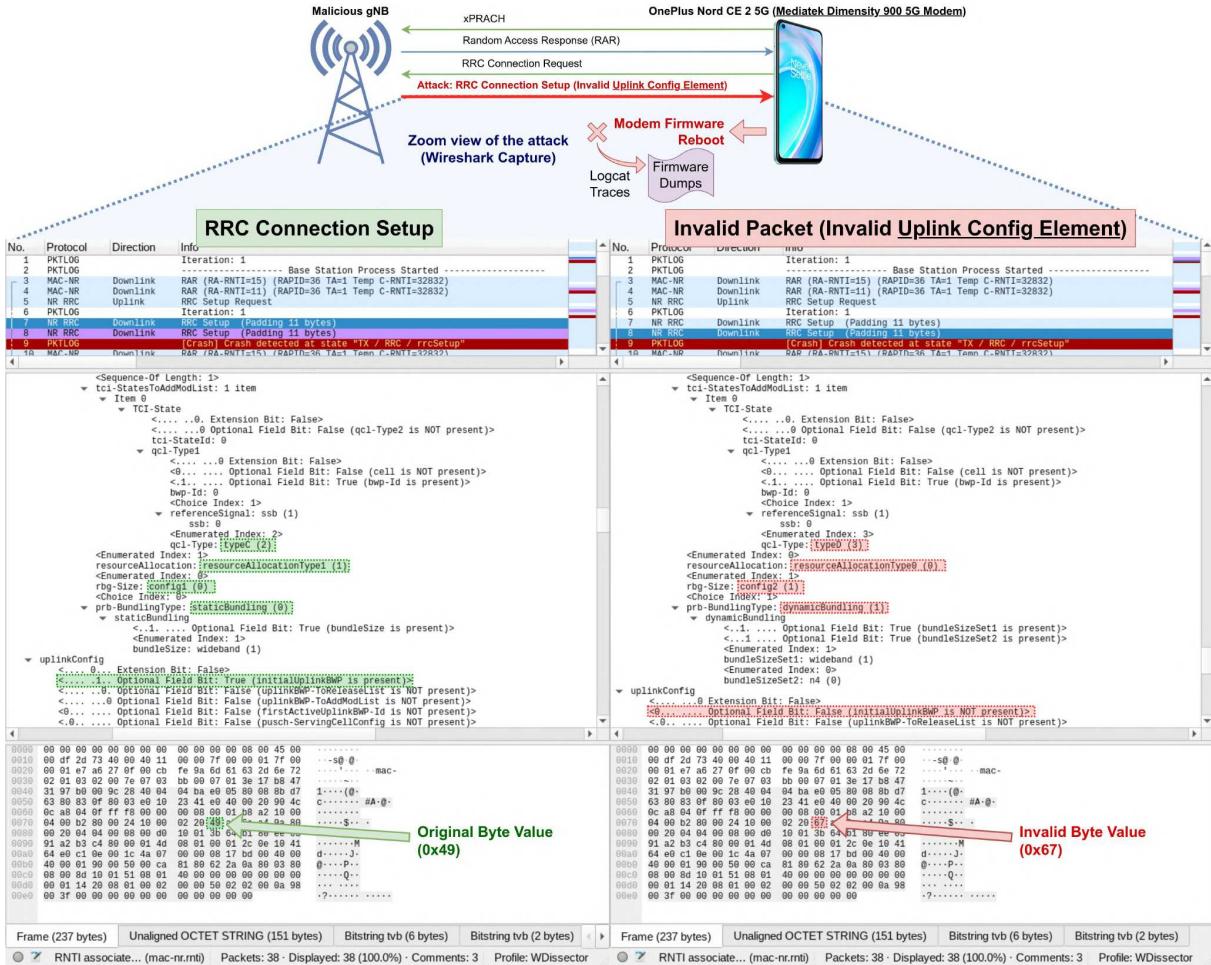
[ASSERT] file:mcu/l1/nl1/internal/md97/src/rfd/nr_rfd_configdatabase.c line:4380 p1:0x00000001

Impact: *The attacker can block 3GPP Modem connectivity by continuously sending such invalid packet.* Furthermore, this vulnerability is fairly easy to trigger since no information about the target's SIM card information is required to launch the attack. This is because the invalid downlink frame is sent *during* the RRC attach procedure, which happens before any NAS authentication procedure.

Figure 19: Invalid RRC Uplink Config Element.

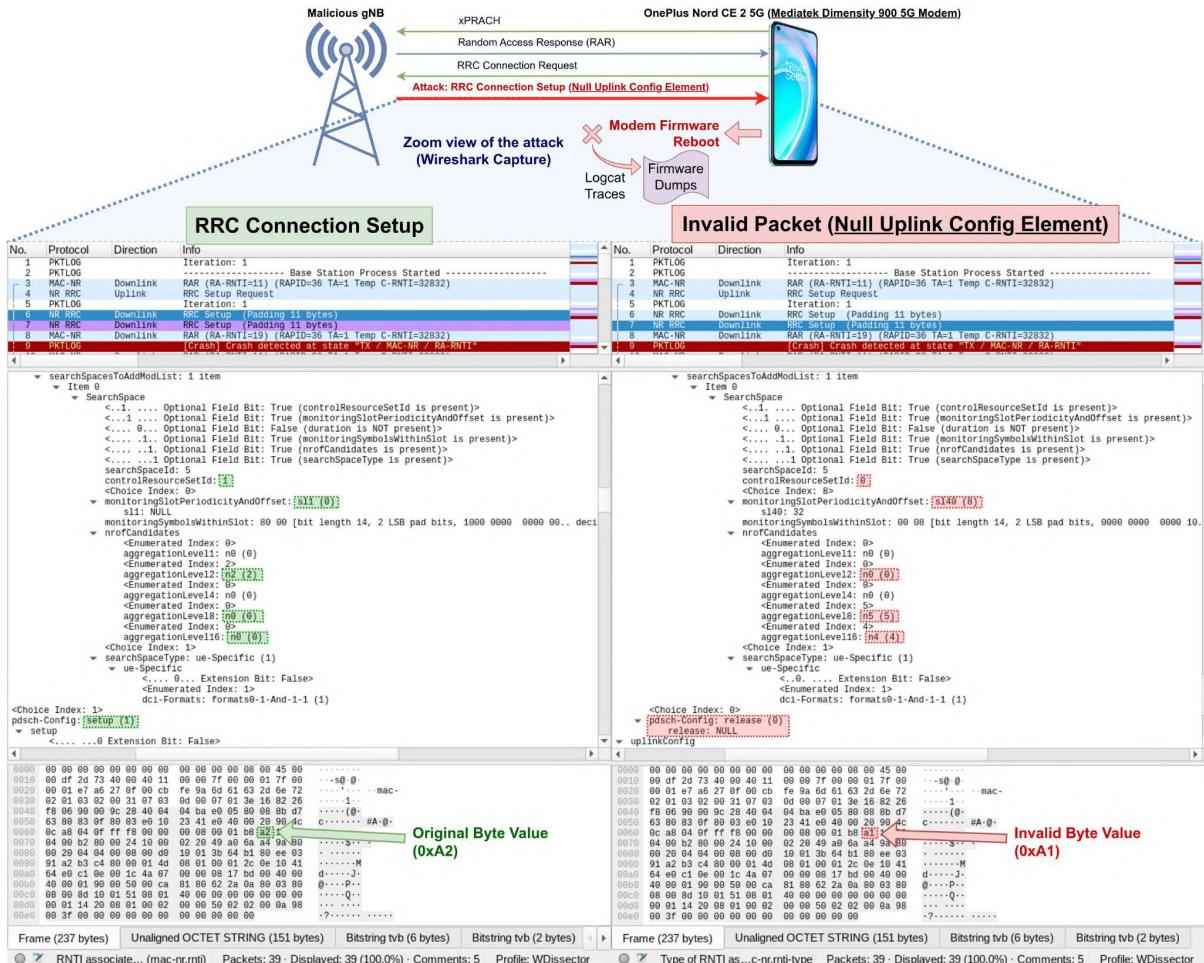
[ASSERT] file: dsp3/coresonic/msonic/modem/brp/nr_nr_brp/src/nr_brp_top_irq.c line:927

Impact: *The attacker can block 3GPP Modem connectivity by continuously sending such invalid packet.* Furthermore, this vulnerability is fairly easy to trigger since no information about the target's SIM card information is required to launch the attack. This is because the invalid downlink frame is sent *during* the RRC attach procedure, which happens before any NAS authentication procedure.

Figure 20: Null RRC Uplink Config Element.

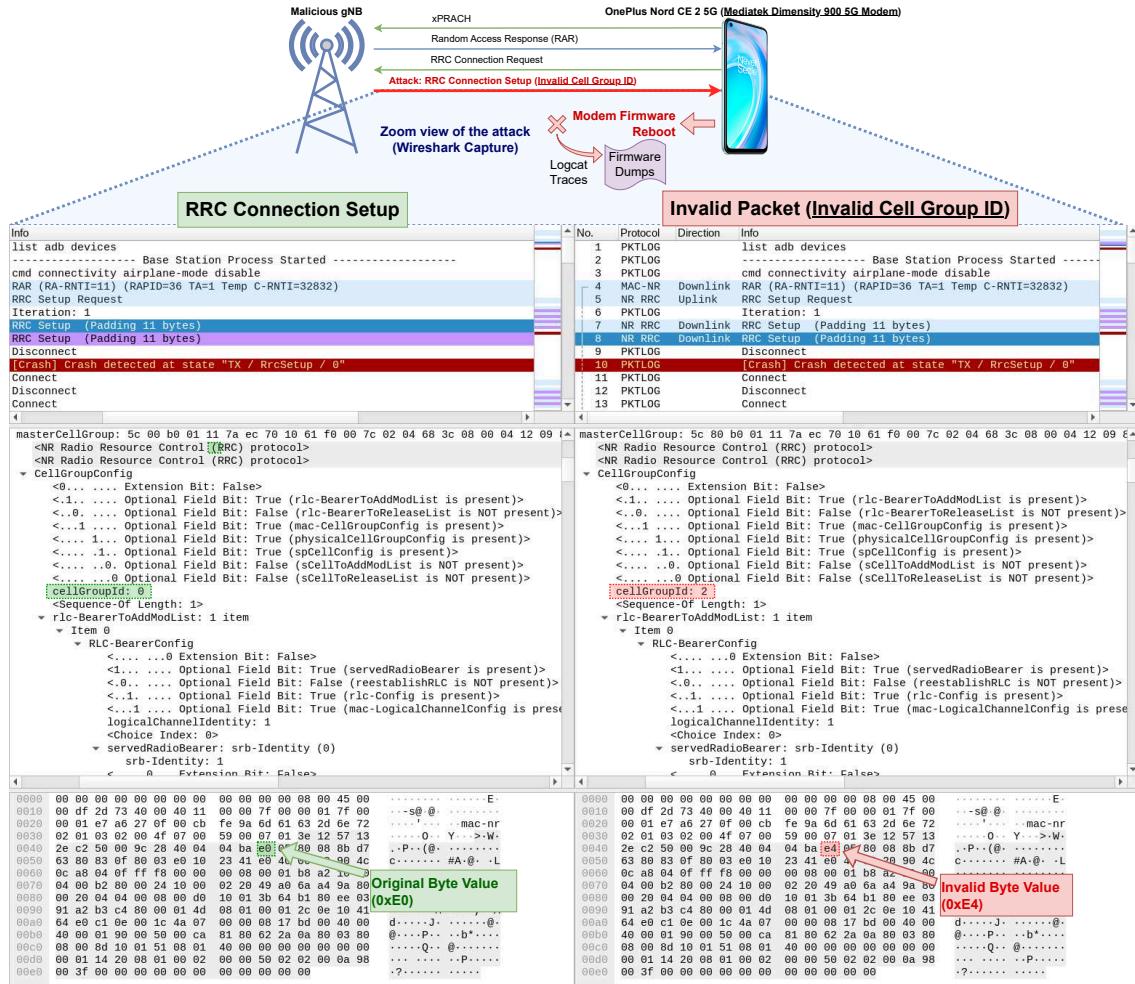
[ASSERT] file:mcu/l1/nl1/internal/md97/src/ctrl/nr_ctrl_mgm.c line:16460

Impact: The attacker can block 3GPP Modem connectivity by continuously sending such malformed packet. Furthermore, this vulnerability is fairly easy to trigger since no information about the target's SIM card information is required to launch the attack. This is because the invalid downlink frame is sent *during* the RRC attach procedure, which happens before any NAS authentication procedure.

Figure 21: Invalid RRC CellGroup ID.

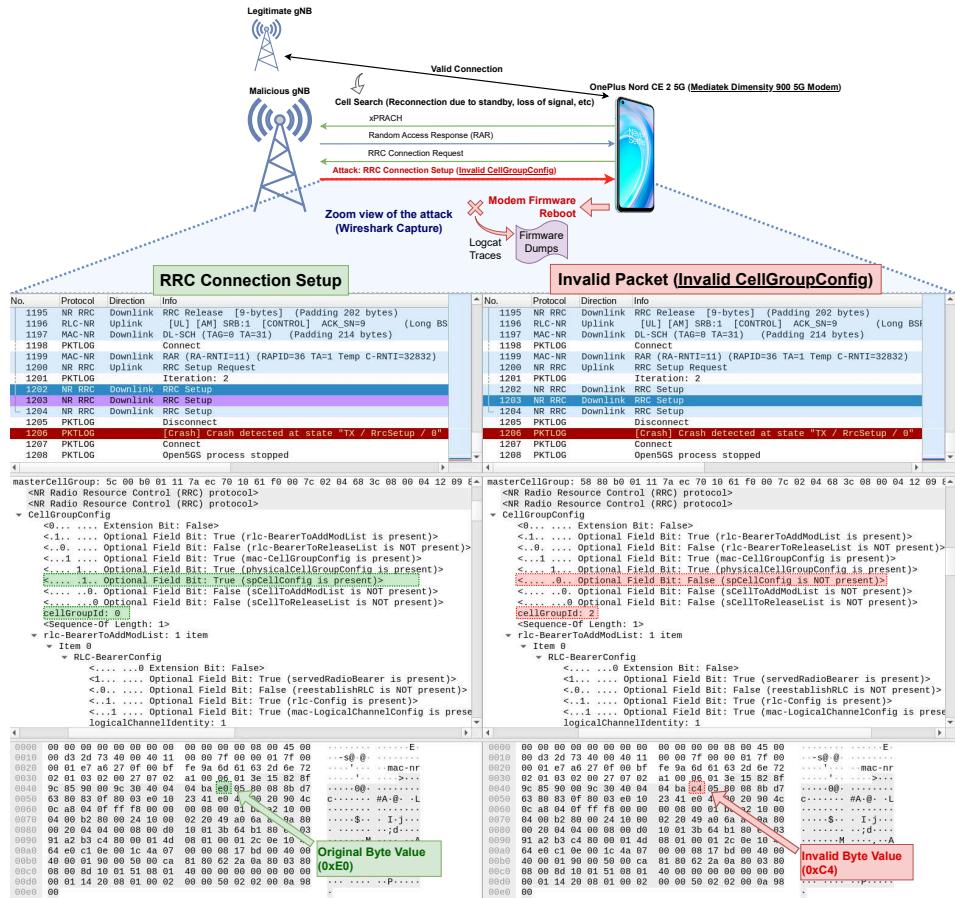
[Fatal error(MPU_NOT_ALLOW)] err_code1:0x0000001D err_code2:0x910885CE err_code3:0x910885CA
 [Fatal error(MPU_NOT_ALLOW)] err_code1:0x0000001D err_code2:0x910885AC err_code3:0x910885A8

Impact: *The attacker can block 3GPP Modem connectivity by continuously sending such malformed packet.* Furthermore, this vulnerability is fairly easy to trigger since no information about the target's SIM card information is required to launch the attack. This is because the invalid downlink frame is sent *during* the RRC attach procedure, which happens before any NAS authentication procedure.

Figure 22: Invalid RRC CellGroupConfig.
