Salt attack and rising damp

A guide to salt damp in historic and older buildings

David Young for Heritage Council of NSW · Heritage Victoria · South Australian
Department for Environment and Heritage · Adelaide City Council

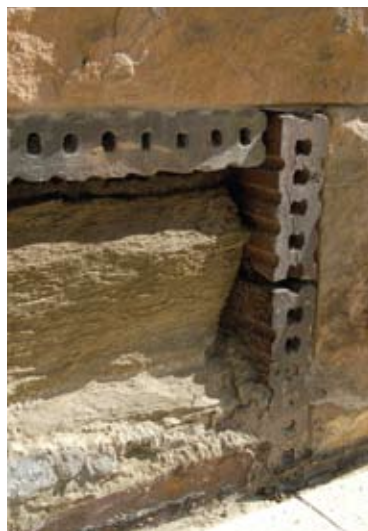
Figures 9 and 10 Hard burnt and glazed ventilating ceramic tiles and bricks. Made for the purpose, these are among the best dampcourses ever used, particularly the example at left from 1879. At right is a 1930s example which (together with its adjacent brickwork) is a remedial undersetting of an 1840s church of rubble limestone. Both examples were laid with open perpendicular joints to prevent damp travelling through the permeable mortar. In both cases salt attack is damaging the masonry below the DPCs — and each building will need treatments to control the salts (see Sections 13 & 14).

Some of the most effective DPCs used were glazed hard-burnt ceramic tiles or bricks, often with perforations allowing ventilation (Figures 9 & 10). These DPCs were laid without mortar in the perpendicular joints to prevent moisture passage through permeable mortar. The open joints also allowed through-wall ventilation. It is a great pity that glazed brick units suitable for DPCs are not made today as they have many advantages.

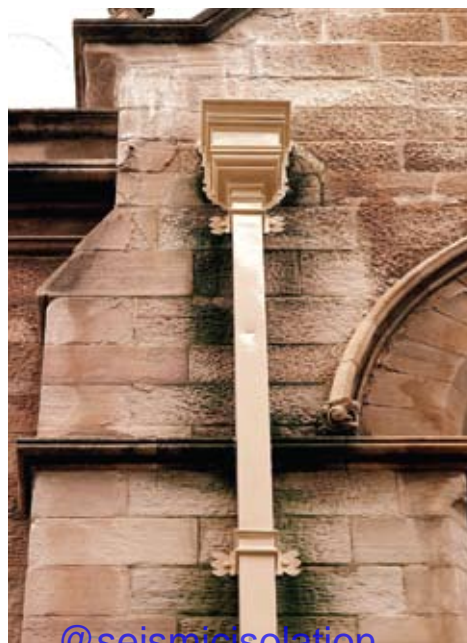
Figure 14 (right) Two examples of falling damp. Overflow from the blocked rainwater head is made apparent by dark green algae. The coping above the rainwater head is allowing water through to the stones below. Salt attack is causing these stones, above and to the left of the rainwater head, to decay.

The typical debris that builds up in roof gutters and on parapets (such as fallen leaves, bird manure, mosses and dirt) contains weak acids which will contribute to masonry decay by slowly dissolving weaker components leading to progressively more porous and permeable materials. Salts also accumulate on the tops of buildings, not only near the coast, where sea spray is a major factor, but even in central Australia, where wind storms whip up salts from the dry salt lakes and where tiny particles of salt rain from the sky. Though the rates of accumulation of air-borne salt are relatively low, with time a building can absorb sufficient salt to cause damage, particularly when it is all concentrated at one point, such as the top of a blocked downpipe or rainwater head. The importance of regular maintenance of gutters and downpipes cannot be over-emphasised (Figure 14).

evaporates from the wall surface and leaves the salts behind (Figures 4 & 14). Tracing damp back to the point of entry can be difficult, particularly when the masonry is rendered and/or painted and the moisture is trapped behind the render or paint coating.

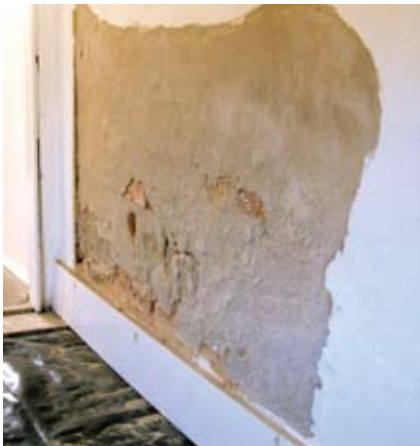
Figure 31 Sacrificial plaster decaying as intended. Plastic sheeting is used to catch the salts and prevent their recycling through the soils and walls.

As they crumble, sacrificial mortars and plasters will produce a dust of sand, lime and salt which should be collected and periodically removed, rather than allowing the salt to re-enter the soil and so be recycled up the wall. When protected from rain strike (internally, in a cellar, or on a veranda) a drop-sheet of strong plastic sheeting can be useful (Figure 31). An alternative treatment, using half round PVC piping beneath a timber floor is shown in Figure 27.

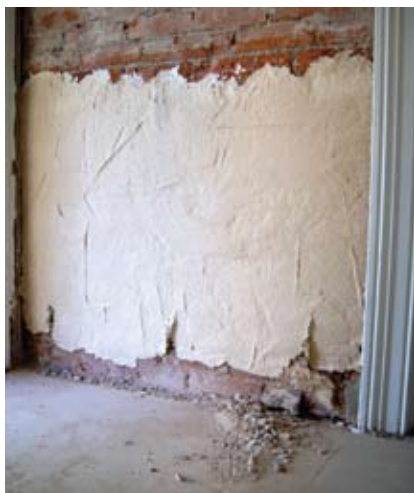
Figure 32 Absorbent poultice shortly after application to an interior wall from which plaster has been removed. The poultice is left on the wall until it is dry, which may take 2–3 weeks depending on weather conditions.

Poultices are applied wet to dryish masonry; the water contained in the poultice soaks slowly into the wall and dissolves salts, while the poultice shrinks onto the wall face (Figures 32 & 33). As the wall dries, water carrying salts in solution is drawn back to the surface by the high suction created by the fine pores in the poultice. The water evaporates and salts precipitate within the poultice, which is left on the wall until it dries out; this may take several weeks, depending on the weather. The poultice is then removed, taking the salt with it. Two or three cycles of poulticing may be required to reduce salt concentrations down to an acceptable level.

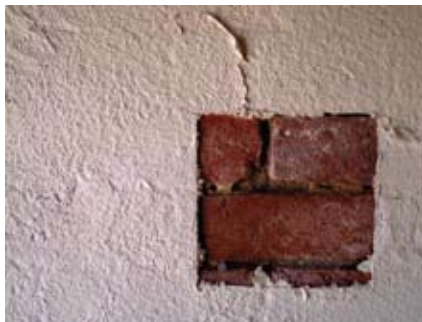
Figure 33 A square section of dried poultice has been cut out for chemical analysis. Sampling of the same point during subsequent cycles of poulticing is aided by a marker such as the galvanised nail in the bottom left of the 'window'.

As well as sampling the masonry for its salt content, poultice materials can be sampled as they are about to be removed from the wall (Figure 33). The results will not be comparable with those from the wall itself but can be used to monitor the effectiveness of poulticing over a series of cycles; later cycles will generally draw less salts, although experience suggests that sometimes the second cycle will draw more salt than the first. While a reduction in salt content will demonstrate the declining efficacy of further poulticing, it will not prove conclusively that the wall has been desalinated: only samples taken from the wall will do that. However, sampling the poultices has the advantage of not damaging the masonry: this may be important, particularly in high-value works such as sculpture.

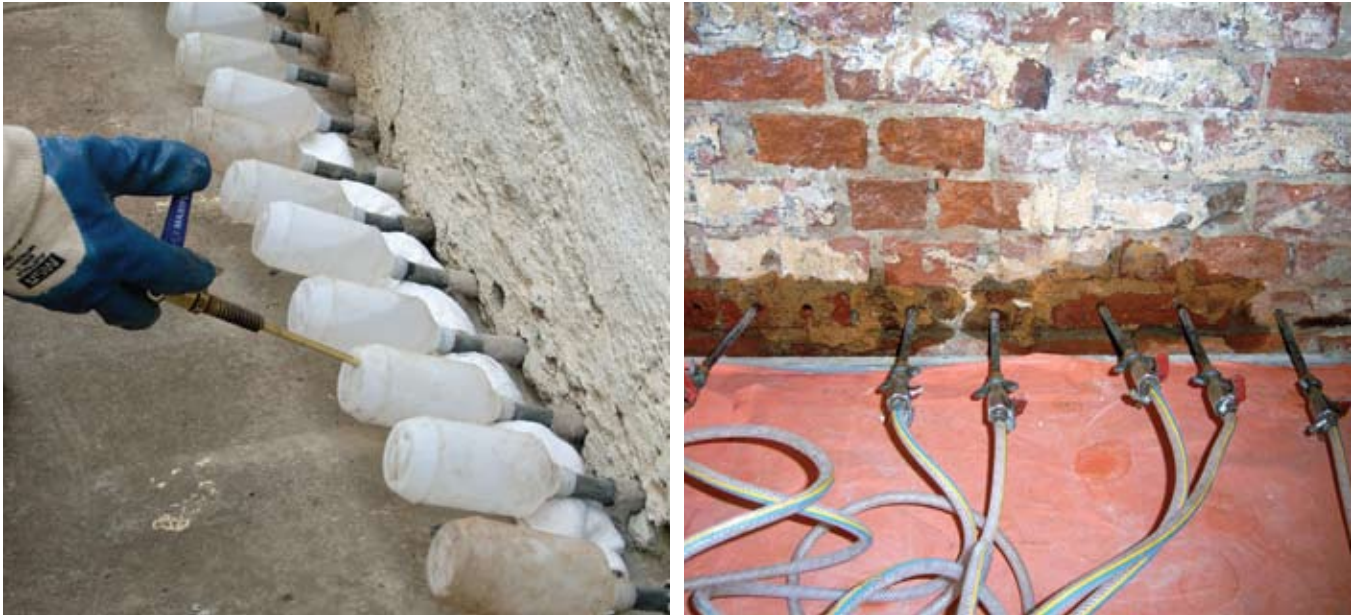
Figure 41 and 42 Chemical impregnation. On the left: the gravity feed system in which small plastic bottles are filled with a lance. Depending on the nature of the masonry and thickness of the wall the bottles are filled three and sometimes four times. Open holes just above the drilled line are used to indicate extent of penetration. On the right: low-pressure injection in progress on an interior wall from which plaster has been removed. Note the variation in the permeability of the brickwork; the brick on the left is already saturated and the lance is moved on while the central brick slowly fills with fluid.

Fluid is delivered into the holes by either a tube or a lance depending on whether it is to be gravity-fed or injected under low pressure (Figures 41 & 42). The choice of technique is to some extent determined by the nature of the masonry: gravity-fed diffusion is suitable for porous mortars and soft bricks, while normal bricks can be injected under low pressure (20–70 psi, 150–500 kPa). High pressure injection (greater than 150 psi, 1000 kPa) risks the blowout of weak mortars and imperfect coverage in sound materials due to viscous fingering, a process in which the fluid advances as a series of fingers, leaving gaps between.

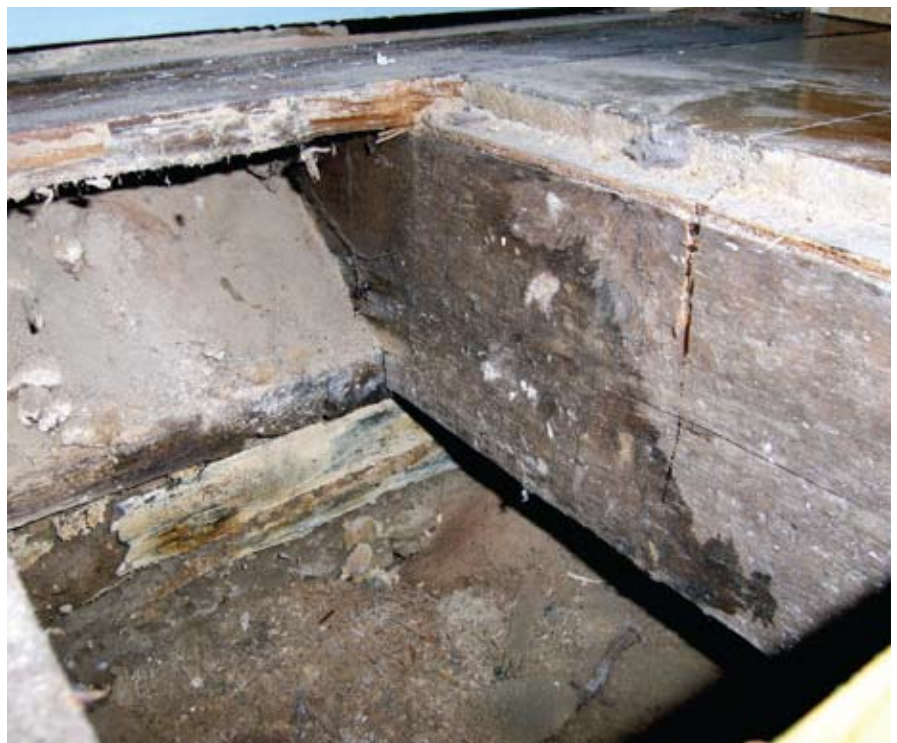
Figure 49 The photograph at right is looking beneath a floor against a damp wall, and shows a wet zone on the timber joist and plaster debris on the floor plate, which is wet and rotten. The diagram below is a sectional view showing how the plaster debris drops behind the floorboards and sits on the floor plate. The debris provides a path or bridge around the DPC. Even though the DPC may have been only partially effective, the newly created bridge will add to the rate at which damp rises. And the salt that caused the first plaster to fail is being recycled into the wall where it will cause more damage. Furthermore, the plaster debris holds moisture against the floor timbers, increasing the risk of fungal rot and insect attack.

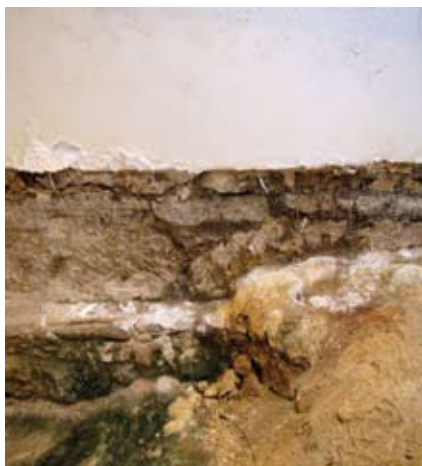
Figure 53 Damaged plaster on a damp wall; the dampness is indicated by green algae and white salts crystallising on the stonework and fill below. The recent plaster is decaying because it contains gypsum.

Gypsum plasters should not be used where there is any risk of continuing dampness. This is because gypsum, which is calcium sulphate ($\text{CaSO}_4 \cdot 2\text{H}_2\text{O}$) is a slightly soluble salt and any moisture will trigger salt attack within the new plaster (Figure 53). Use only lime or lime-cement plasters where walls may be subject to continuing dampness. Portland cements contain gypsum and other salts which may add to a damp problem. Specify low-alkali cements to keep salts to a minimum.

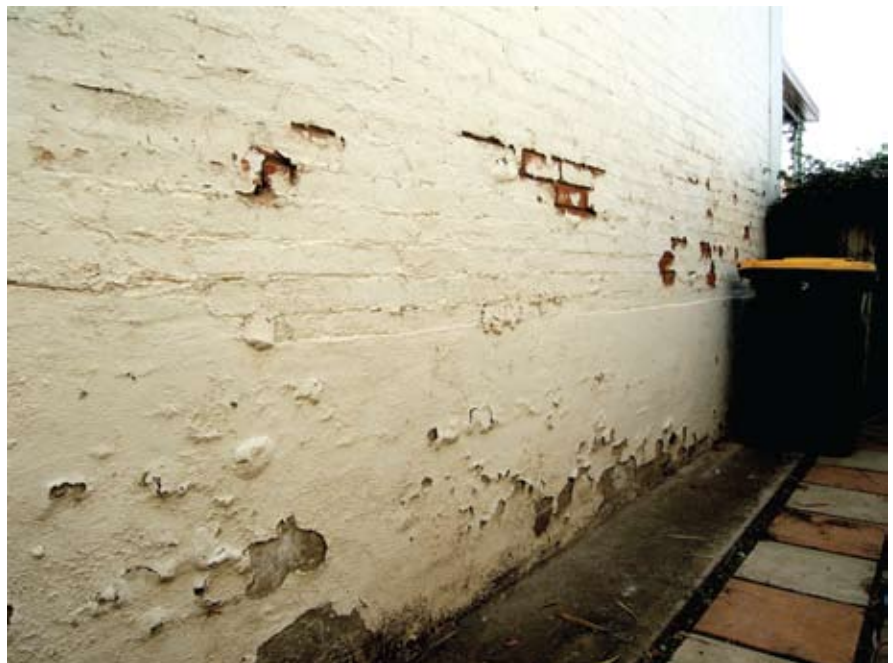
Figure 54 Failure of an acrylic paint coating due to salt damp. The bottom part of the wall is rendered in cement, which has contributed to the damp rising further due to its relative (but not total) impermeability. Decay of the brickwork is focussed where the paint film fails because that's where salt crystallises as moisture evaporates. The paint and the render should be removed and replaced with a more vapour-permeable coating such as limewash.

The same principle can be applied to plasters or renders. By using weak plasters the evaporative front (and hence decay) is moved from the original masonry out into the new plaster. Provided there is sufficient evaporation from the sacrificial plaster, decay can be limited to the lower parts of a wall. These treatments are the opposite of the incorrect practice of rendering the base of affected walls with dense, relatively impermeable cement renders. This simply prevents the evaporation of moisture, which continues rising up the wall until it can evaporate above the render, starting the problem all over again (Front cover & Figure 54).

Acrylic (water-based) paints are more vapour-permeable than alkyd (oil-based) paints; the latter should not be used where walls remain damp or are still drying out after DPC insertion. Even the acrylics can be too impermeable for old walls (Figure 54). In these circumstances alternative coatings such as cement-based paints and traditional limewashes should be considered. Limewashes are more vapour-permeable than cement-based paints.

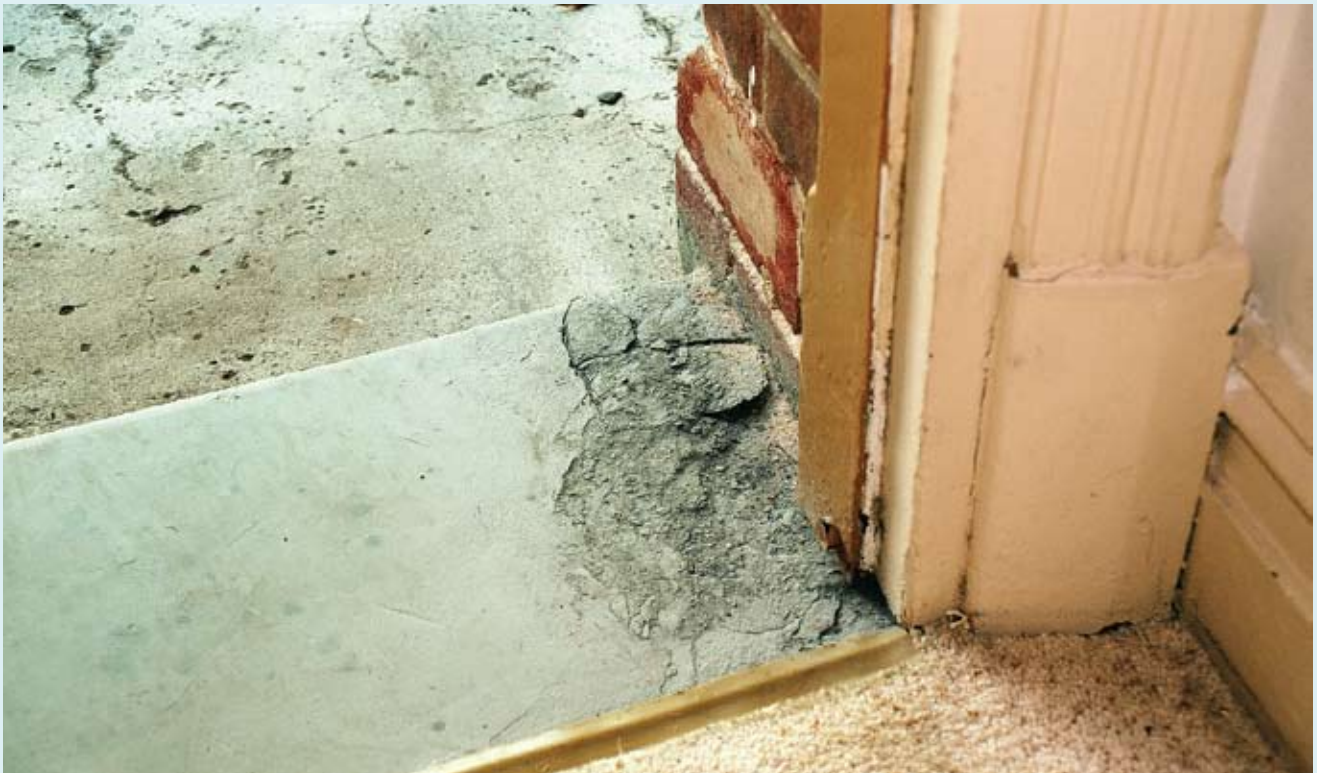
Box 9, Figure 55

The third step, which is now doing fine after ten years, had its edges sealed with slate sealer prior to installation (several coats of siloxane dampcourse fluid would be an alternative). The new step is bedded on a plastic DPC and on weak mortar that will decay sacrificially in preference to the adjacent brickwork.

A brick house built in about 1900 had a slate front doorstep. Mild damp affects parts of the house particularly near the front door, causing the doorstep to delaminate and become powdery on the surface due to salt attack. The badly worn step was replaced in the mid-1980s with a new piece of slate from the same quarry. Within five years the new step began to decay in the same manner (Figure 55, below). What happened? Why did the first step last eighty-odd years and yet the second need replacing after ten? Perhaps the slate is not what it used to be?

The dense layered nature of slate contributes to its demise — its very fine pore structure has a high suction along the layers, while being relatively impermeable across the layers. Thus the slate will draw any available moisture in from its edges — edges which are butted against salty brickwork.
