## **5GHOUL : Unleashing Chaos on 5G Edge Devices**

### VULNERABILITY DISCLOSURE REPORT

December 07, 2023, UTC -12

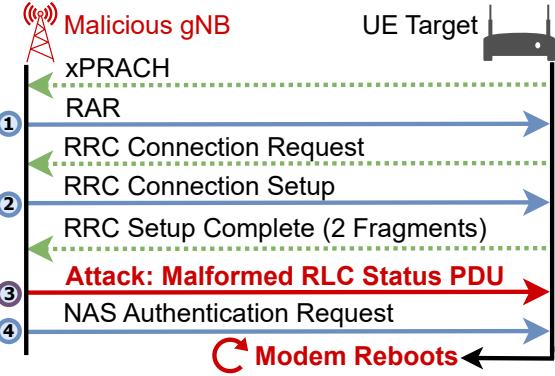
Figure 3: Illustration *V5 - "Invalid MAC/RLC PDU"*

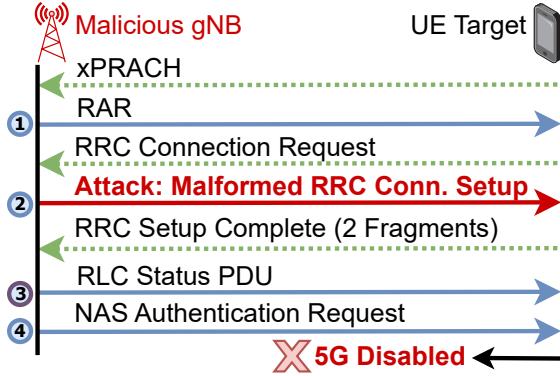
Figure 4: Illustration **V7** - “*RRC Invalid pdccch-Config*”

More surprisingly, vulnerability **V7** (see Figure 4) can prevent *ARP5s* to connect to any 5G network, while keeping 4G/3G connectivity intact (*i.e.*, *downgrade attack*). Nevertheless, such behavior of **V7** highlights that the mobile device modem enters an erratic state such that the user needs to manually reboot the phone, thus power cycling the modem to fully restore 5G connectivity. As illustrated in the Video 1, the im-

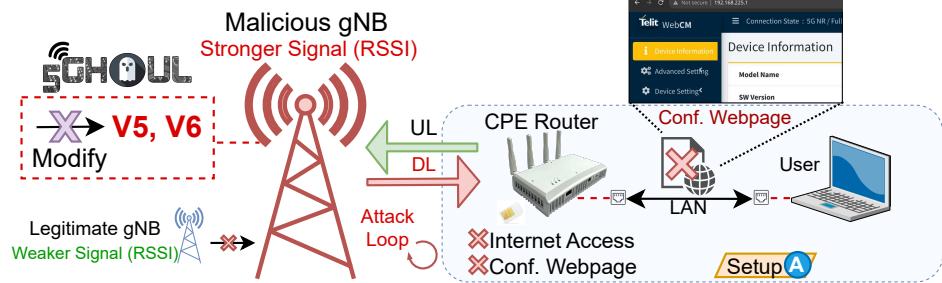
Figure 5: Impact of exploiting  $V5, V6$  on *Telit FT980m* operating as CPE Router (**Setup A**)

During our tests, the *FT980-WW* CPE exhibited more proactive attempts to recover 5G connectivity after attacks exploiting  $V5$  and  $V6$ , while the *Raspberry Pi 3B+ with OpenWRT* was less proactive, often requiring manual reconnection

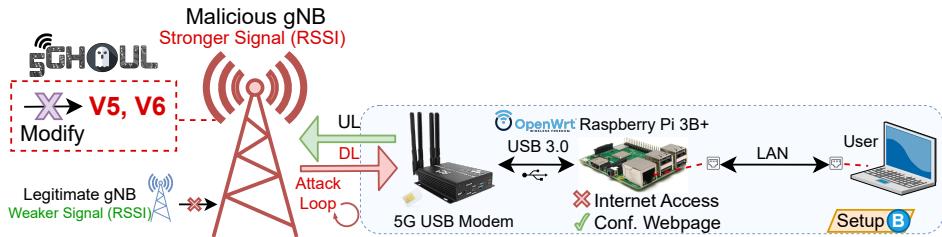
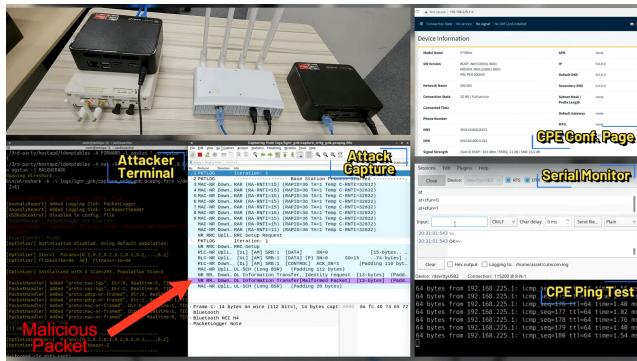
Figure 6: Impact of exploiting  $V5, V6$  on *RM500Q-GL* modem operating as CPE Router (**Setup B**)

In **Setup B** (shown in Figure 6), a Raspberry Pi 3B+ with *OpenWRT 22.03.4* [12] and *RM500Q-GL* 5G USB Modem (see Table 1) were used. This setup offered better isolation against attacks exploiting  $V5$  and  $V6$  since the *Configuration Webpage* was hosted by the *Raspberry Pi 3B+* processor instead of the modem itself. This allowed the user to remotely attempt to steer the CPE device by selecting a different mobile network to connect.

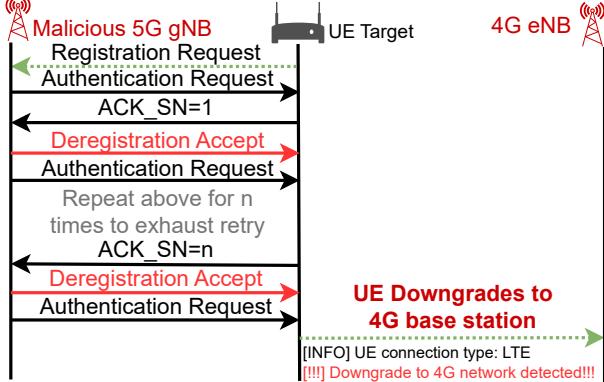
Figure 7: Downgrade via *NAS flooding*.

Our downgrade attack vector **DA1** is illustrated in Figure 7 and in Video 3. In this attack, the target device is kept in a *NAS Authentication procedure* loop by receiving many (i.e., flooding) *NAS Authentication Request*, followed by *NAS Deregistration Accept* many times. After the target device goes through an arbitrary number of retries in this scenario, it falls back to connect to the nearest 4G base station. *Notably, the UE cannot re-establish the 5G connection by merely toggling the airplane mode; it necessitates initiating a new connection process with the base station.* Such downgrade attack highlights the capability of 5GHOUL exploitation to be used as a valuable tool for 5G NR security testing beyond DoS vulnerabilities. Such tooling capabilities of launching both attacks and test cases are detailed in Section 5.

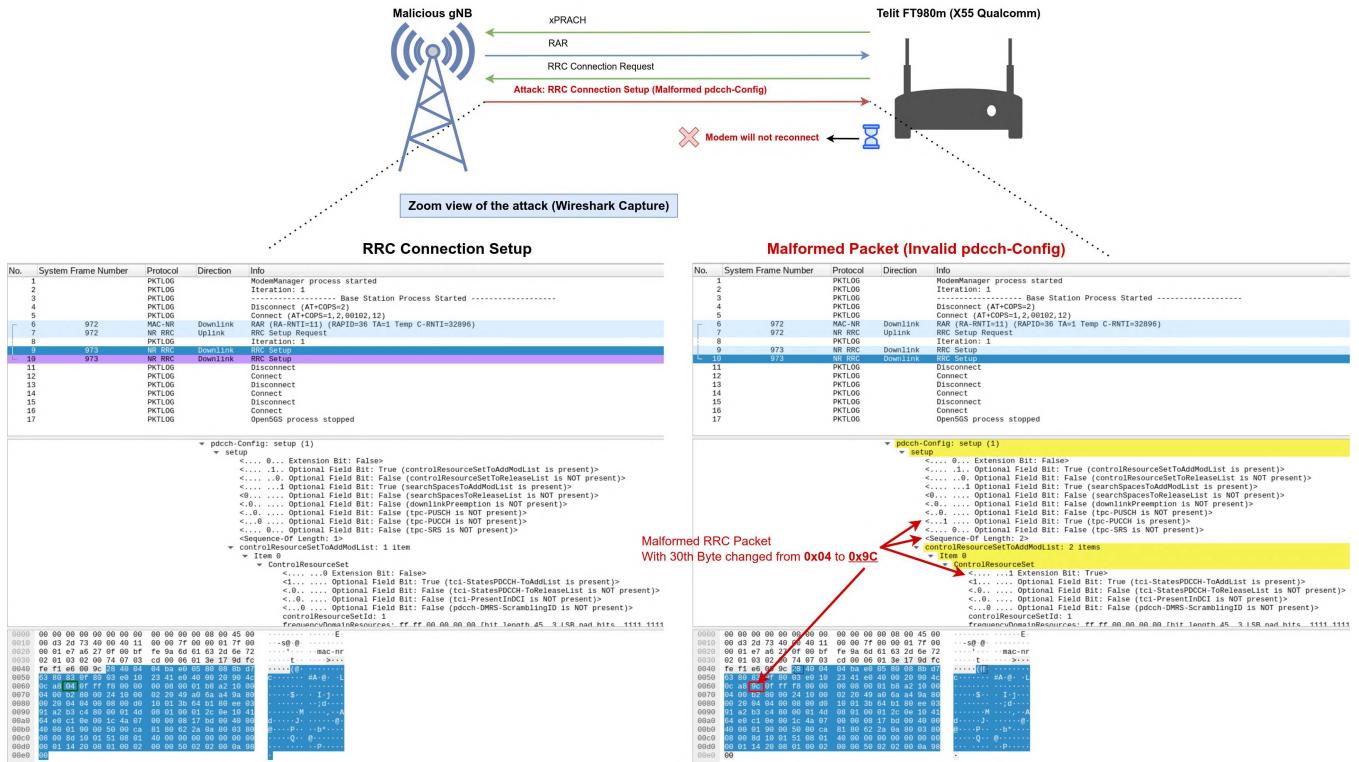
Figure 13: Disabling 5G / Downgrade via Invalid RRC pdcch-Config.

### 7.3 V7: Disabling 5G / Downgrade via Invalid RRC pdcch-Config (CVE-2023-33042)

An attacker within radio range can trigger a 5G connectivity downgrade or denial of service within the **Qualcomm's X55/X60** modem firmware by means of sending malformed RRC frame to the target 5G UE (smartphone, CPE router) from a nearby malicious gNB. During the *RRC Attach Procedure*, the attacker (malicious gNB) sends a malformed NAS PDU, changing the 30th byte of the ***RRC d1InformationTransfer*** payload from **0x04** to **0x9C**. This modifies optional bits of the **pdcch-Config** such as **tpc-PUCCH** and **Sequence-Of Length** (See these bytes highlighted in red in the Figure 12). After the malformed message is sent to the 5G UE, connection to any 5G network fails. For example, USB Modems or CPE Routers are often not able to scan 5G networks via the serial command **AT+COPS=?** and hence connection to any gNB (including legitimate ones) fails. Moreover, attempting to connect to any listed 5G network does not succeed either. This behavior was verified to occur in all of our 5G-capable Qualcomm devices such as **Asus Rog Phone 5S**, **Quectel RM500Q-GL** etc (see Table 2). Once the attack is launched, the X55/X60 modem remains affected until the user reboots the phone. Simply switching airplane mode on and off does not restore 5G communication.

**Impact:** An attacker within Qualcomm X55/X60 UE radio range can deny or downgrade 5G connectivity by sending a single malformed packet. The user needs to manually reboot the phone to recover 5G connectivity. Furthermore, this vulnerability is fairly easy to trigger since no information about the target's SIM card information is required to launch the attack. This is because the invalid downlink frame is sent during the RRC attach procedure, which happens before any NAS authentication procedure.

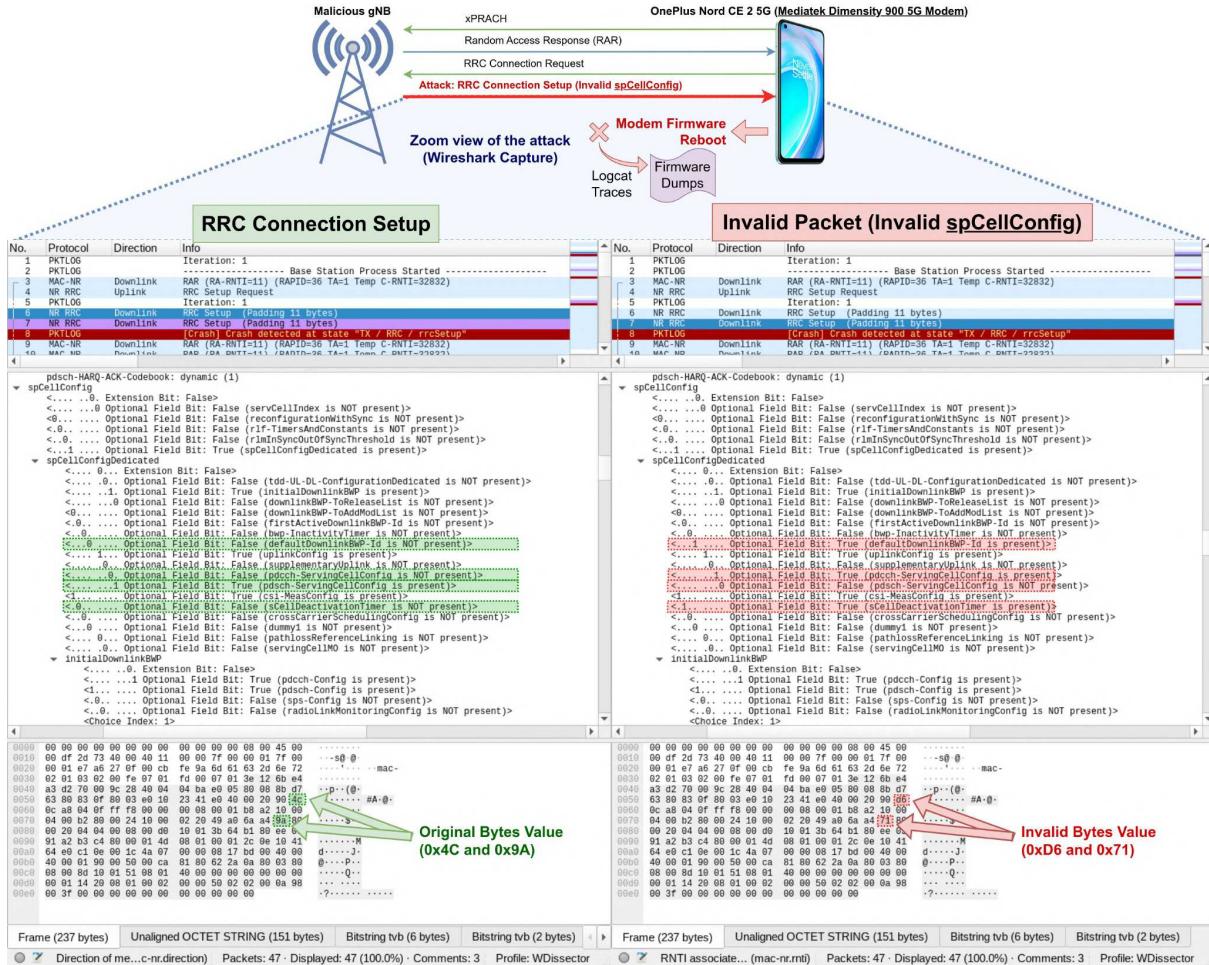
Figure 14: Invalid RRC Setup spCellConfig.

[ASSERT] file:mcu/l1/mml1/mml1\_endc/src/mml1\_endc\_db\_hdlr.c line:524 p1:0x91920c70

**Impact:** *The attacker can block 3GPP Modem connectivity by continuously sending such invalid packet.* Furthermore, this vulnerability is fairly easy to trigger since no information about the target's SIM card information is required to launch the attack. This is because the invalid downlink frame is sent *during* the RRC attach procedure, which happens before any NAS authentication procedure.

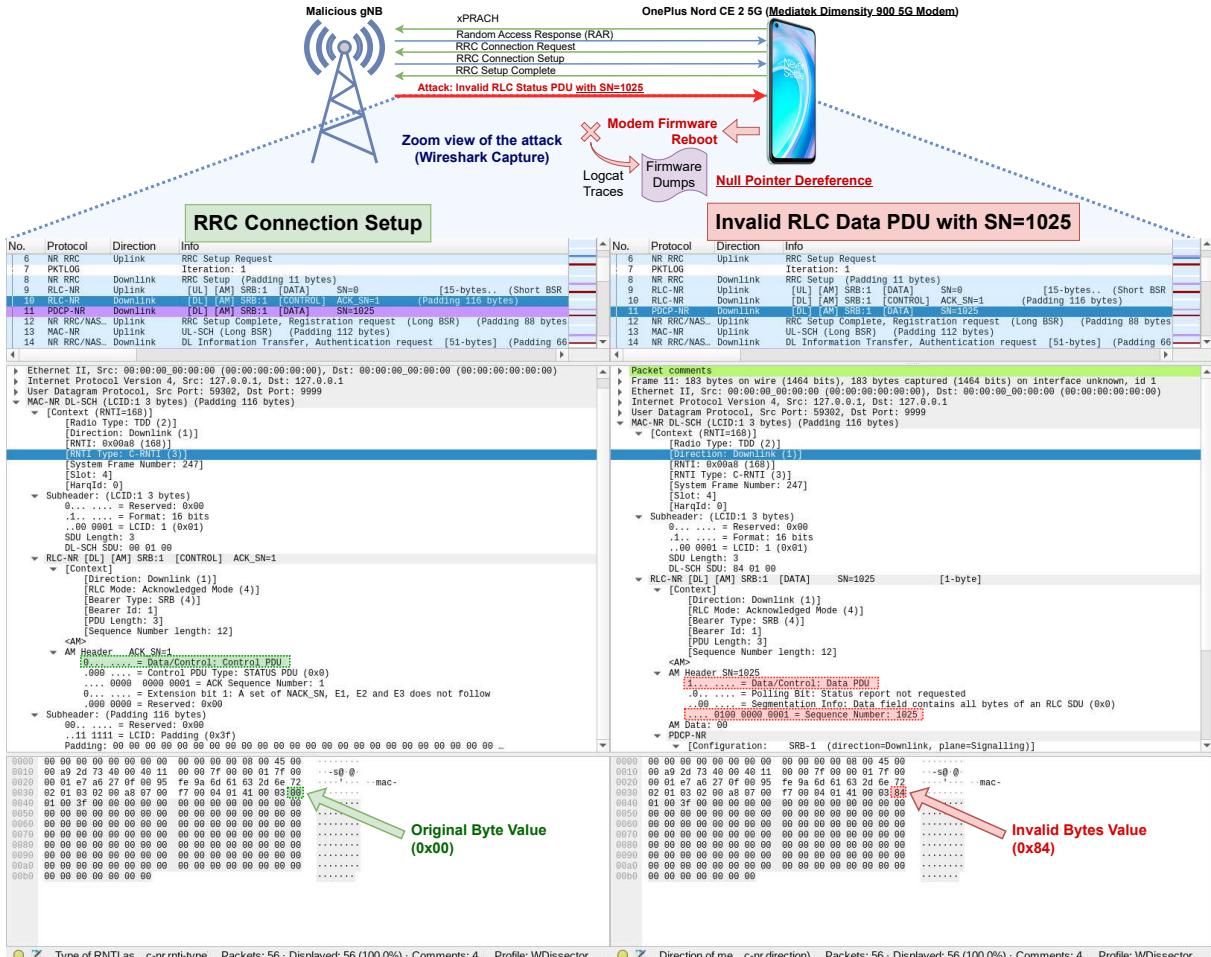
Figure 16: Invalid RLC Data Sequence.

[Fatal error(MPU\_NOT\_ALLOW)] err\_code1:0x0000001D err\_code2:0x910D66F6 err\_code3:0x910D66E2

**Impact:** The attacker can block 3GPP Modem connectivity by continuously sending such invalid packet. Furthermore, this vulnerability is fairly easy to trigger since no information about the target's SIM card information is required to launch the attack. This is because the invalid downlink frame is sent *after* the RRC attach procedure, which happens before any NAS authentication procedure.

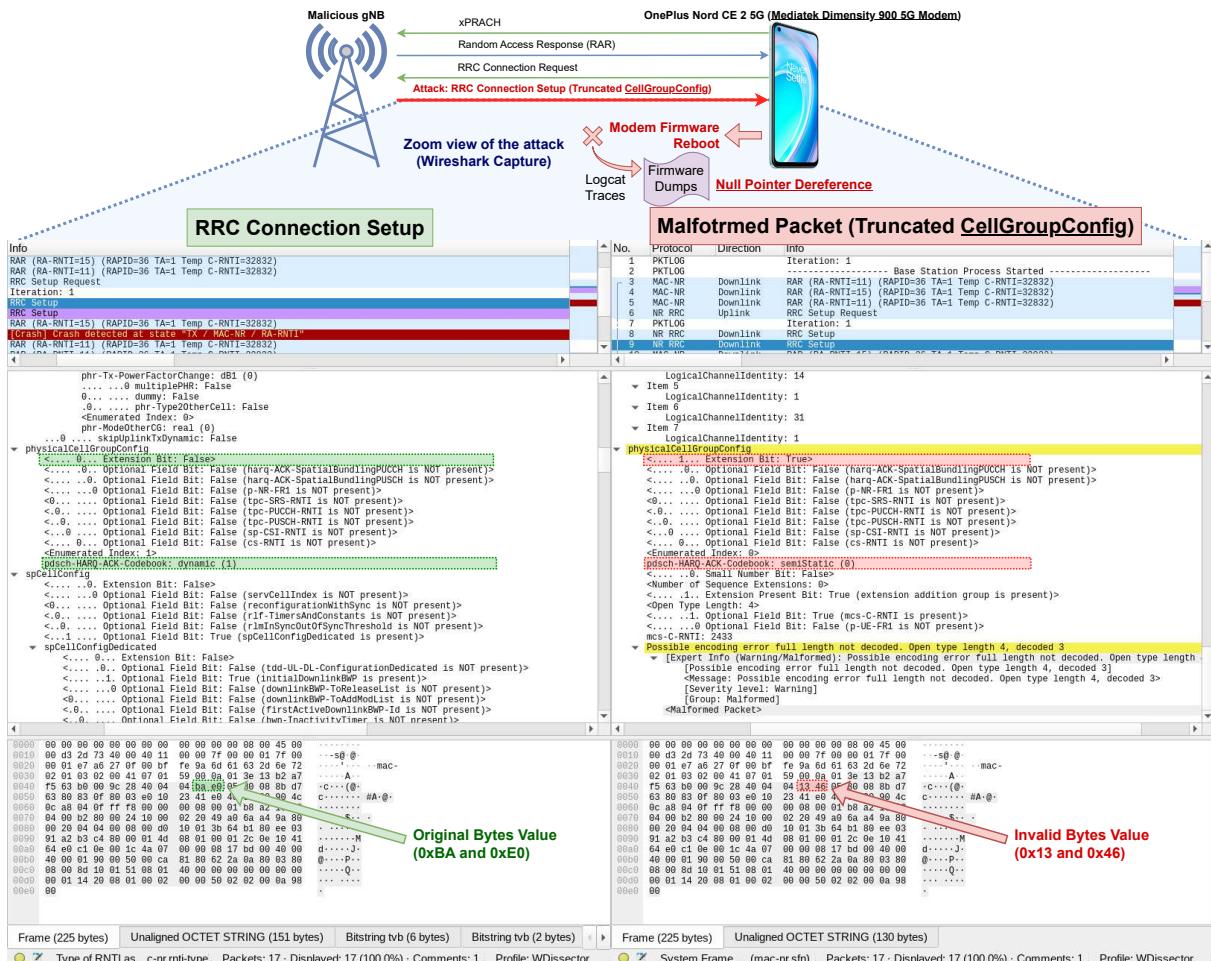
Figure 17: Truncated RRC physicalCellGroupConfig.

[Fatal error(MPU\_NOT\_ALLOW)] err\_code1:0x00000001D err\_code2:0x90F5D83A err\_code3:0x90F5D836

**Impact:** The attacker can block 3GPP Modem connectivity by continuously sending such malformed packet. Furthermore, this vulnerability is fairly easy to trigger since no information about the target's SIM card information is required to launch the attack. This is because the invalid downlink frame is sent during the RRC attach procedure, which happens before any NAS authentication procedure.

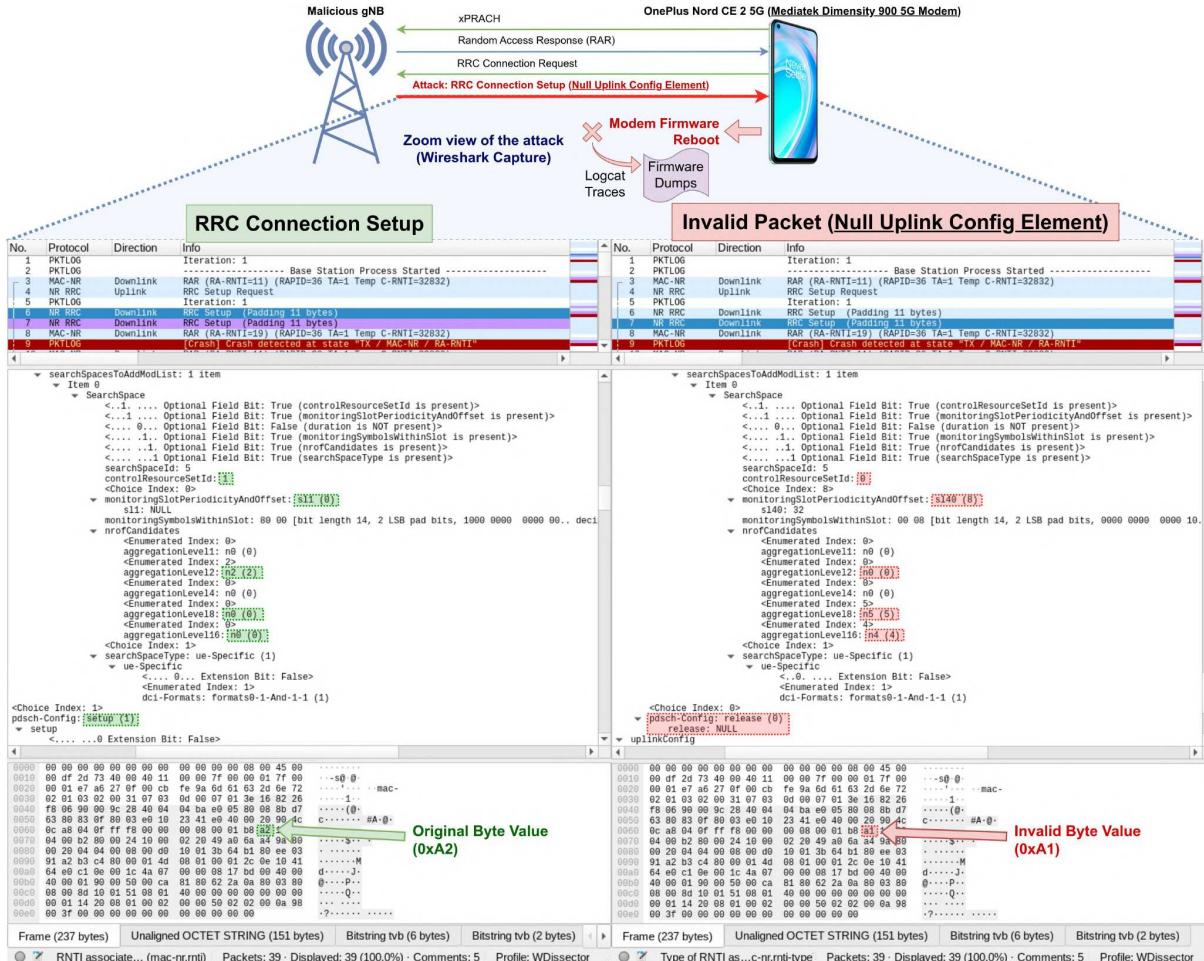
Figure 20: Null RRC Uplink Config Element.

[ASSERT] file: dsp3/coresonic/msonic/modem/brp/nr\_nr\_brp/src/nr\_brp\_top\_irq.c line:927

**Impact:** *The attacker can block 3GPP Modem connectivity by continuously sending such invalid packet.* Furthermore, this vulnerability is fairly easy to trigger since no information about the target's SIM card information is required to launch the attack. This is because the invalid downlink frame is sent *during* the RRC attach procedure, which happens before any NAS authentication procedure.
