## Mechanical Hardware

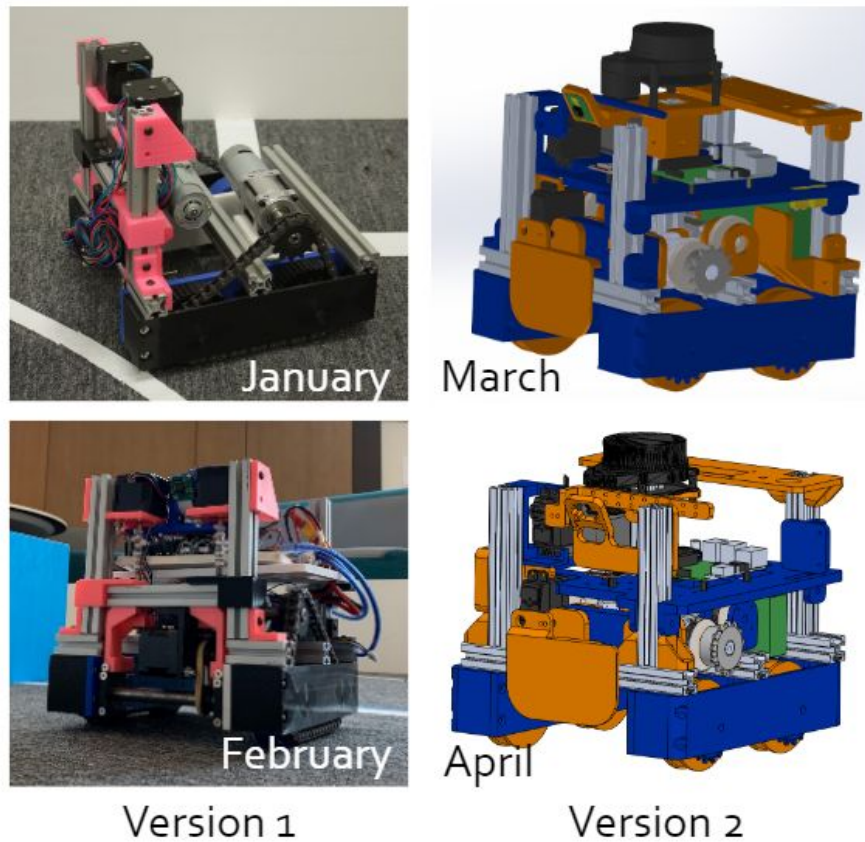
**Figure 1:** Mechanical Progression

We constructed a 4 wheel differential drive robot. Each side has a motor powering the wheels with a chain and sprocket system. There is an opening with a movable flap in the center section on the bottom for the debris to be collected. The robot fits within the 9" x 9" x 11" size requirement. It was constructed with an 8020 aluminum frame and custom PLA+ 3D printed brackets.

We initially intended on using a spinning rod to actuate vertically to collect and dispose of the debris. We called this mechanism the gate. It utilized three stepper motors. During the testing of the robot, the stepper motors were run using a basic program to make them turn. During this test it was discovered that the rubber tubing connecting the stepper motors to the threaded poles was not tight enough, allowing the motors to slip through the tubing. This, alongside the front gate making the robot front heavy lead to the decision to remove the stepper motors and front gate completely. The front gate can be seen in Figure 1 with the pink 3D printed material and the two servo motors on top. In its place, a servo motor was mounted onto the side of the robot and attached to a paddle that will lift it up to allow objects underneath the robot.

The servo motor not only solves the connection problem of the stepper motors but is considerably easier to program. Removing the added weight from the stepper motors at the top of the gate also lowered the center of gravity. This allows the robot to make more sudden stops and maneuver easier around the obstacles on the field. The simpler mechanical approach helped free up more space for additional electronics.
