ISO-9650 liferaft — Spares : *Alternative painter activation label*

This Service Bulletin has been technically approved by Survitec Design Authority.

Dated: 04-Jun-2021

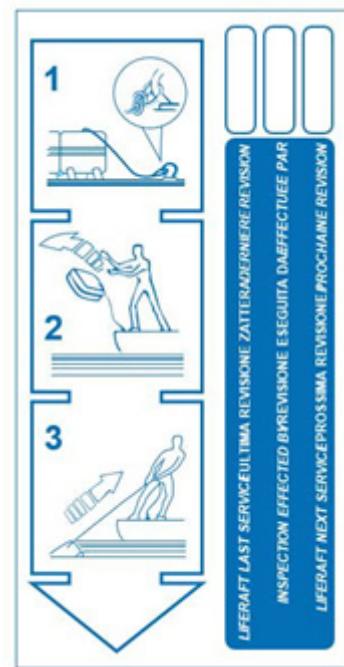
FIGURE 1
Painter activation label (old)
P/N E15500126

A painter activation label (P/N E15500126) is attached to the fabric valise on ISO-9650 liferafts and gives instructions on how to use the painter line. This label is no longer available. However, Survitec has found an alternative.

From now on, when you need to order a new label, you must order P/N E15500125 (**Figure 2**). Existing stock of E15500126 (**Figure 1**) can still be used.

The alternative, painter activation label (P/N E15500125) contains the same pictorial content as well as a multi-lingual service record section. When using this label, it must be trimmed so that it has the same finished dimensions as the old label.
