FACTORS CONTRIBUTING TO FIRES IN SHIP ENGINE ROOMS

Agata Krystosik-Gromadzińska^{1*}

¹West Pomeranian University of Technology in Szczecin, Faculty of Maritime Technology and Transport
Chair of Thermal and Safety Engineering Technologies, Szczecin, Poland

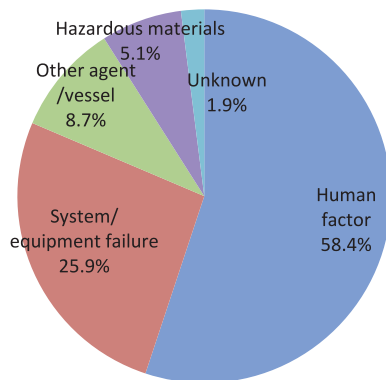
Figure 2. Percentage of incidents involving the investigated marine accidents and incidents for the period 2014-2023, organized by types

According to the EMSA 2024 report (European Maritime Safety Agency, 2024), human element was a direct cause of 58.4% of incidents (Fig. 2), while the percentage of contributing factors related to human element was over 80% (Fig. 3). In previous years, human factors have been also the primary type of accident event.

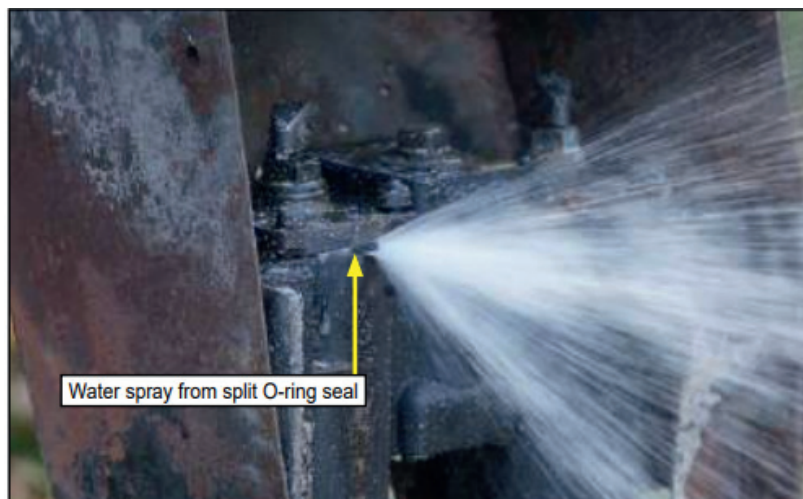
Figure 5. Fuel filter leakage test

Figure 5 presents a leak simulation. This simulation depicts tests conducted during the fire investigation of the vessel Moritz Schulte, which suffered an engine room fire in 2020. The fire was caused by leaking fuel coming that came into contact with a hot surface.

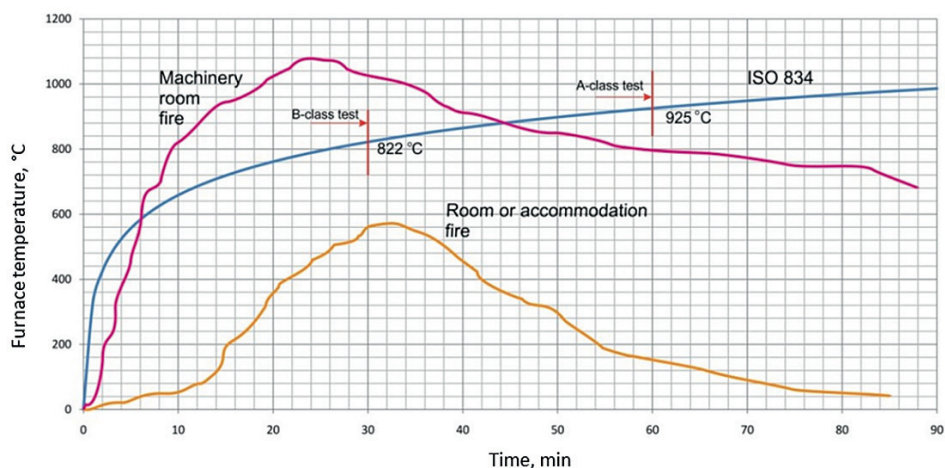
Figure 6. Temperature patterns: standard fire time-temperature curve according to standard ISO 834 (ISO, 1999) for a typical fire in the cabin of restricted use of combustion materials and in the machinery space of category A
