FNK0107-Troubleshooting

At the time of this writing, compatibility issues associated with the latest Raspberry Pi OS release ("**Trixie**") have been observed. Once an official update addressing these issues is available, we will promptly update our resources and discontinue the relevant troubleshooting notes here

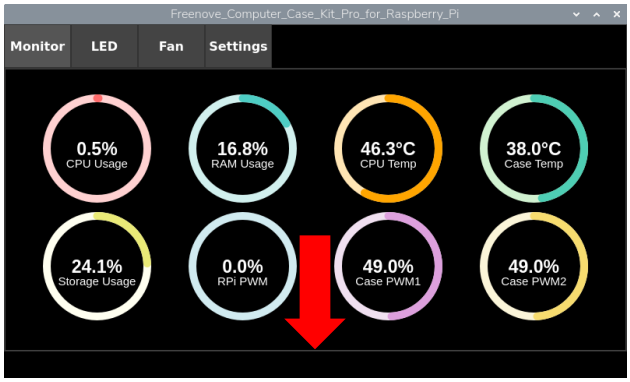
Issue 1: Black bars at the bottom of the DSI screen

After completing the settings in section 3.1.8, a black bar appears at the bottom of the DSI screen. This issue occurs in both landscape and portrait modes, and it is consistently located at the bottom of the current display orientation.

When you embed the accompanying control software into the DSI screen, the bottom portion of the software may not be displayed completely. This is because our control software is rendered starting from below the system status bar.

Open the **app_ui.py** file located in **the Freenove_Computer_Case_Kit_Pro_for_Raspberry_Pi/Code** directory. Find the line that says **self.isMaximized = False**, and change False to True to fix the issue.

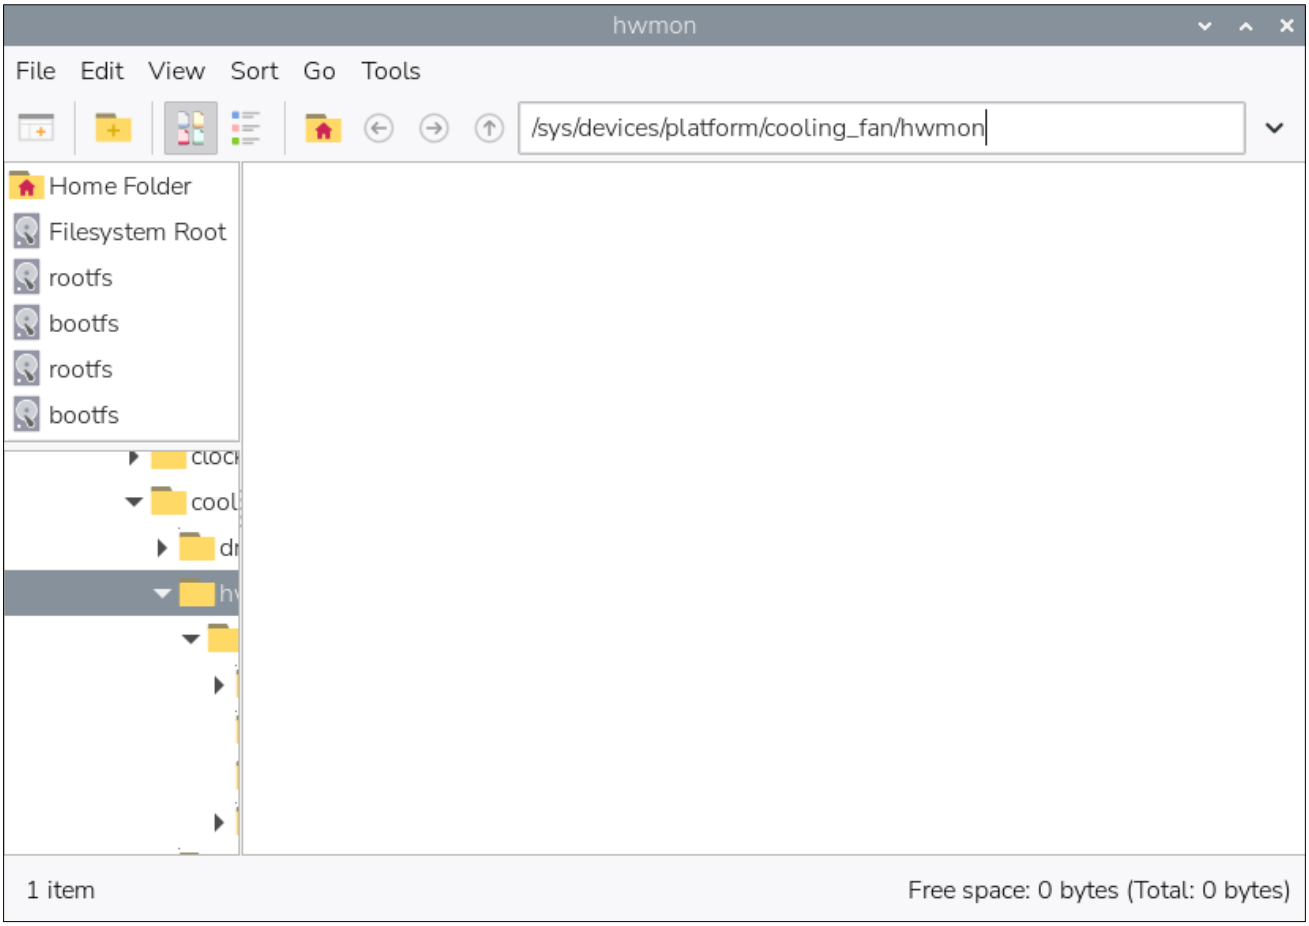
2. Missing or Incomplete System Files: The hwmon4 file in the directory **/sys/devices/platform/cooling_fan/hwmon/** may be missing, or the files within it may be incomplete. This prevents the system from reading the PWM value from the Raspberry Pi's fan interface. Please verify that the files in this directory are intact.
