# PROFESSIONAL ETHICS

# Engineering as Social Experimentation

## The Challenger Case Study

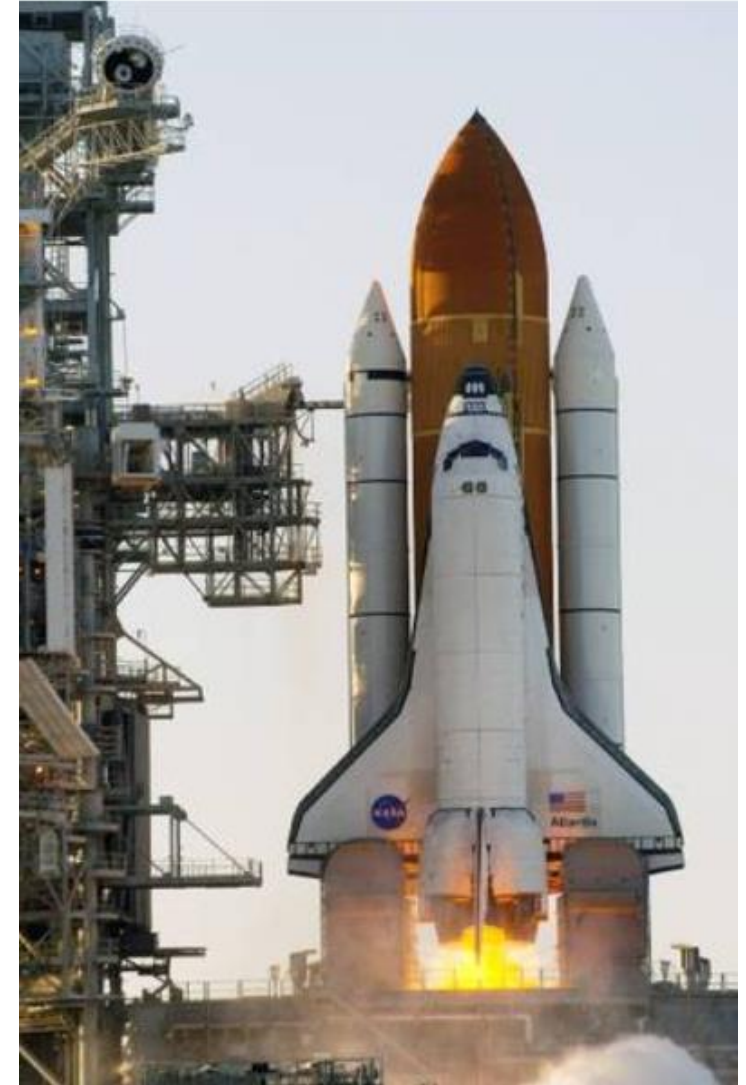
- Launches like a rocket, maneuvers in Earth orbit like a spacecraft, and lands like an airplane.
- Reusable Spacecraft designed to fly at least 100 missions.
- Three main parts:
  - Orbiter (houses the crew)
  - Large external fuel tank (holds fuel for engines).
  - Two solid rocket boosters (Used in first two minutes)

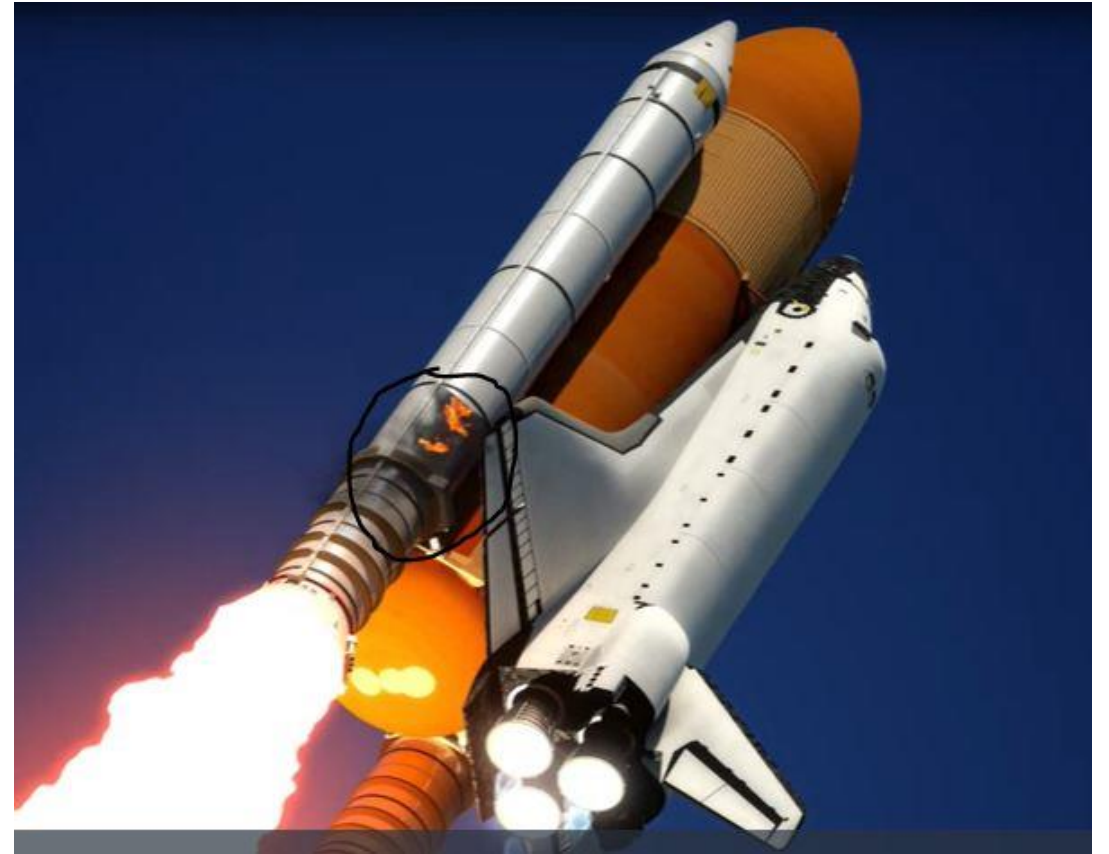
- From 600ms after lift off until 3 and a half seconds, dark smoke came out of the booster.
- At this very spot, some 59 seconds after lift off, one could see hot gases that burned a hole in the booster which then led to the explosion.

- The segments of each booster was joined into three major sections.
- The sections were interlocked by a tang and clevis joint.
- The tang and clevis joint was sealed by two rubber O-rings.
- Through the heat generated by the burning propellant from the boosters, these rubber seals expand to fill the joints of the three sections and prevent the hot exhaust from escaping.
