Radiation Tests: LT1681 Controller Chip

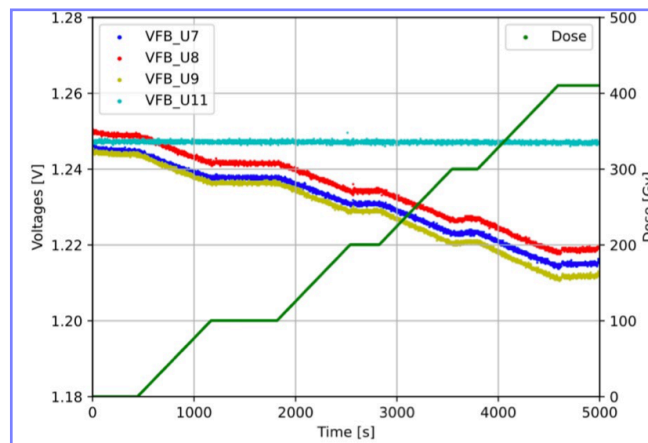
LT1681 test board at PIF

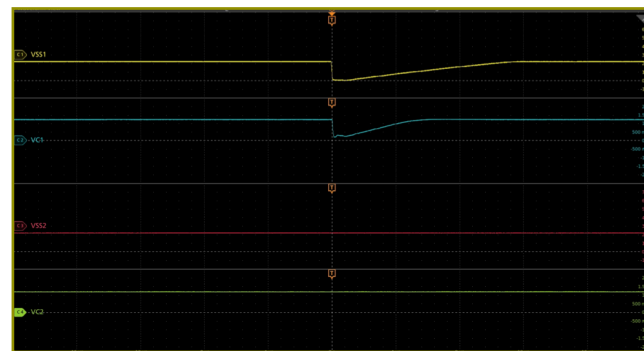
- TID and SEE tests performed together at a flux of 2.4×10^8 p/cm²/s
 - Frequency of output pulses were monitored, as well as 1.25 V and 5 V reference voltages
 - No change in frequencies happened and a maximum of 3% drop in 1.25 V reference voltages was seen (will cause 3% brick voltage drop)
 - The soft start pin was also being monitored for Single Event Upsets (SEUs), as there is an internal SR latch connected to this pin
 - Few SEUs were observed, but due to external protection, transients were short, and they won't cause any trips in the bricks
- In overall, **the chips passed TID and SEE tests**
- **NIEL tests showed no issues**

1.25 V reference voltage in LT1681

SETs in LT1681
