Crash Pattern Summary and HSIP Warrant Analysis

NC 180/NC 226 (Post Rd) at SR 1103 (Pleasant Dr / Pleasant Hill Church Rd), Cleveland County, NCDOT Division 12

Order # 41000079736 | PH/SS # TSUINT716412 | TEAAS Intersection Analysis Report, 9/1/2016 to 8/31/2026 (10 years), Y-line 150 ft | 35.246324, -81.509409

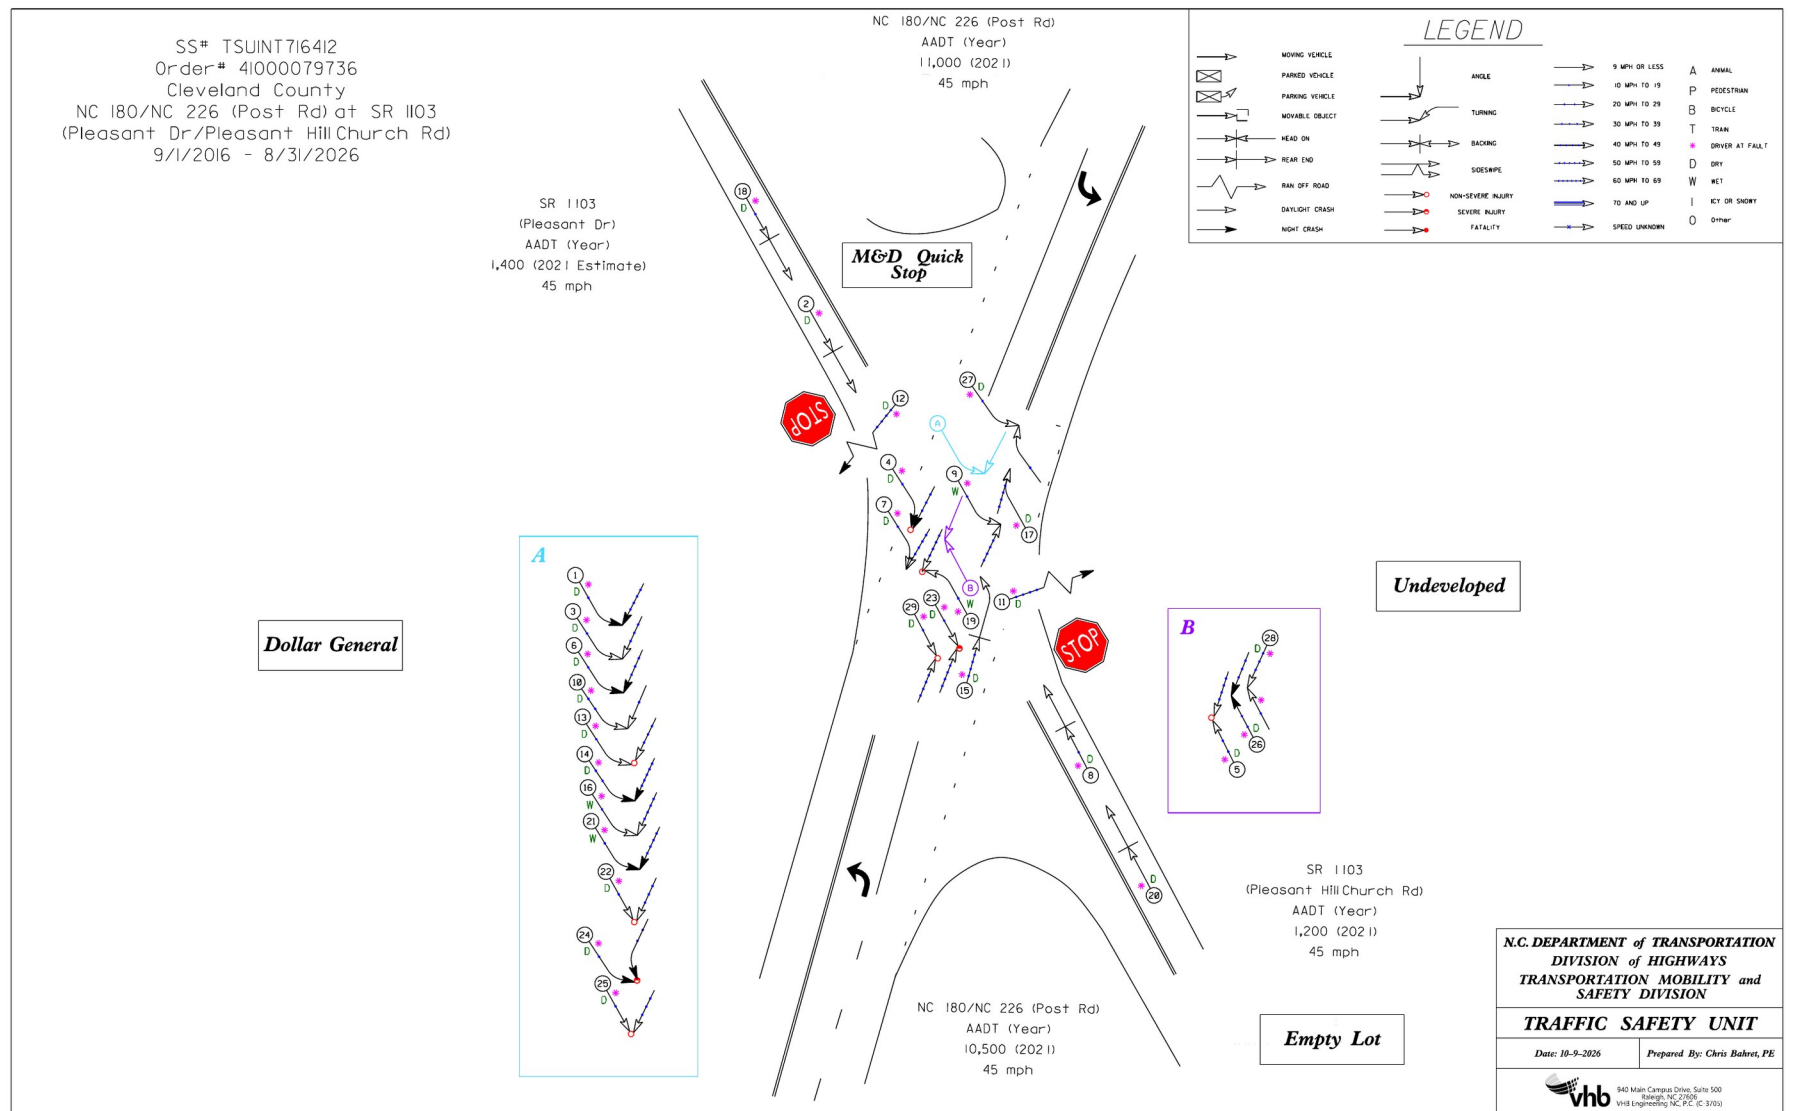
Figure 2. Collision diagram, 9/1/2016 to 8/31/2026 (MicroStation sheet, enlarged; maps/41000079736_CollisionDiagram_labeled.pdf). Numbers are the TEAAS report order of Appendix A.

- **c. Pleasant Dr left turns in front of southbound traffic are the pattern: inset A.** Nine crashes (1, 3, 6, 10, 13, 14, 16, 21, 24) show a Pleasant Dr driver turning left toward northbound NC 180 and being struck by a southbound through vehicle (in 24 the southbound vehicle was itself turning left onto Pleasant Hill Church Rd). Two angle crashes (22, 25) put a Pleasant Dr driver crossing straight into the same southbound lane. The diagram stacks these 11 crashes at one point, the southbound lane just beyond the Pleasant Dr stop line: 38 percent of all crashes and four injuries (13 Class B, 24 Class A, 22 and 25 Class C) at a single conflict point. Four of the nine left-turn crashes were at night (1, 6, 14, 21) and two on a wet road (16, 21).

- **e. Pleasant Hill Church Rd: five frontal crashes, four of them with southbound traffic.** Three angle crashes stacked in inset B where a Pleasant Hill Church Rd driver crossing straight was struck by a southbound vehicle (5 Class B at dusk, 26 at night, 28 with both drivers at fault), one left turn onto

southbound NC 180 struck by a southbound vehicle (19 Class C, wet) and one right turn in front of a northbound vehicle (17).

Result. The location meets Warrant I-1r, Frontal Impact Rural: 22 frontal impact crashes, 76 percent of all crashes, with 45 percent of the crashes in the last three years. The identified pattern is minor-street vehicles from SR 1103, chiefly Pleasant Dr drivers turning left or crossing in front of southbound NC 180 traffic (inset A on the diagram), failing to yield to through traffic.

2. The dominant conflict is a Pleasant Dr driver turning left (9 crashes) or crossing (2) in front of southbound NC 180 traffic, stacked at one point just beyond the Pleasant Dr stop line (inset A: 11 of 29 crashes, four with injuries). With the six other Pleasant Dr entries, 17 of the 22 frontal crashes and 7 of the 9 injury crashes start on that one approach, and in 13 of the 17 the vehicle struck was southbound. The 49 degree skew places southbound traffic far behind the stopped driver's left shoulder and the M&D Quick Stop sits in that sight triangle; sight distance, the skew and the driveways are the field questions that decide the countermeasure.

- Stop-approach conspicuity on SR 1103, Pleasant Dr first: oversize STOP signs with retroreflective post strips or flashing LED borders, STOP AHEAD signs, CROSS TRAFFIC DOES NOT STOP plaques, refreshed stop bars, and transverse rumble strips on the Pleasant Dr approach.

- Sight-line clearing in the northwest quadrant (M&D Quick Stop frontage) and driveway management on Pleasant Dr.
- Advance intersection warning on NC 180 in both directions with street-name plaques, and an intersection conflict warning system (VEHICLE ENTERING WHEN FLASHING beacons on the southbound approach, actuated from the SR 1103 approaches) if the sight-distance review supports it.

- Intersection lighting, given 7 frontal crashes in the dark at an unlit location.
- Geometric correction of the skew: realigning the Pleasant Dr approach to meet NC 180 near 90 degrees, which turns the look-back for southbound traffic into a normal left look, or offsetting the two SR 1103 legs.

- Restricting the Pleasant Dr left turn and the through movement: a reduced-conflict (J-turn) configuration on NC 180 removes the 9 left-turn and 2 crossing crashes of inset A and the inset B

crossings from Pleasant Hill Church Rd at their source; an all-way stop or signal study is the alternative. Minor-street volumes of 1,200 to 1,400 vehicles per day are unlikely to satisfy volume warrants, but the 6 crashes of the last study year, 5 of them frontal, are worth a check against the MUTCD crash-experience signal warrant during the field investigation.
