Ether**CAT**[®] Slave Controller Development Products

Frequently Asked Questions and Troubleshooting

ET1100

ET1200

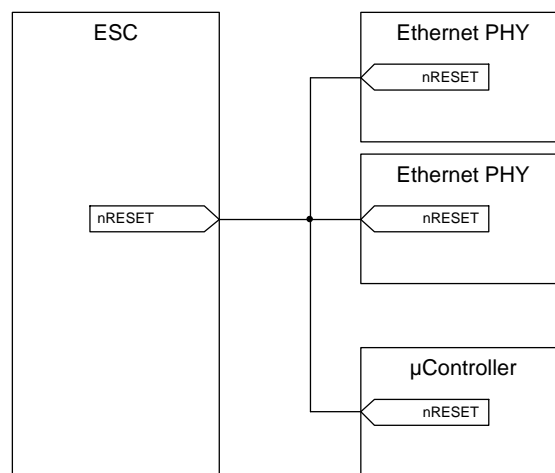
Figure 1: Reset connection principle

If EEPROM emulation is used, the μ Controller should be able to process EEPROM commands once communication is possible, otherwise an EtherCAT master might time-out.

A μ Controller attached to the PDI should also be reset by the ESC (e.g. by a soft reset via register 0x0040:0x0041).

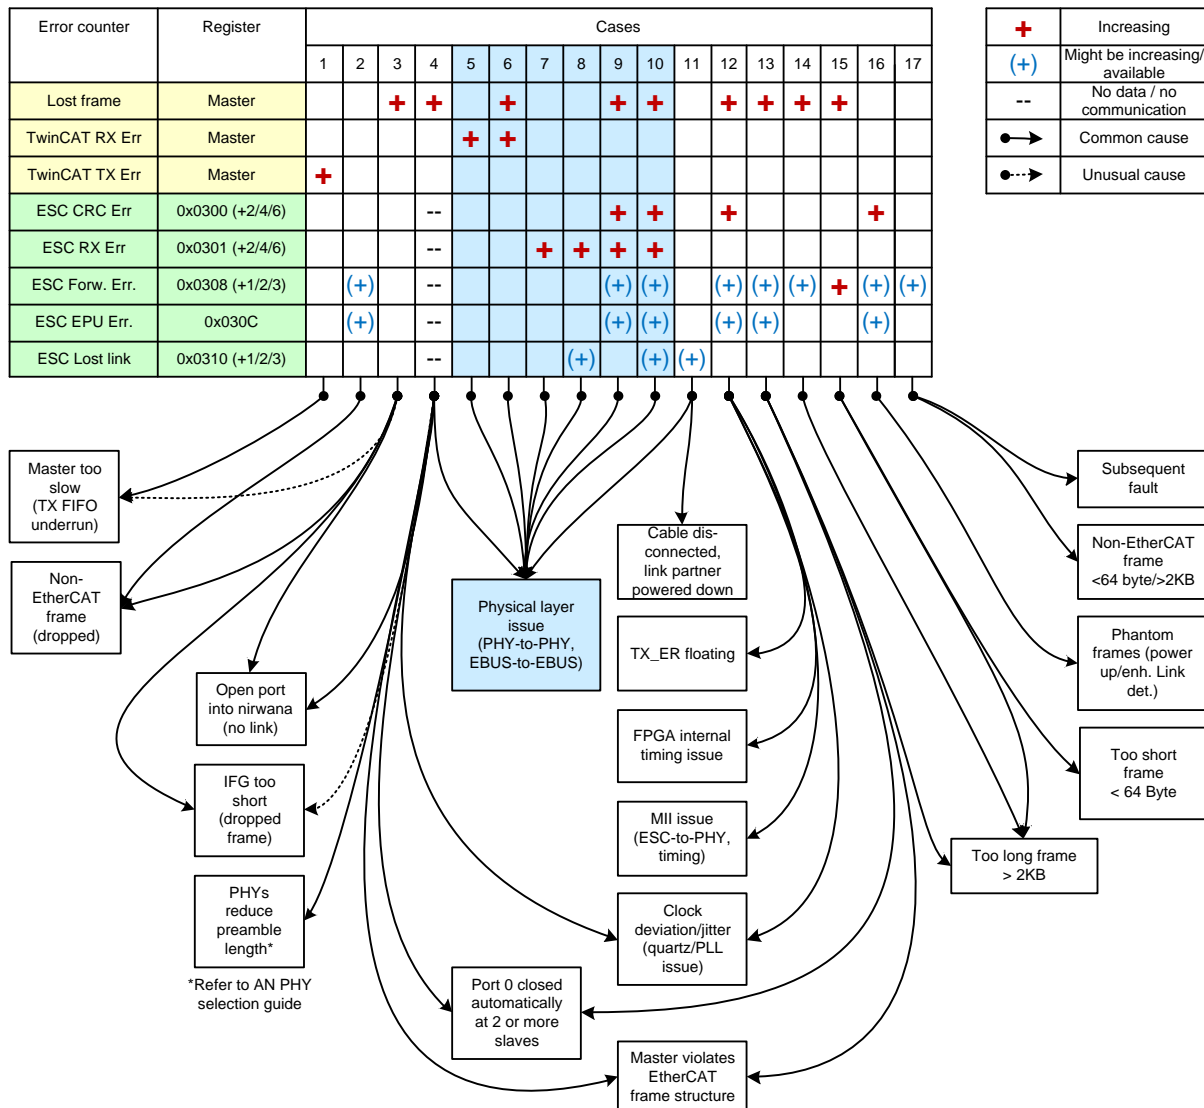
Figure 2: Error counters interpretation guide

The following diagram can be used to identify possible error causes. At first, find out which error counters are increasing in your network (or device), and at the master. Compare this with each of the cases shown in the main table of Figure 2 and find the most similar case. Follow the arrows at the bottom of each column to the possible error causes. Use Table 1 for comments and error localization.

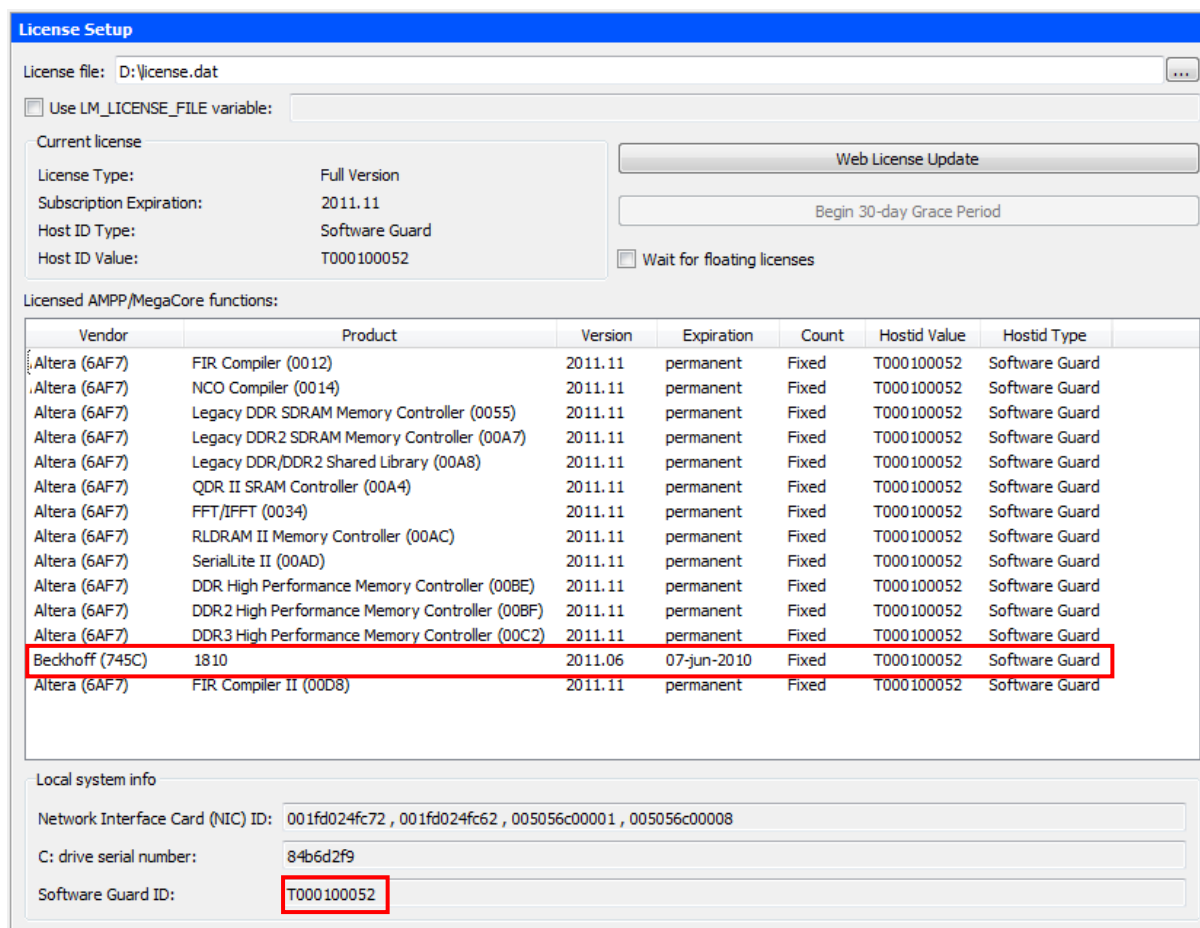
Figure 3: Example license

The EtherCAT IP Core license has Vendor “Beckhoff (745C)”, and Product “1810”. Full license and OpenCore Plus license cannot be distinguished in this window, only during compilation.

1. The version column states the latest release month of an EtherCAT IP Core for which the license is valid. In the example, the license is valid as long as the release month of the IP Core is June 2011 or earlier.
2. The Expiration column shows the date when the license expires. The example license is valid until 2011/06/07. This is the latest date at which you can synthesize the IP Core with this license.
3. The Count column is basically for floating licenses¹ (number of seats). If the value is “Fixed”, you have a node-locked license with one seat.

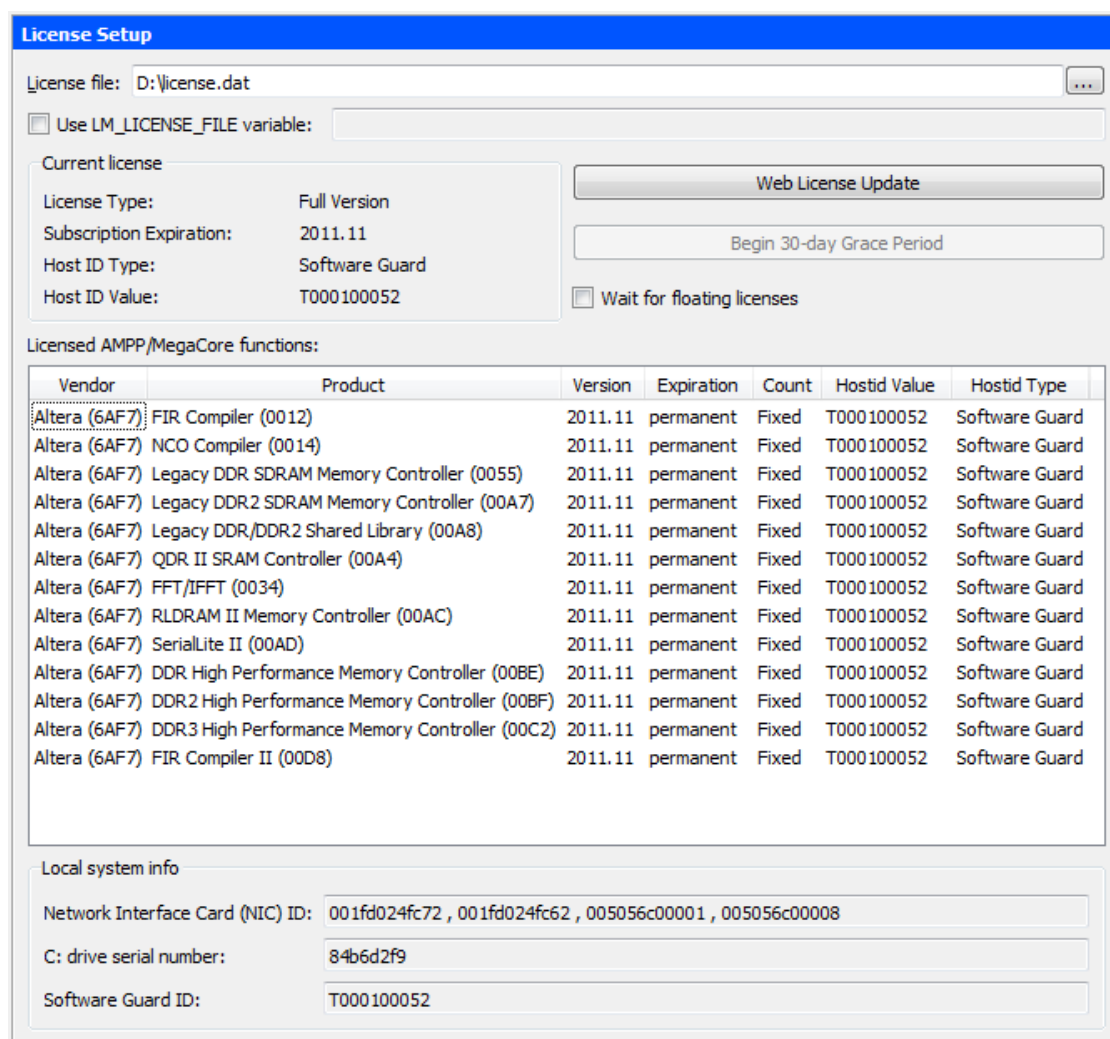
Figure 4: License setup: No license available, expecting "Beckhoff (745C) / 1810"

Error: Can't find valid feature line for core EtherCAT VendorID (745C_1810) in current license
Error (10003): Can't open encrypted VHDL or Verilog HDL file
"C:/EDA/Altera/Quartus101/ip/beckhoff/ethercat_2.4.0/reference_designs/EL9800_DIGI_EP3C25F256/
ethercat_digitalio/ETHERCAT_VENDORID.VHD" -- current license file does not contain a valid
license for encrypted file
Info: Found 0 design units, including 0 entities, in source file
ethercat_digitalio/ethercat_vendorid.vhd
Error (10003): Can't open encrypted VHDL or Verilog HDL file
"C:/EDA/Altera/Quartus101/ip/beckhoff/ethercat_2.4.0/reference_designs/EL9800_DIGI_EP3C25F256/
ethercat_digitalio/ETHERCAT_IPCORE_TOP.VHD" -- current license file does not contain a valid
license for encrypted file
Info: Found 0 design units, including 0 entities, in source file
ethercat_digitalio/ethercat_ipcore_top.vhd
Error (10003): Can't open encrypted VHDL or Verilog HDL file

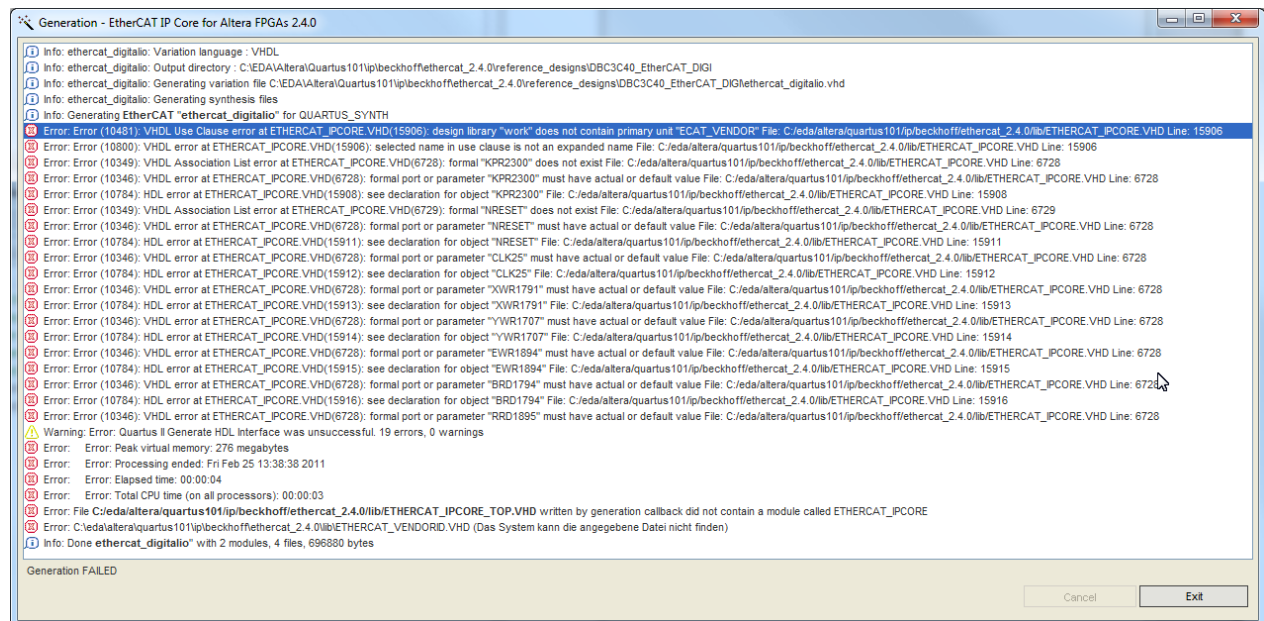
Figure 6: MegaWizard generation issue

Error: Error (10481): VHDL Use Clause error at ETHERCAT_IPCORE.VHD(15906): design library "work" does not contain primary unit "ECAT_VENDOR" File: C:/altera/quartus101/ip/beckhoff/ethercat_2.4.0/lib/ETHERCAT_IPCORE.VHD Line: 15906

If the vendor ID package is missing in the installation folder (e.g., because it was not installed/found during installation), it has to be added manually to the installation folder. Refer to the EtherCAT IP Core datasheet for instructions. Regenerate the EtherCAT IP Core afterwards.

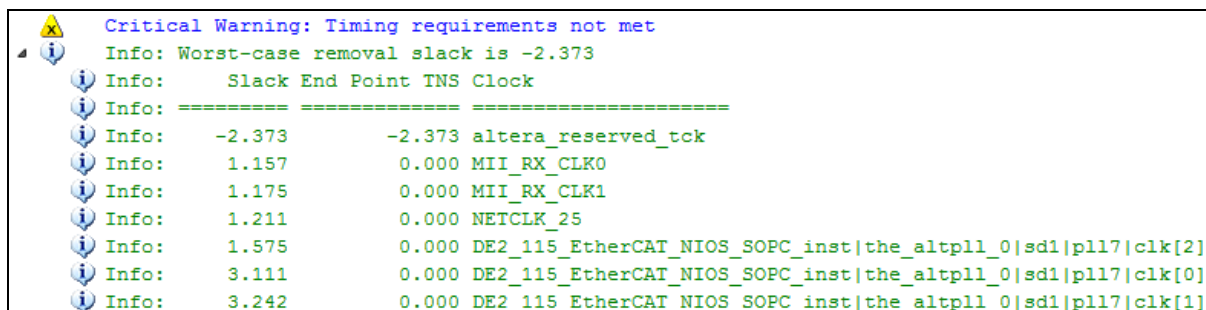
Figure 10: Timing requirement of OpenCore Plus logic not met

Sometimes timing requirements are not met with OpenCore Plus. Experience shows that timing violations related to the clock altera_reserved_tck can be ignored. They do not occur with the full version.

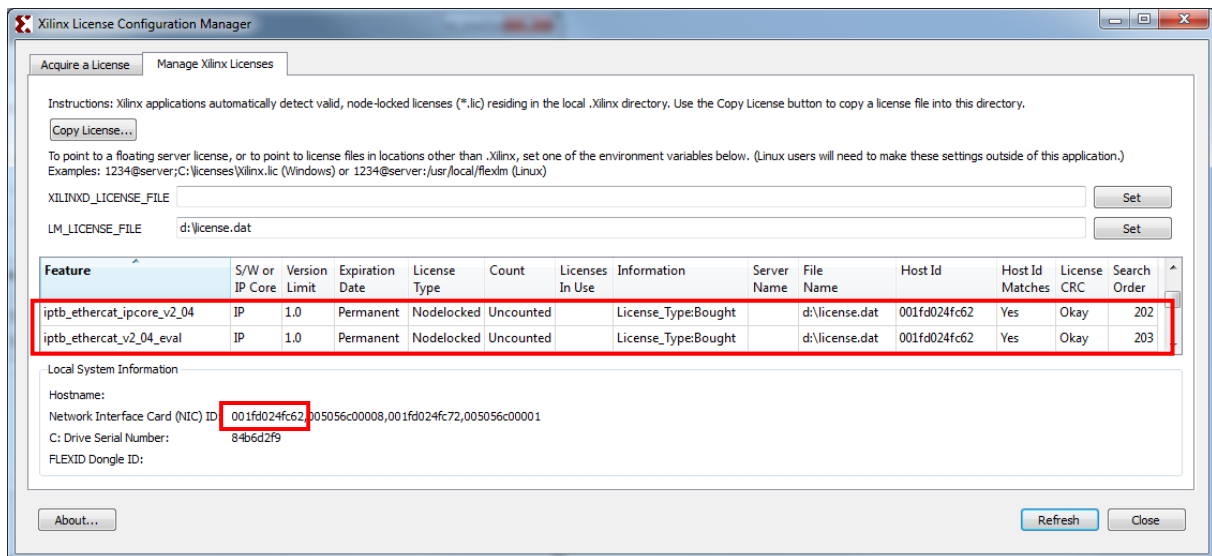
Figure 11: Example license

You can check if your license is valid by invoking Xilinx ISE, menu Help – Manage License...

- The EtherCAT IP Core license has one of the following features:
 - iptb_ethercat_ipcore_v2_04 for the full version (IP Core Version 2.04a-z)
 - iptb_ethercat_v2_04_eval for the evaluation version (IP Core Version 2.04a-z)

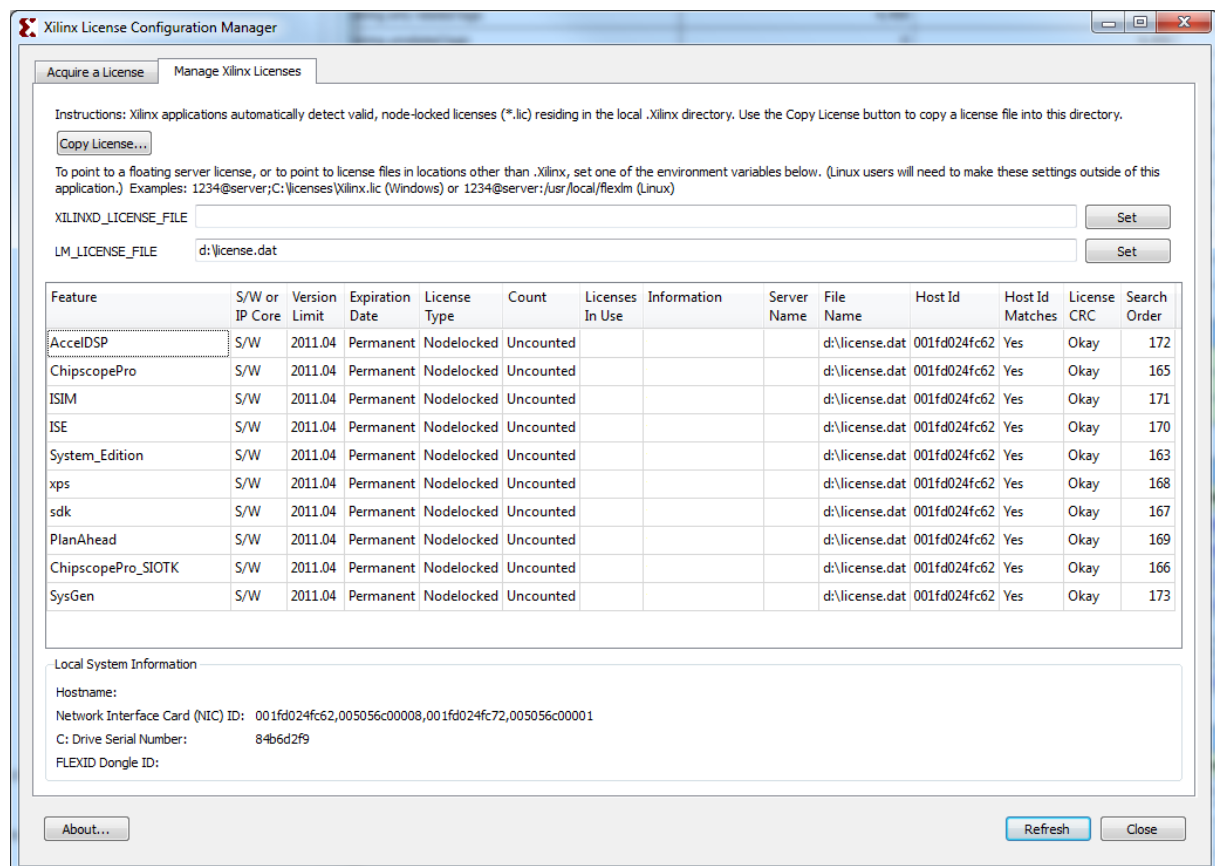
Figure 12: License Configuration Manager: No license available (expecting *iptb_ethercat_...*)

This error occurs if either no valid license was found, or if the type of the license file (full, evaluation) is not the same as the EtherCAT IP Core. The error message shows which license is required by the IP Core (highlighted).

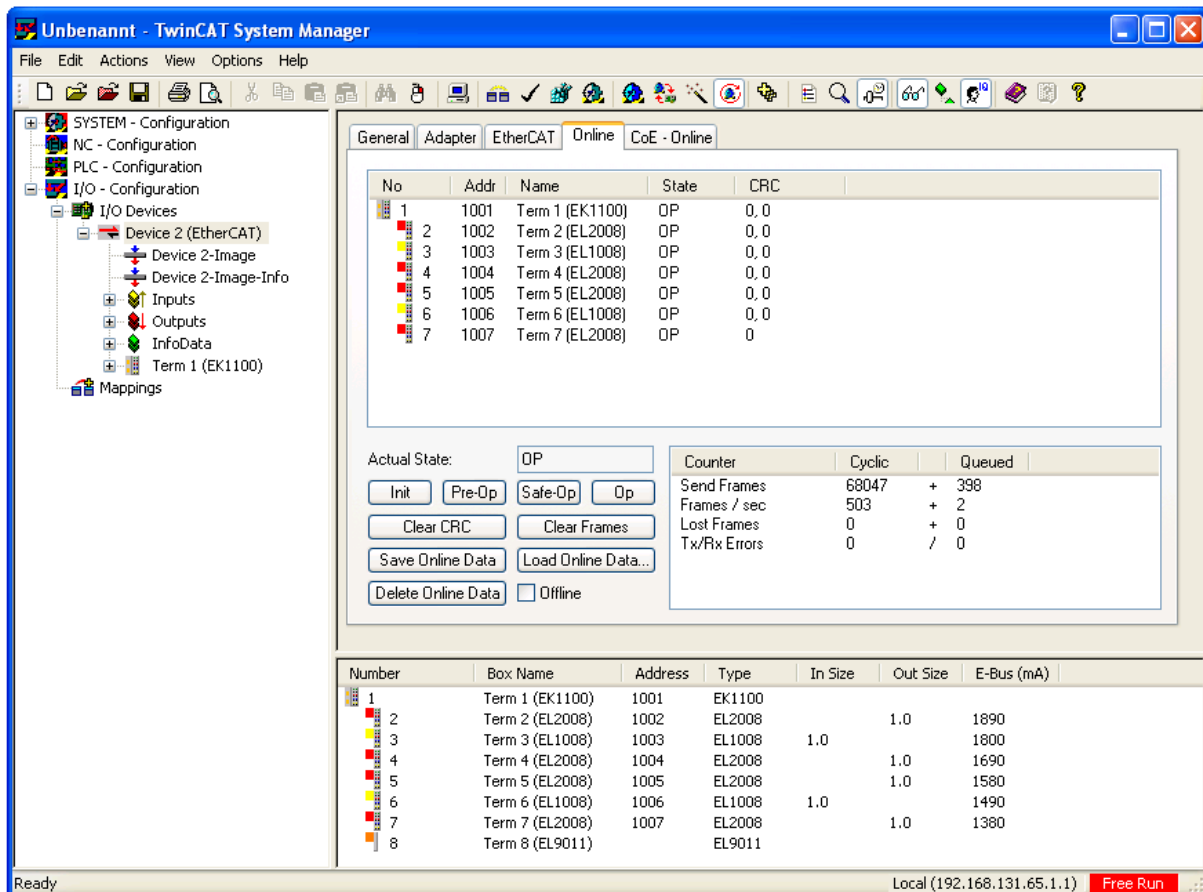
Figure 13: TwinCAT logging CRC error counters

By default, TwinCAT reads out the ESC error counter registers 0x0300/0x0302/0x0304/0x0306 (CRC error port 0-3) and clears them. The results are accumulated in software and displayed in the CRC column for each port of the ESC (separated by commas).

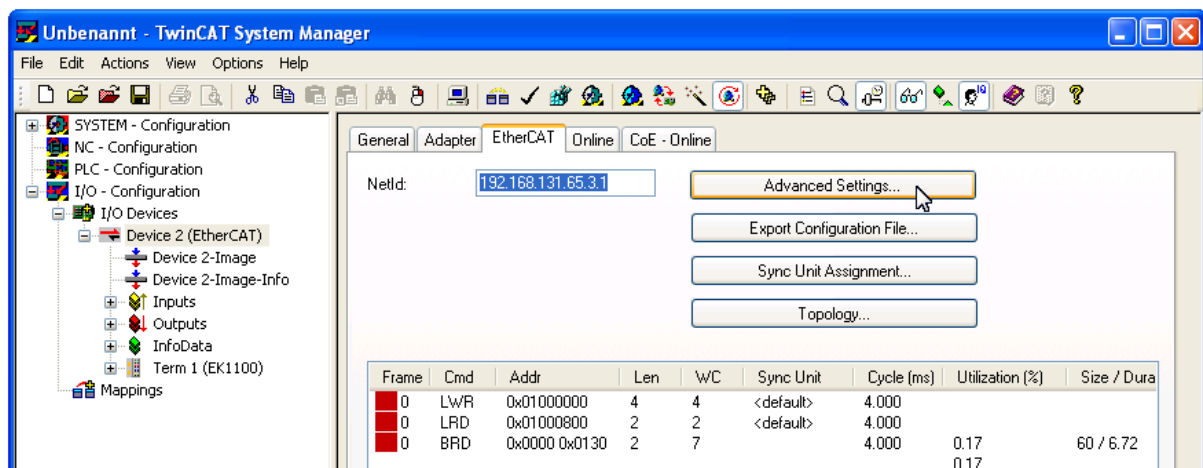
Figure 14: Go to EtherCAT Advanced Settings

1. Go to the “EtherCAT” tab and open “Advanced Settings...”:

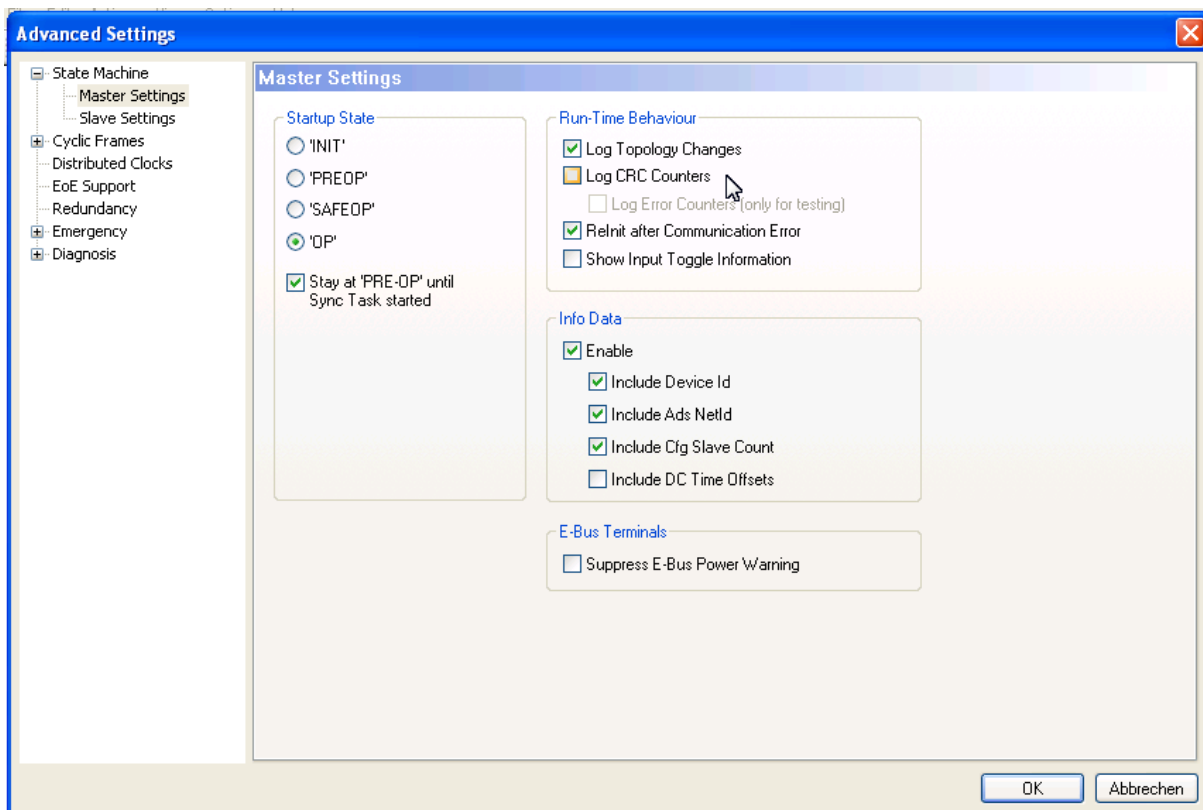
Figure 15: Unselect CRC Counter logging

2. Unselect “Log CRC Counters” and press OK.

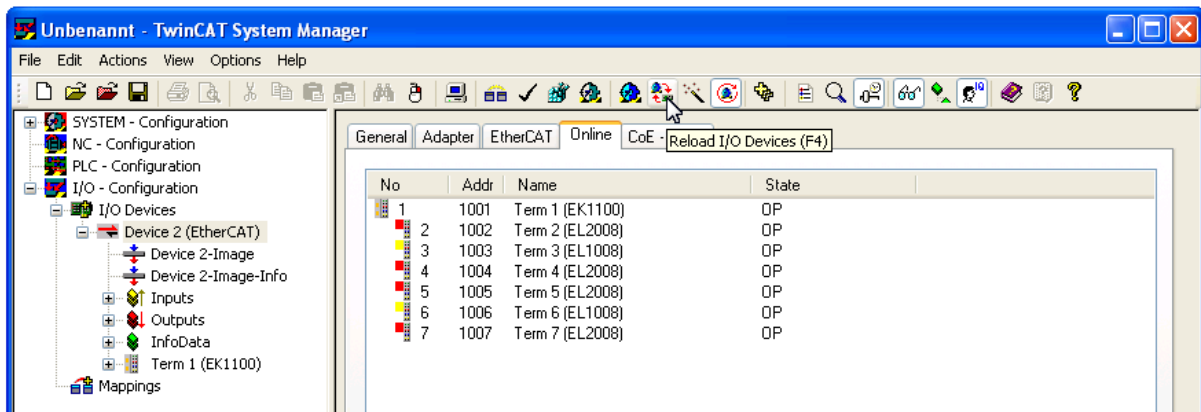
Figure 16: Reload I/O Devices (F4) after disabling CRC logging

- Although the CRC column is not visible anymore, TwinCAT still reads out and clears the CRC error counter registers. Activate the new settings by reloading I/O devices (press F4 or use the button).

It is very important to reload I/O devices (F4) after disabling “Log CRC Counters”, otherwise the error counters will still be cleared automatically by TwinCAT.

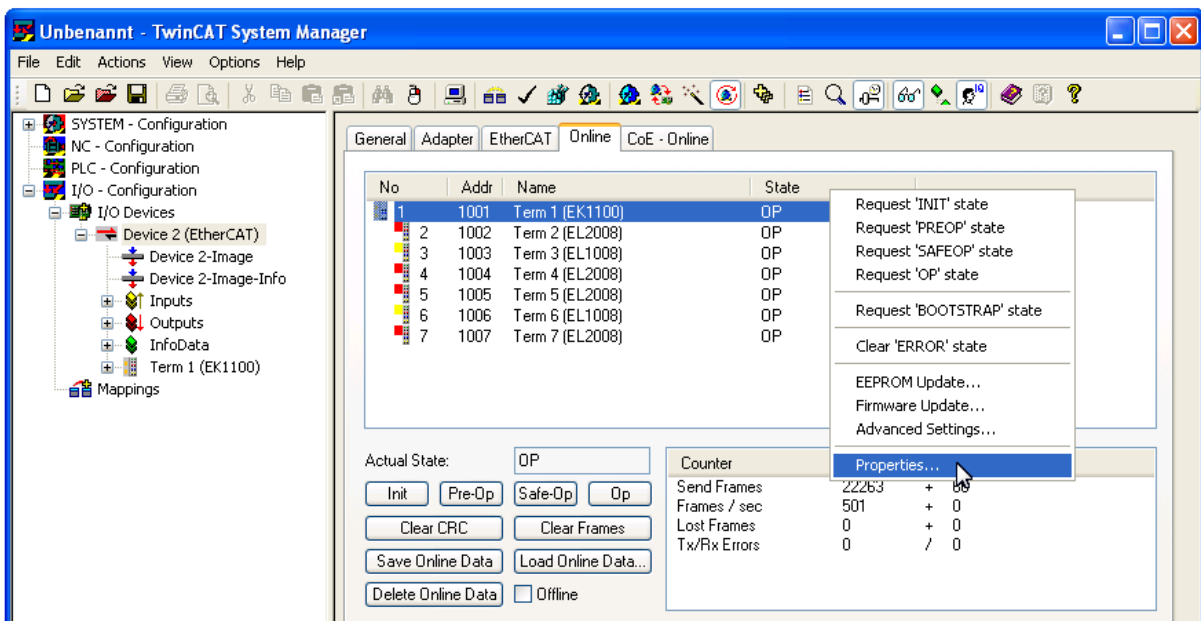
Figure 17: Online view properties

- Now you can add the error counters to the online view. Right-click into the Online view area and select “Properties...”

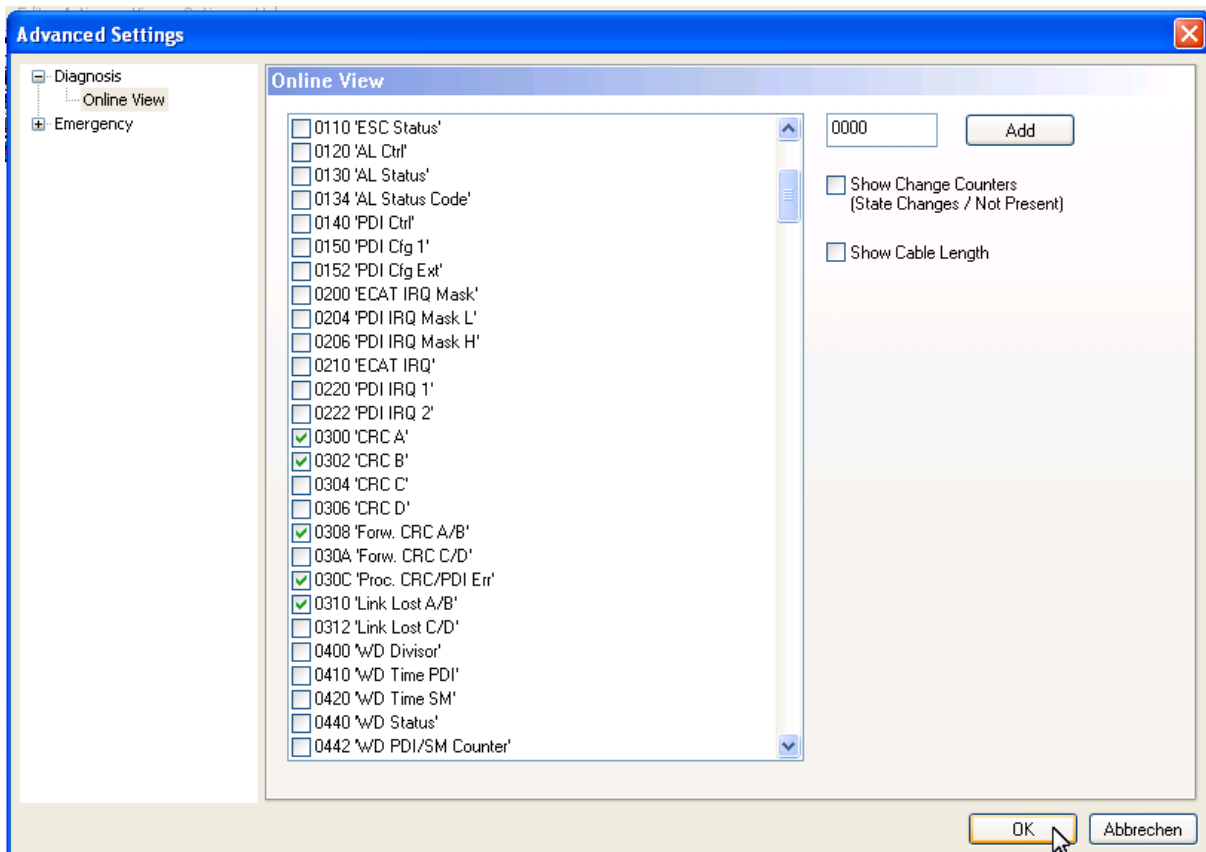
Figure 18: Select registers for online view

5. Select the following registers for online viewing, and press OK:

- "0000 ESC Rev./Type" and
 - "0002 ESC Build"
- to identify the type of ESC.

NOTE: TwinCAT uses A/B/C/D to enumerate the ESC ports 0/1/2/3.

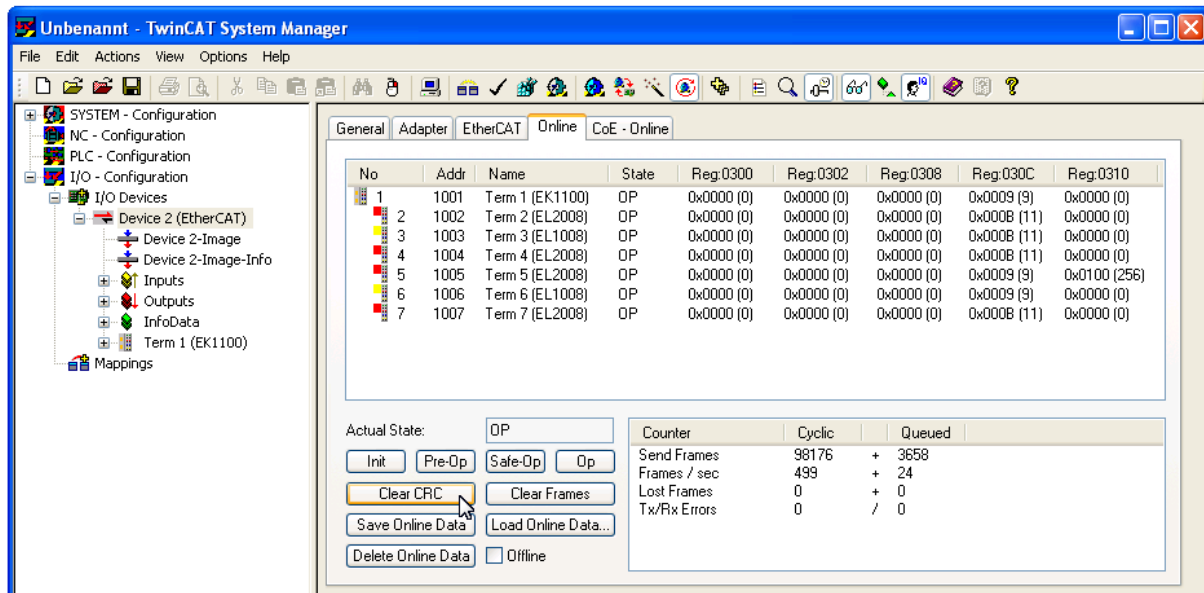
Figure 19: Some power-up errors without significance

Please note that the error counters are shown as 16 bit values, i.e., the column called “Reg. 0300” shows in fact registers 0x0300 (lower 8 bit, right side) and 0x0301 (higher 8 bit, left side).

Press the buttons “Clear CRC” and “Clear Frames” to clear the TwinCAT counters in the lower right area (Lost frames, Tx/Rx Errors).

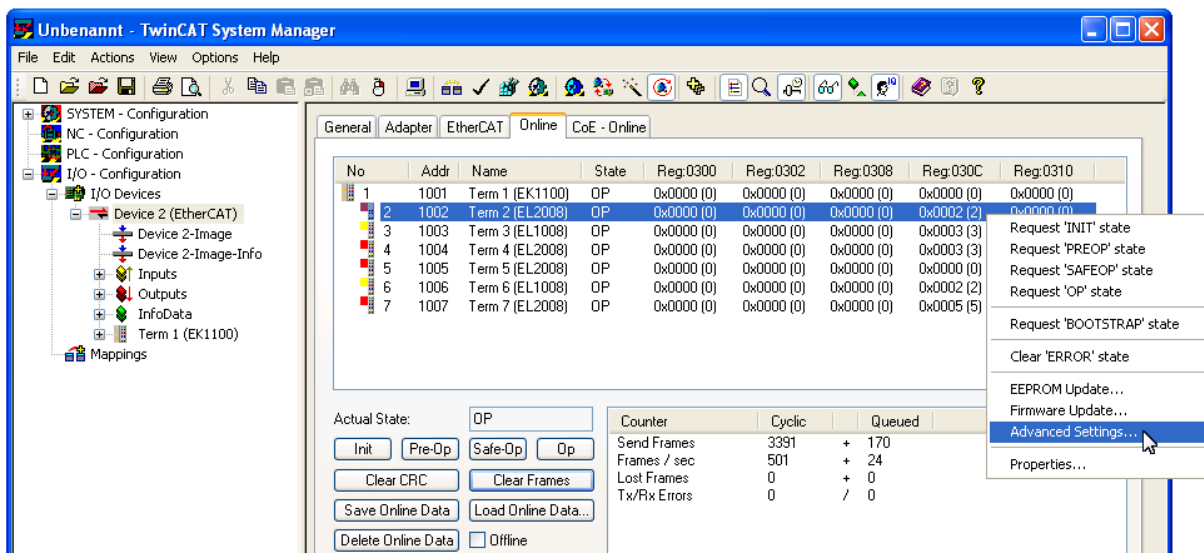
Figure 20: Clear error counters manually in the advanced settings

7. If you want to clear all the error counters, follow these steps for each ESC. At first, highlight the ESC with the error counters you want to clear. Right-click into the row and select “Advanced Settings...” from the context menu.

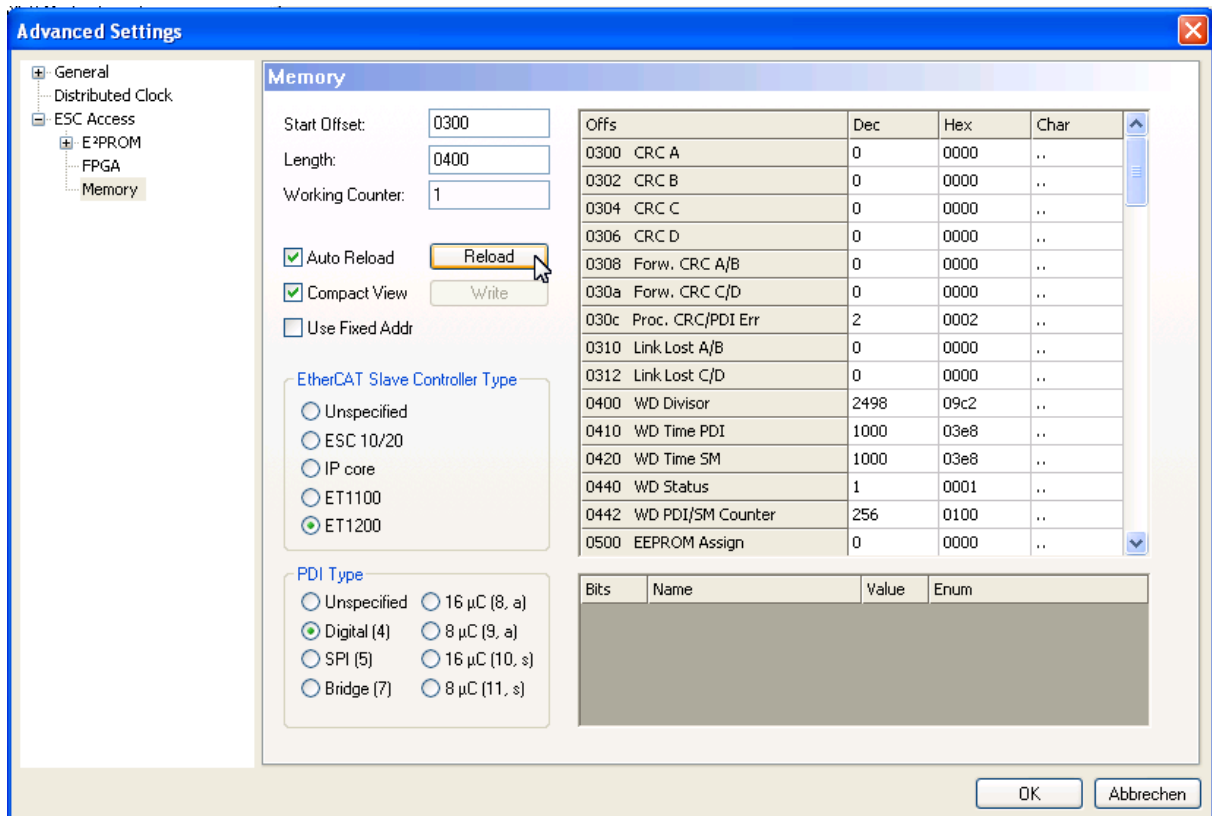
Figure 21: Error counters in the Advanced Settings window

8. Enter “Start Offset” of 300, activate “Auto Reload” and “Compact view”. Press the “Reload” button to see the error counters from 0x0300 ff. The error counters are again shown as 16 bit values.

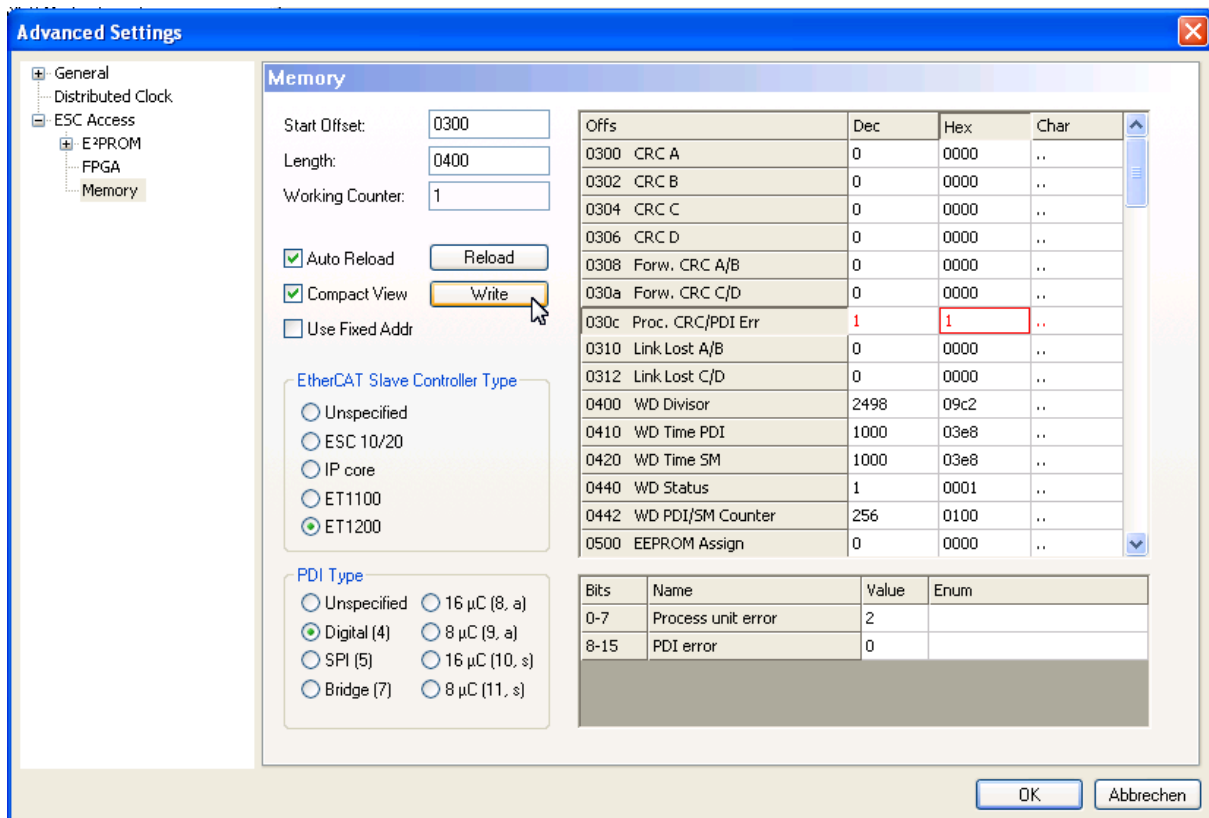
Figure 23: Write to the error counter to clear it

10. Press the “Write” button to write the new value, which in fact clears the error counter.
