# SMT10-04-120-220 (43) Linear Actuator By Sterling Motion Block Replacement

This same instruction manual applies to the SMT10-04-128-239 (42F) model.

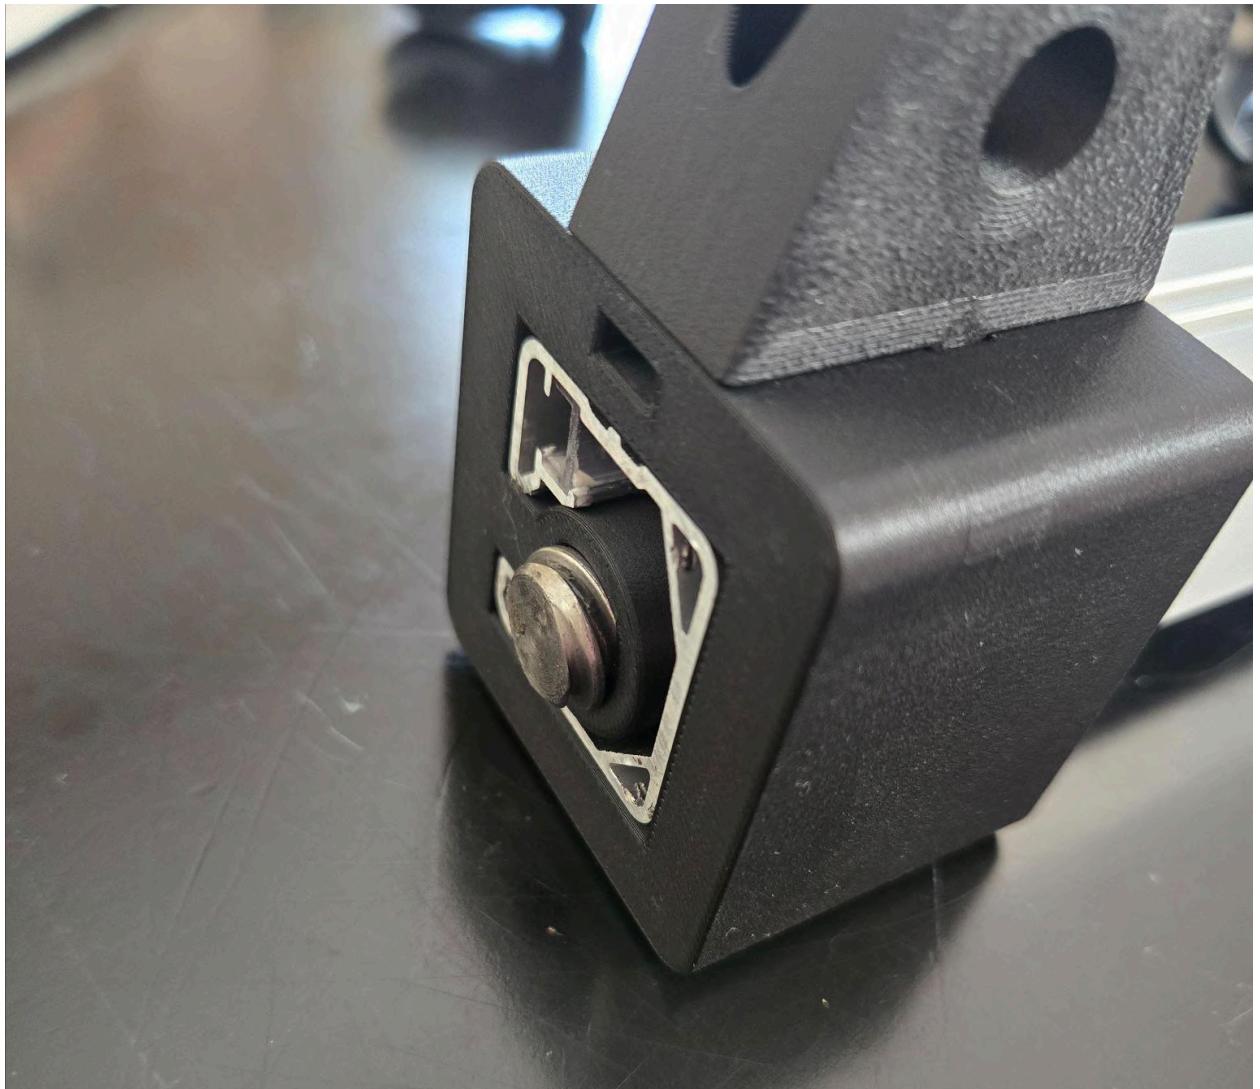
9. Slide the block down the aluminum rail, until it hits the lead screw.

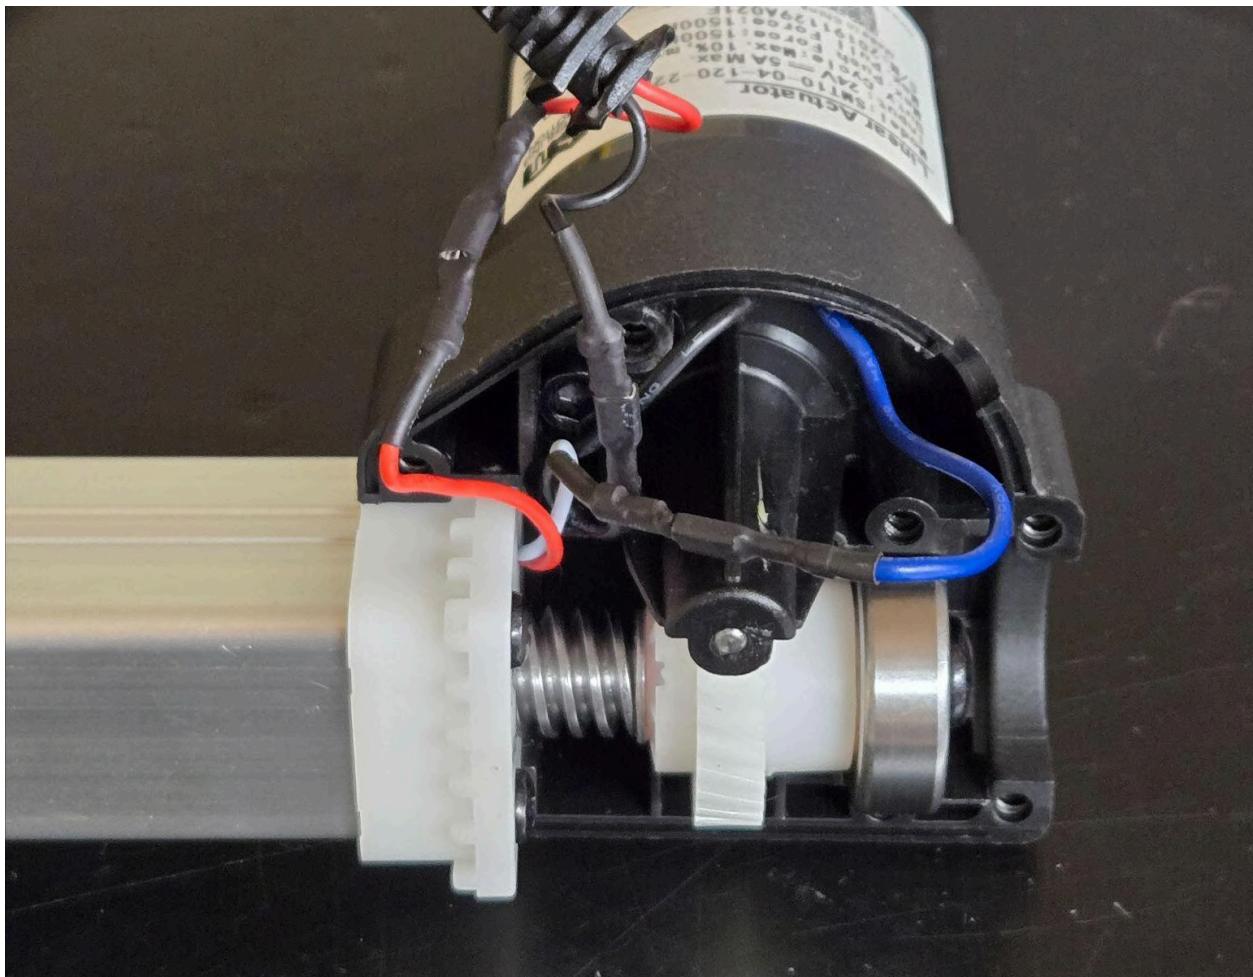
13. The spacing should look like this:
