MRI guidelines for Medtronic
implantable infusion systems

Instructions for use

MRI information for Model 8637-20 and 8637-40 SynchroMed™ II pumps and Model 8667-20 and 8667-40 SynchroMed III pumps 9

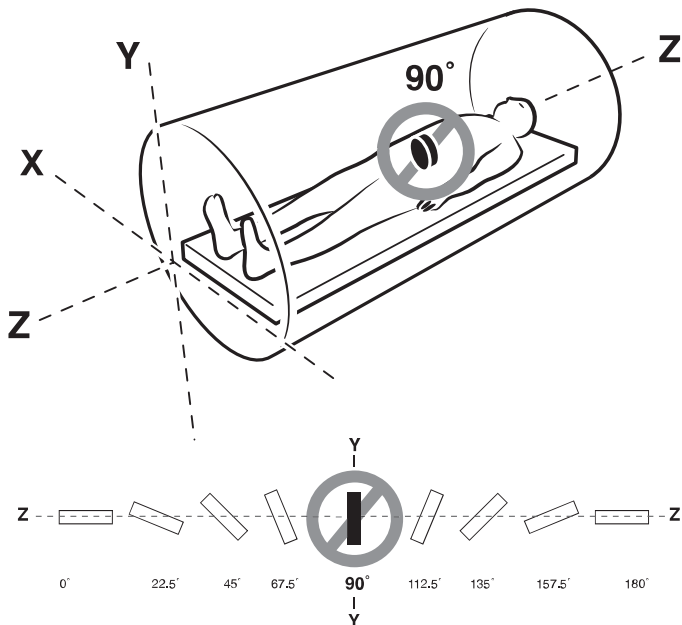
Figure 1. Pump positions in relation to z-axis MRI orientations

Note: If the pump face is oriented at 90° to the z axis, the refill port would be facing towards the patient's feet or head.

90° alignment of an implanted pump with the z axis (Figure 1) of 1.5-T and 3-T horizontal, closed-bore magnetic resonance imaging (MRI) scanners can cause MRI-induced demagnetization of the internal pump motor magnets, which can result in permanent, nonrecoverable stoppage of the pump. This is due to the orientation of the pump with respect to the magnetic field of a horizontal, closed-bore MRI system. SynchroMed II and SynchroMed III pump performance has not been established using other types of MRI scanners such as open-sided or standing MRI.

Prior to MRI, confirm the pump is not oriented 90° with respect to the z axis of the MRI scanner (see Figure 1). Palpate the pump to determine the orientation. The pump diameter is about 87.5 mm (3.4 inches) including the catheter access port. If the pump face is oriented at 90° to the z axis, do not initiate the MRI scan. Also, determine if the patient implanted with a SynchroMed II or SynchroMed III pump can safely be deprived of drug delivery. If the patient cannot be safely deprived of drug delivery, alternative delivery methods for the drug can be used during the time required for the MRI scan. If there is concern that depriving the patient of drug delivery may be unsafe for the patient during the MRI procedure, medical supervision should be provided while the MRI is conducted.
