# SMT10-04-120-220 (43T) Linear Actuator By Sterling Motion Block Replacement

This same instruction manual applies to the SMT10-04-128-239 (42F) model.

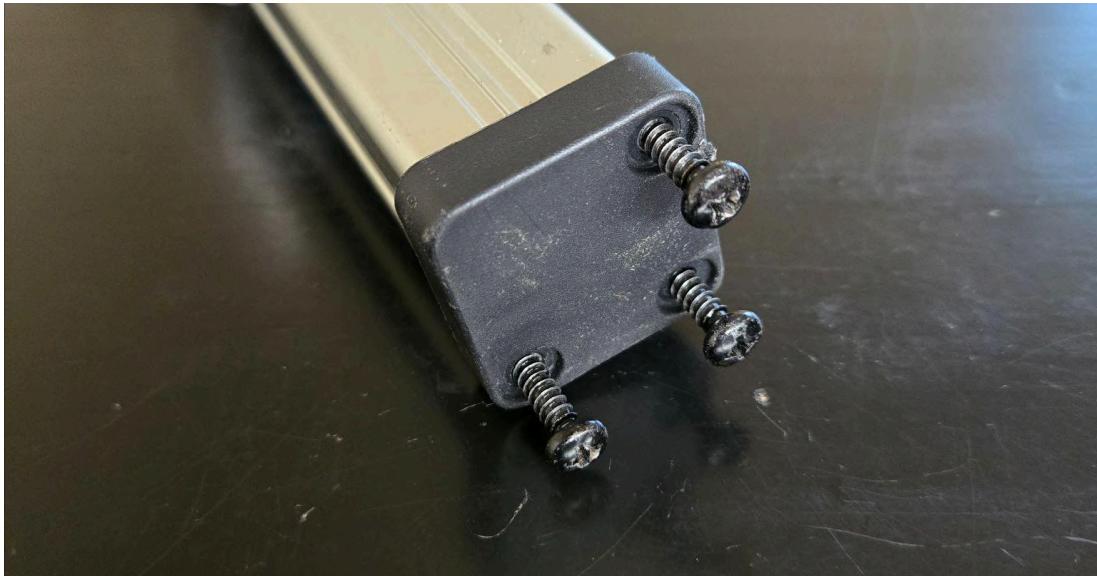
1. Remove the 3 small screws from the cap on the end of the assembly.

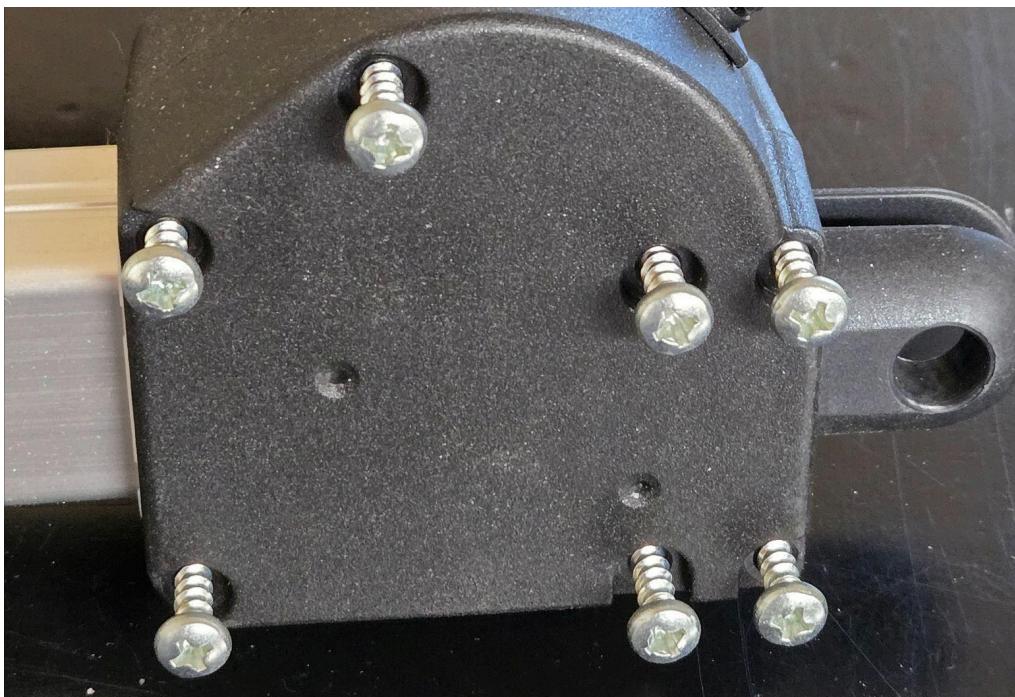
2. Remove 7 screws. These screws are quite long, I would recommend a cordless drill if it is available.

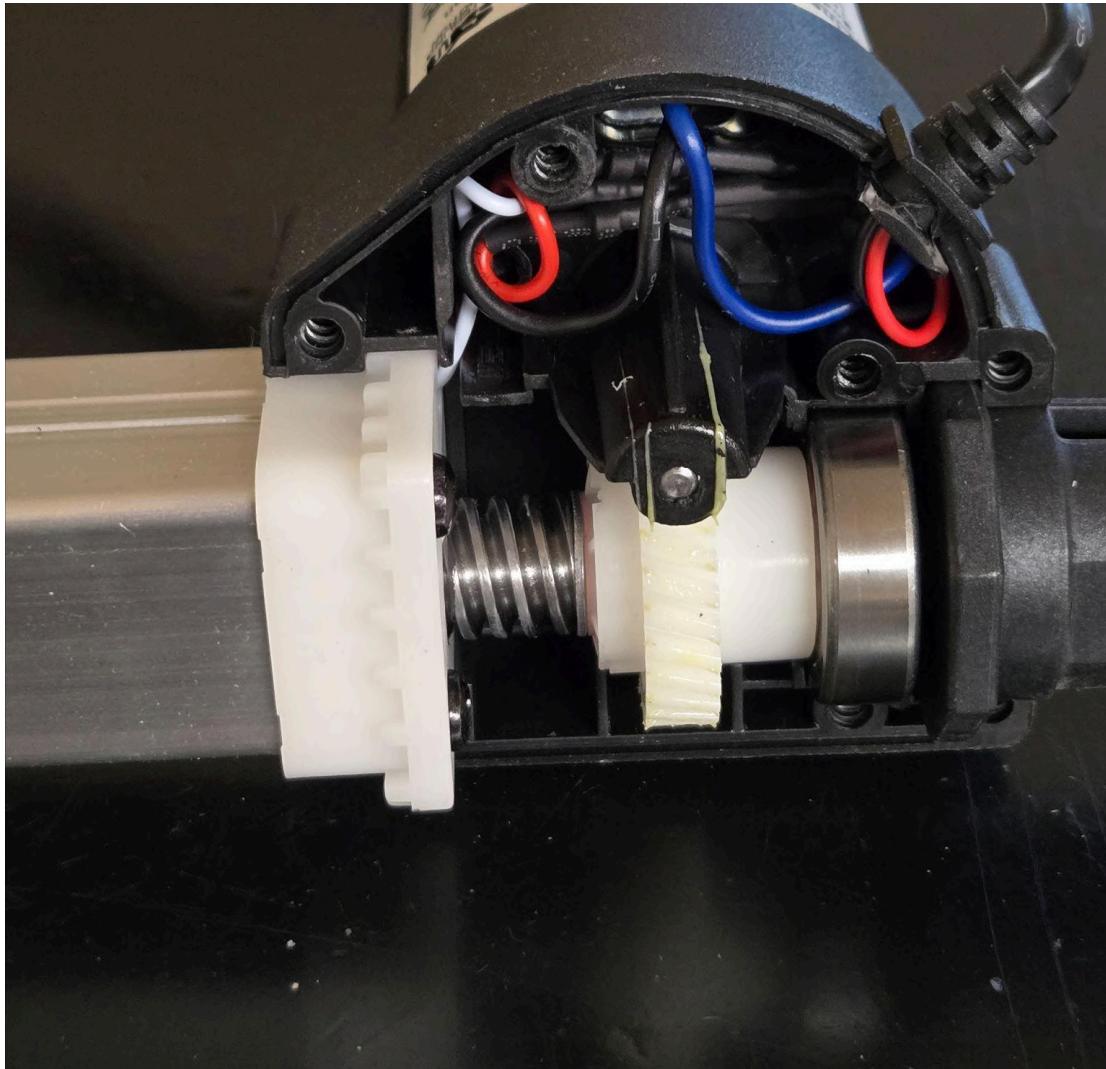
3. Remove gearbox cover. There are no clips holding it in place, only the fasteners that were just removed. Here is what that looks like:

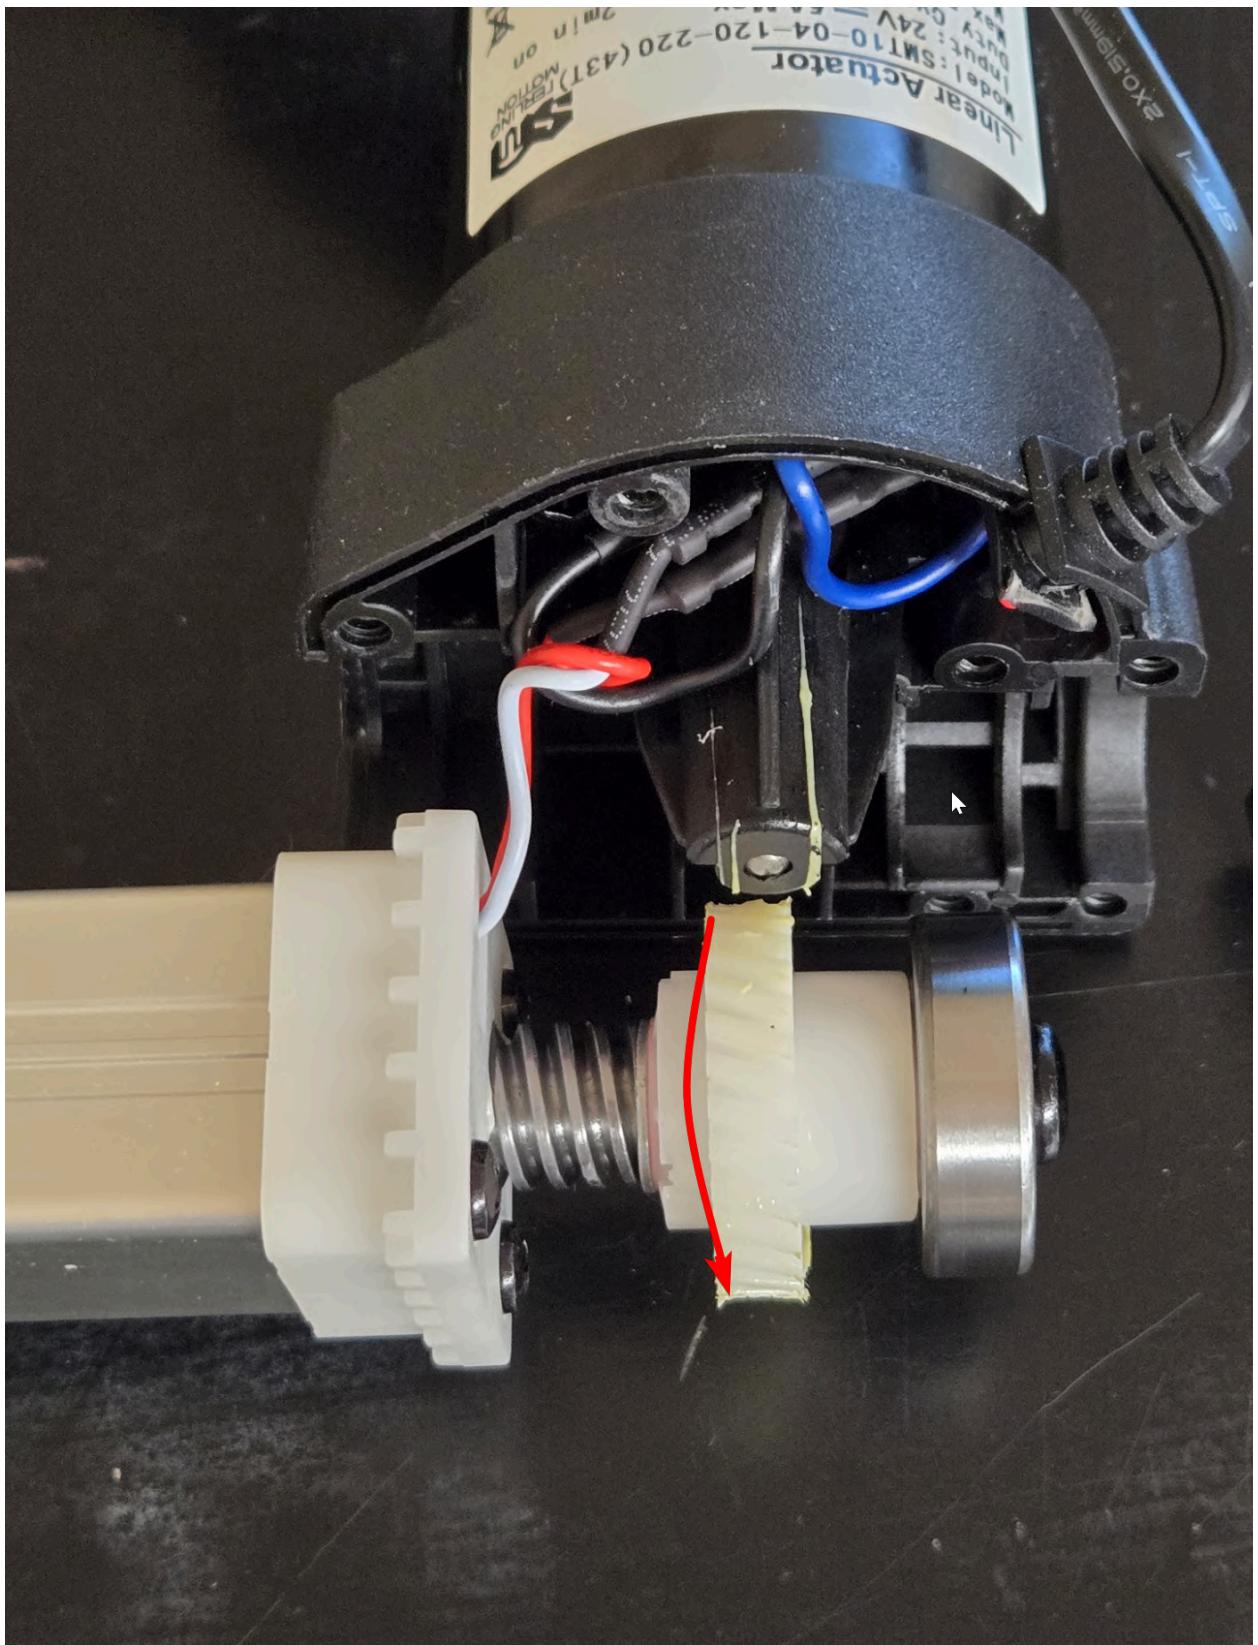
5. Rotate the plastic gear off of the worm gear. The wires do not need to be disconnected.  
Pulling the bottom of the plastic gear will rotate it off of the worm gear.

6. Twist the plastic gear counter-clockwise (the bearing pictured above is the top for reference) and either 2 things will happen
  - a. The broken plastic block will slide to the end of the aluminum rail and you can take it off.
  - b. The lead screw comes out and the plastic block doesn't move. If this happens keep going in the same direction, then push the lead screw down back into the aluminum rail. This will push the plastic block off the end. Repeat as many times as necessary to remove the block.
7. (Optional) At this time if you have some grease, you can apply it to the threads on the block so they will be spread around by the lead screw.
8. Place the new block on the aluminum rail, with the "MOTOR SIDE" text facing the motor.

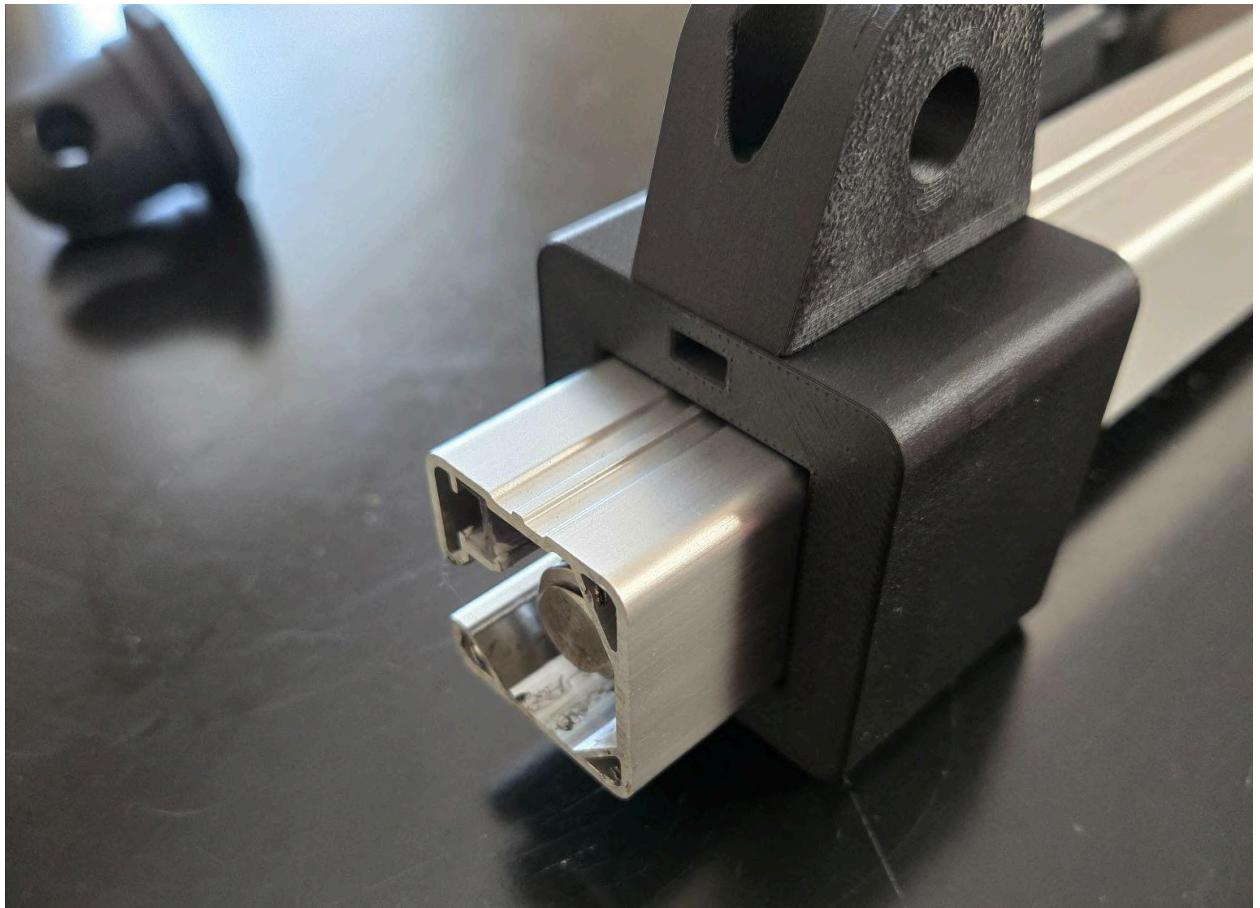
9. Slide the block down the aluminum rail, until it hits the lead screw.

10. Turn the lead screw with the plastic gear clockwise so it goes into the block.
  - a. Turning the lead screw this direction will force the plastic gear into the aluminum rail screws pictured in the photo above. To more easily screw on the block, pull the lead screw out a little to avoid this.
11. Ensure the block is fully on the aluminum rail with at least  $\frac{1}{4}$  inch of extra rail past the block. (Pictured below)

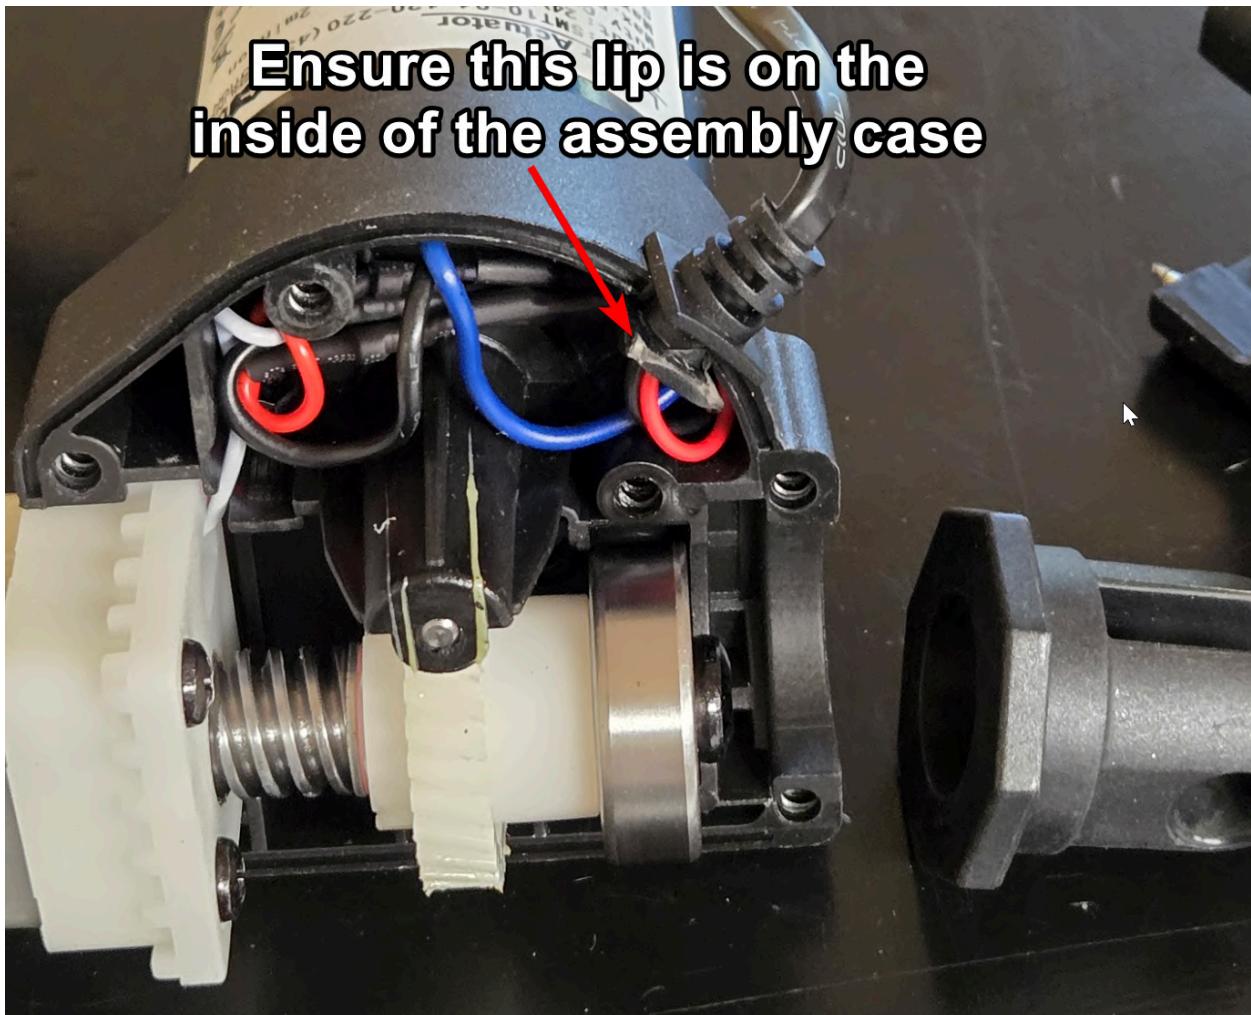
13. The spacing should look like this:

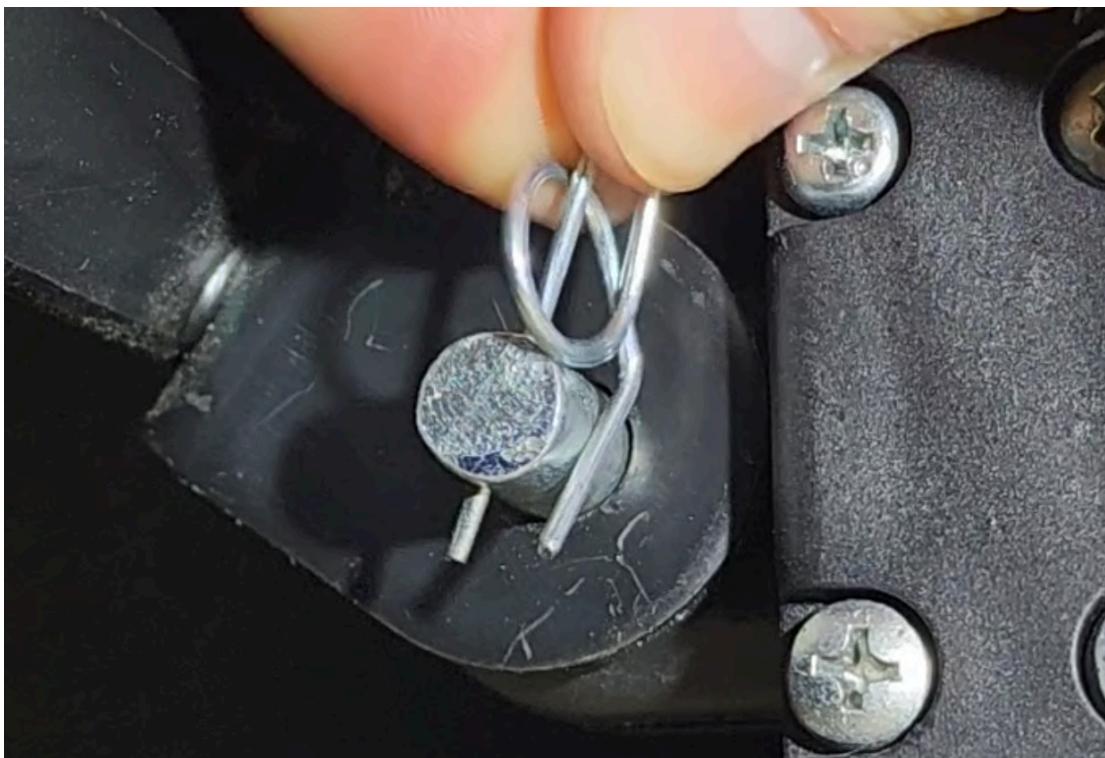
4. Make sure the hole in the main pin is roughly up/down so that the retaining ring pin can be pushed in easily.

5. Push the retaining ring pin in, flat side through the hole.

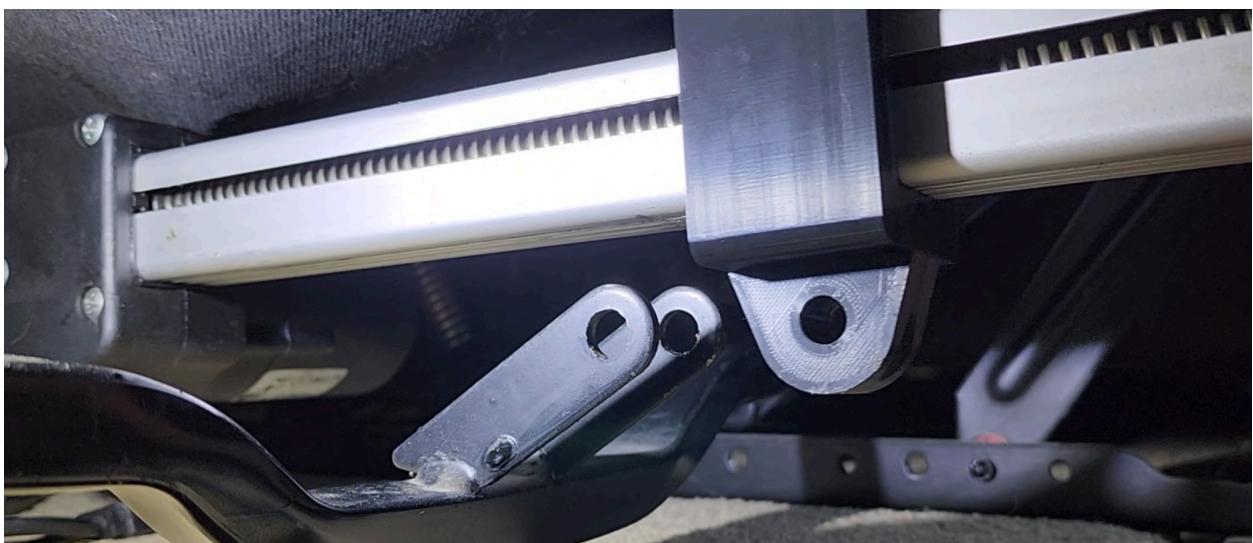
6. Twist the retaining ring pin so that the ring snaps into the locked position on the main pin. It should look like this when complete.
