EmStat Pico MUX16 pinout correction

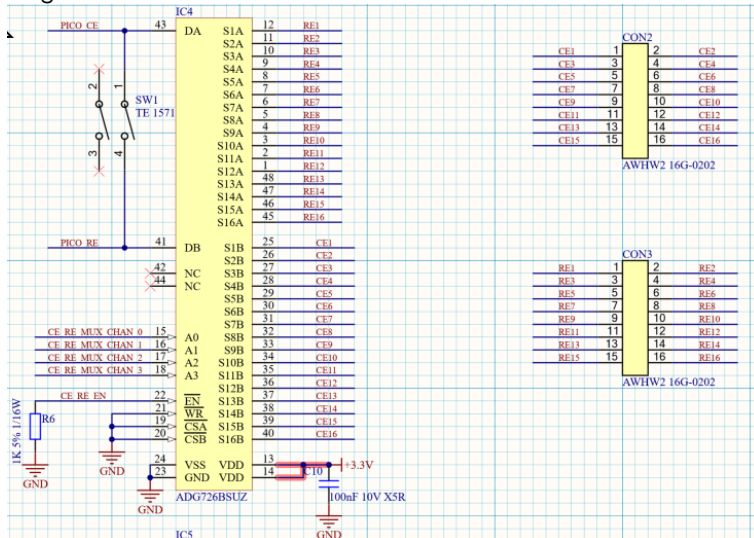
Original Schematic:

CE and RE were switched so that CON3 was CE1 to CE16 and CON2 was RE1 to RE16.
