1 Calibration

1.1 Ongoing Performance Monitoring

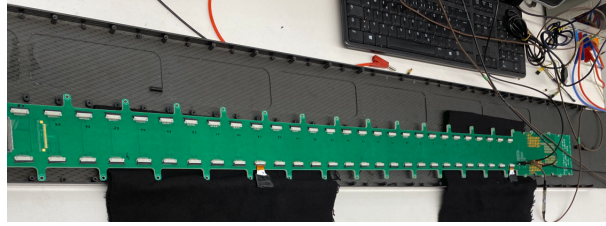
Figure 1: *Figure 1: Tests with two LEDs on the board 1: signals measured at odd connectors 1 and 19 on the left side.*

This method needs to be improved as tests have shown that the signals measured from both sides of the scintillator tile vary in intensity, although it was assumed that these LEDs would be used for accurate measurements. Figure 1 shows a time delay measurement. Further, for calibration, we used such signal sources as Sr-90, Na-22, and a laser.

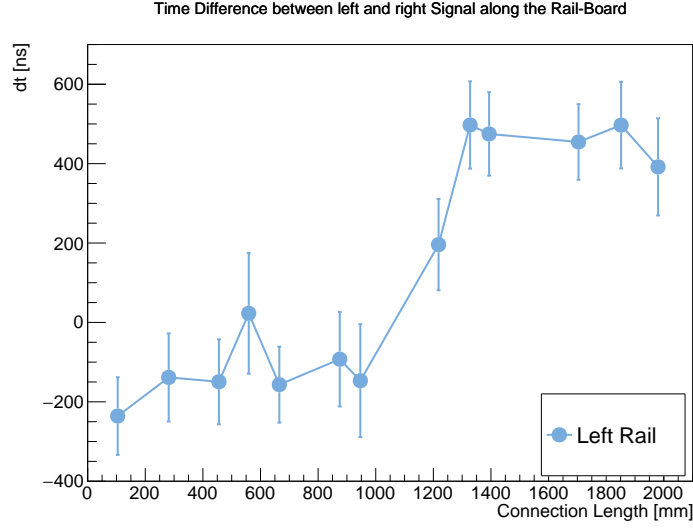
Figure 5: Time difference between the left and right SiPM arrays signals, measured in the middle of the scintillation plate.

ps range (or double the time resolution of the scintillator) (see Fig. 4), but the time difference between the two signals increases on the second part (see Fig. 5, shown for the left part of the board) of the railboard due to waveform distortion (reflections, different signal attenuation on two sides of one slot).
