TECHNICAL NOTE EDITION ANGLAISE

77 11 310 122 Edition 2 - NOVEMBER 2003

Twingo

FRONT WIPER MOTOR

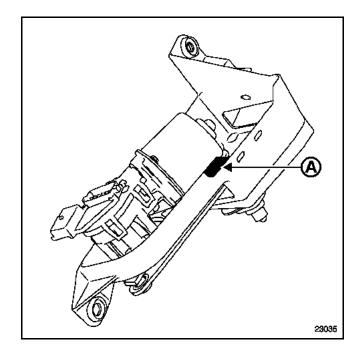
Due to modifications to the front wiper motor, it is now necessary to remove section (A) of the mounting when replacing the motor.
