# 1 Calibration

## 1.1 Ongoing Performance Monitoring

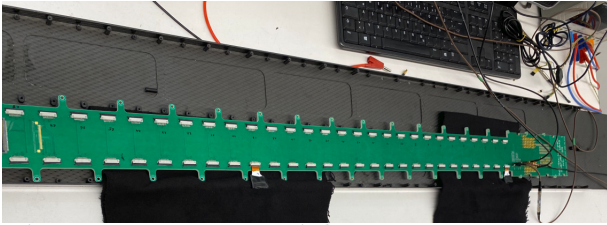
This method needs to be improved as tests have shown that the signals measured from both sides of the scintillator tile vary in intensity, although it was assumed that these LEDs would be used for accurate measurements. Figure 1 shows a time delay measurement.

**Figure 1: Tests with two LEDs on the board 1: signals measured at odd connectors 1 and 19 on the left side.**
