Understanding the Surface Features of Fatigue Fractures: How They Describe the Failure Cause and the Failure History

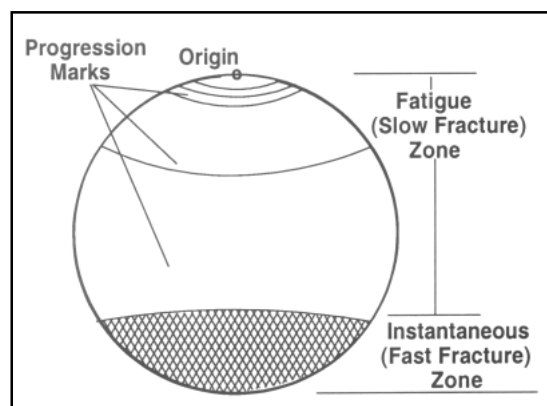
Fig. 1 Macroscopic surface features

Figure 1 shows the major surface features seen on almost every fatigue face. The *origin* is where the crack actually started. The crack then grew slowly across the *fatigue zone*, with a typical growth rate averaging approximately 10^{-6} in./stress cycle. During this slow crack growth, there were variations in the load that resulted in corresponding variations in the crack growth rate that appear as *progression marks*. Eventually, the crack reached the point where the remaining material was overstressed, and the overload zone resulted. In the *overload zone*, most cracks grow as macroscopically brittle fractures, and the crack growth rate is approximately $\frac{1}{2} \times$ the speed of sound in the piece. However, the overload zone may develop by either ductile or brittle fracture mechanisms.

- A single origin *usually* indicates a failure with low overstress, while the presence of multiple origins may be the result of either high stress or high stress concentrations.

- The *fatigue zone* is the area of slow crack growth. There are low-cycle fatigue failures where the crack growth occurs over relatively few cycles, frequently less than a hundred. However, in most of the machinery failures analyzed by the author, the crack has taken between 400,000 and 20,000,000 cycles to grow across the fracture face. The plane of this fatigue zone is very important, because it develops perpendicular to the plane of maximum stress in the part, thus helping the investigator to understand the source of the stress.

- The *progression marks* show how the crack has grown and are only present in fractures where there have been substantial variations in the component stress as the crack grew across the piece. (The traditional name for these indicators has been *beach marks*, because they frequently look like the lines that waves leave on a sandy beach. However, *progression*

marks is a much more descriptive term, because these lines tell us exactly how the crack face has progressed across the piece.) There are actually two mechanisms that generate progression marks. Most commonly, they are seen in the older portion of a failure, where they show gross changes in load, such as startup and shutdown forces. However, in the latter stages of a fracture life, they show the individual stress cycles.

- The *overload zone*, or fast fracture zone, is the portion of the piece where the final catastrophic failure occurs. This zone is usually macroscopically brittle, although in a small percentage of the pieces, ductility is present. In this area, the crack propagates at approximately $\frac{1}{2}$ the speed of sound in the material. The size of the overload zone

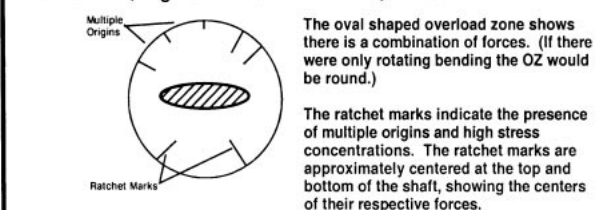
Combined Torsion and either Bending or Tension

Combination of torsion and tension or torsion and bending forces. As the importance of the torsional loading becomes less, the fracture face more closely approaches the perpendicular.

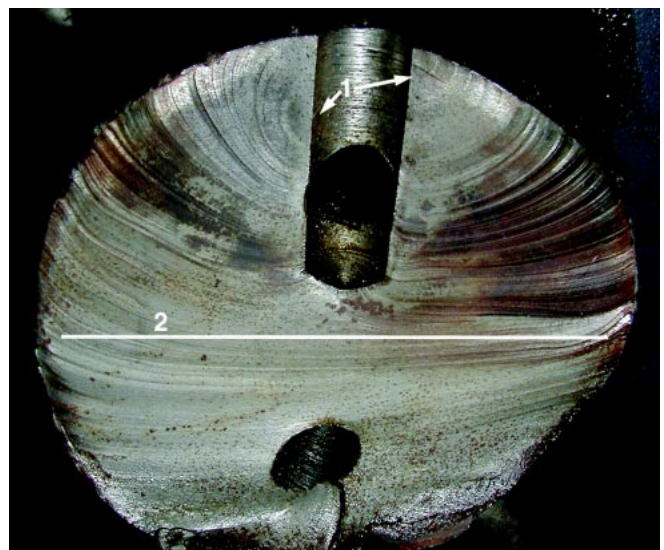
Photo 1 A basic fatigue failure complicated by several holes. Two origins are seen at (1). The progression marks work across the fracture face. At (2) the growth of the fracture face is essentially straight across the face. (With high magnification, fatigue striations may be seen between the progression marks.)

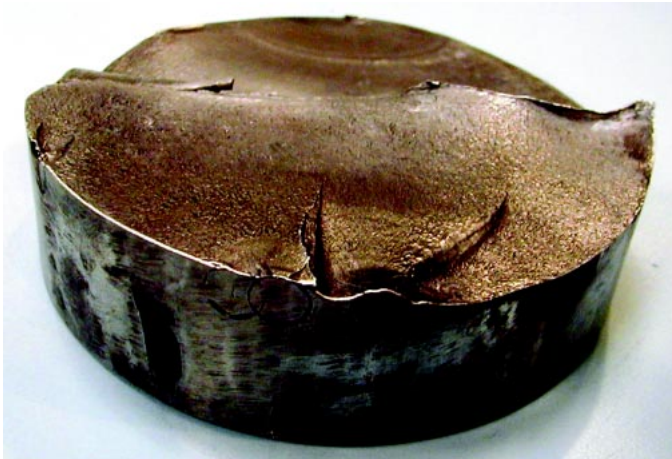
Photo 2 A view of an agitator shaft showing two ratchet marks separating the three failure origins. Note that the origins are not on the same plane and that the ratchet marks are in effect boundaries between the fracture planes. (There is yet another origin on the other side of the failure face.)

Photo 3 This section of a crankshaft shows the ratchet marks that result when a torsional fatigue failure has multiple origins. Note that the sides are at approximately a 45° angle, whereas the sides of the ratchet marks shown in Photo 2 are essentially axial.

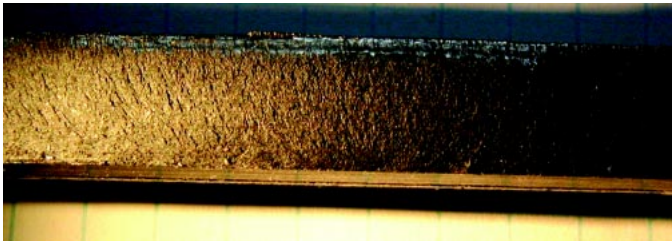
Photo 4 A view of a low-cycle fatigue failure of a gear tooth from a large compressor. Note that both the coarse ratchet marks on the left and the fine ones to the right point away from the origin, which is on the bottom edge of the tooth, just to the right of the center.

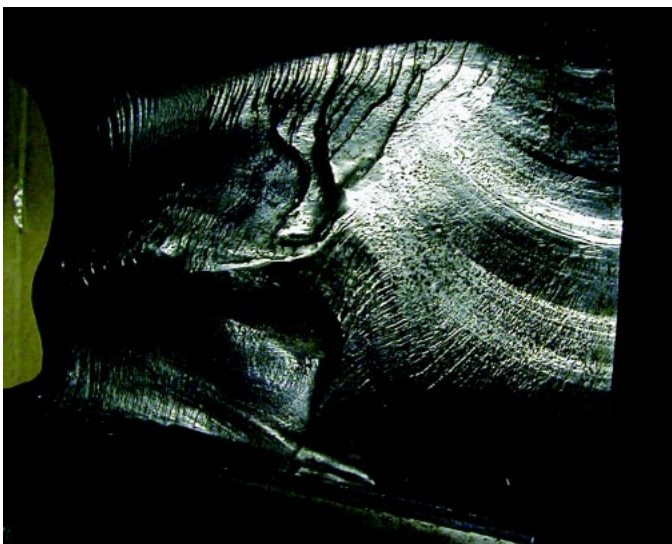
Photo 6 These are "river marks" in a case hardened gear used in a 3500 hp pump drive. Like rivers flowing downstream, they indicate the direction in which the crack progressed and show the crack grew from top to bottom. However, the pressure side of the teeth is toward the bottom, that is, the gear is being driven in an upward direction, indicating a serious torsional problem.

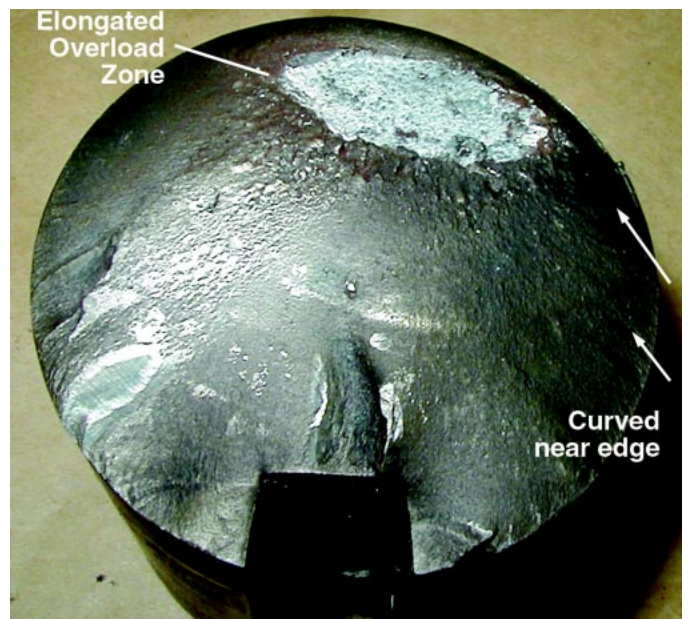
Photo 5 A cross-sectional view of this classic fatigue failure shows that the piece is domed with the smallest radius near the outer edge. This small radius testifies to a high stress concentration that, when multiplied by the stress concentration of the keyway, caused the failure. Also of interest is the shape of the overload zone. The fact that it is elongated indicates some plane bending loads were present.
