Chapter 7

Microscopic Features Characterizing Hydrogen Embrittlement

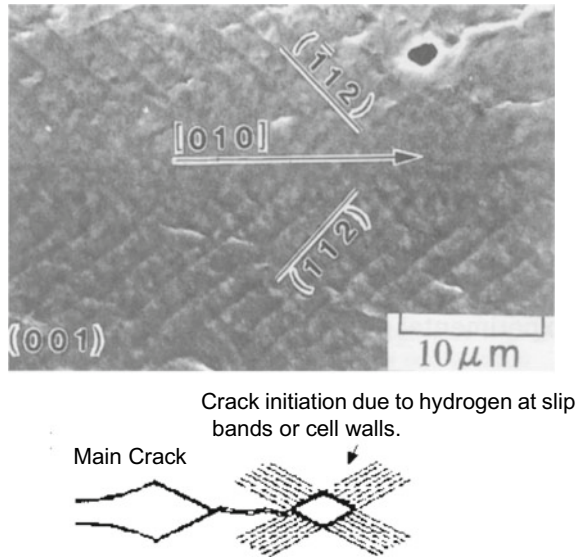
Fig. 7.1 Striations on the tensile-fracture surface of a hydrogen-charged iron single-crystal specimen. The lower illustration is a schematic STM view showing a microcrack formed at the intersection of striations (Terasaki et al. [1])

Early works revealed striations on tensile-fractured surfaces of hydrogen-charged iron specimens [1]. Except for fatigue fractures, striated surfaces are not popular in fractographic features. Striations have been observed mostly for single-crystal and coarse-grain specimens. Figure 7.1 shows striations on the tensile-fracture surface of a hydrogen-charged 0.001% C iron single crystal [1]. The crack growth as a whole was in the $[010]$ direction on a macroscopically $\{001\}$ plane, but the actual growth of the crack front was in the $\langle 110 \rangle$ direction. Striations parallel to the crack front coincided with traces of $\{112\}$ slip planes. Examinations of fine details utilizing scanning tunneling microscopy (STM) and mating of opposite fracture surfaces revealed the formation of fine voids at intersections of striations, as shown schematically in the lower part of Fig. 7.1. Crystallographic relations are consistent with the void formation originating in interactions of dislocations that move on intersecting slip planes.

Formerly, fine striations of about $1\text{ }\mu\text{m}$ spacing along $\{112\}$ slip planes were reported to be associated with the slow crack growth macroscopically on $\{001\}$ and in $\langle 110 \rangle$ directions for Fe-3%Si single-crystal specimens [2]. Acoustic emission (AE) measurements detected discontinuous crack growth in sustained-loading tests for fatigue-prenotched disk-shaped miniature compact tension specimens, which were

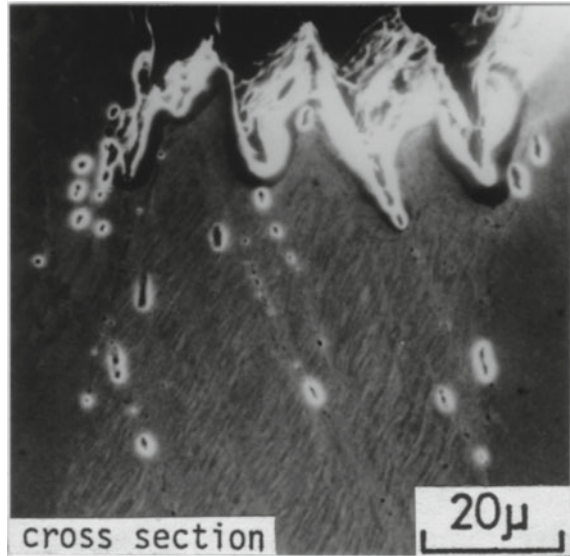
Fig. 7.2 Cross-sectional view of the area beneath the fracture surface of a coarse-grain iron specimen tensile-fractured under hydrogen charging. The surface striations correspond to internal slip bands, and etch pits are formed along slip bands (Nagumo et al. [5])

new cracks by activated dislocations. Direct evidence of the crack nucleation at sites of a high density of dislocations is shown in Fig. 7.2 [5].

More distinct and large striations were also observed. Figure 7.2 [5] shows a cross-section of a commercial pure iron specimen tensile fractured at room temperature under relatively mild hydrogen charging by cathodic electrolysis in a 3% NaCl aqueous solution at a current density of 100A/m^2 . The specimens of 5 mm in diameter had a bamboo structure, and fracture occurred after the onset of necking. The fracture surface exhibits coarse striations extending to internal deformation structures. A cross-sectional observation in Fig. 7.3 [5] revealed that the striations were on the extension of deformation bands in which etch pits and microvoids formed. Trace analyses confirmed the coincidence of the lamellae in Fig. 7.3 with $\{110\}$ and $\{112\}$ slip planes.

Intense slip bands act as crack initiation sites, as revealed in Fig. 7.2. Surface cracks at U-notch bend tests of spheroidized AISI 1090 steel specimens appeared at intense surface rumpling induced by slip bands [47]. The appearance was essentially the same between hydrogen-charged and uncharged specimens, but strain about a factor of two lower than uncharged ones brought about a similar surface roughness level or cracking in hydrogen-charged specimens [47]. A similar U-notch bend test was conducted for quenched-tempered AISI 4340 steel of 1.35 GPa in tensile strength with and without hydrogen precharging under a high hydrogen fugacity estimated to be 1 GPa [48]. Hydrogen charging markedly reduced strain to fracture, and cracks nucleated internally in a mode I manner. The crack extension to the surface was along the characteristic slip path. Simultaneous hydrogen charging, instead of precharging,

On examining the tensile-fracture surface of hydrogenated austenitic stainless steel, Ulmer et al. took notice of the continuity of steps on the fracture surface to internal slip bands and the crack formation along active slip bands [39], similar to Fig. 7.2 for pure iron. It suggests the extent of the region that concerns crack extension. Since hydrogen diffusivity in austenite is very low, the crack formation is hardly ascribed to the precipitation of molecular hydrogen during the test.

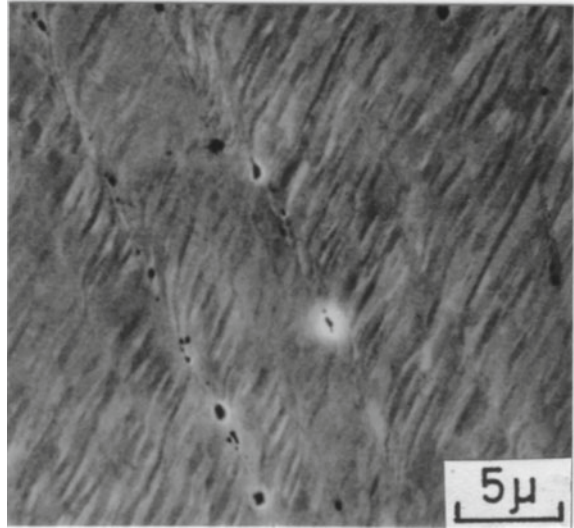
Fig. 7.3 Etch pits and microvoids formed in deformation bands in a coarse-grain iron specimen tensile-fractured under hydrogen charging (Nagumo et al. [5])

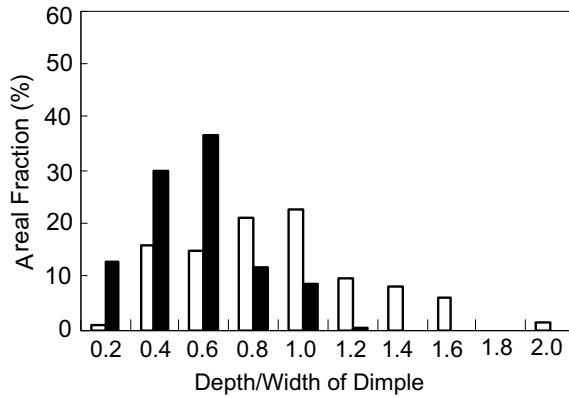
Fig. 7.4 Area fractions of dimples with different depth/width ratio on fracture surfaces of a low-carbon medium-strength steel subjected to a three-point bending test with/without hydrogen precharging. The open and filled bars indicate non-charged and hydrogen-charged specimens, respectively (Nagumo et al. [11])

The fracture surface at a three-point bending test of a mildly hydrogen-precharged low-carbon medium-strength steel plate exhibited patterns consisting of mostly primary and secondary dimples [11]. Hydrogen precharging enlarged primary dimples while reducing secondary dimples. The area fractions of dimples with different depth (*h*)/width (*w*) ratios are shown in Fig. 7.4 [11] for hydrogen precharged and uncharged specimens. Hydrogen precharging increased the area fraction of

shallow dimples ($h/w < 0.5$). It implies that hydrogen reduces the extent of plastic deformation to form dimples; thus, the energy dissipated during ductile crack propagation.

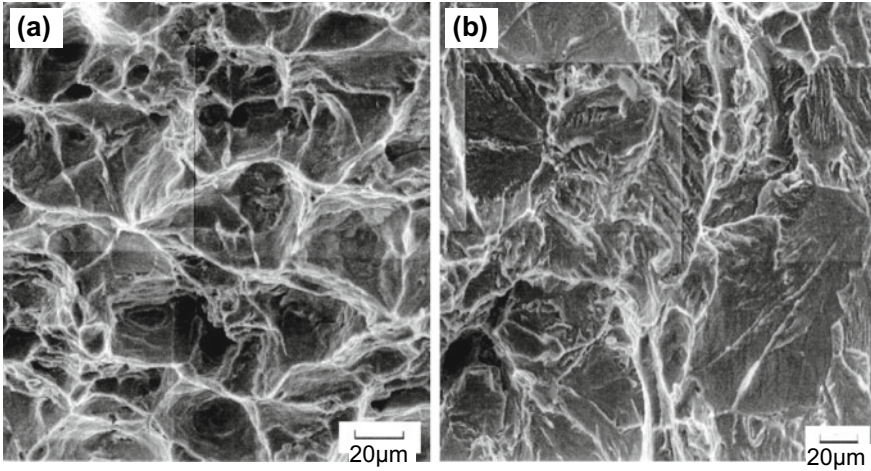
Fig. 7.5 Fracture surfaces of a low-carbon ferrite–pearlite steel subjected to three-point bending tests (a) without and (b) with hydrogen precharging. (a) dimple and (b) quasi-cleavage patterns. Hydrogen charging is conducted by cathodic electrolysis in 3% NaCl+ 3 g/l NH₄SCN at a current density of 5 A/m² (Shimomura et al. [16])

The intermediate range between ductile and brittle fracture is wide. QC locates in the intermediate range, and its morphology is diverse. QC surfaces like a premature dimple fracture often appear in hydrogen embrittled medium-strength steels and moderately embrittled high-strength steels. Figure 7.5 compares low-carbon ferrite–pearlite steel fracture surfaces subjected to three-point bending tests with and without hydrogen precharging [16]. The hydrogen charging was conducted under mild fugacity by cathodic electrolysis in 3% NaCl + 3 g/l NH₄SCN at a current density of 5 A/m². After the onset of the stable crack, shown in Fig. 6.13, dimple patterns for the uncharged specimen changed to QC with irregular morphologies by hydrogen charging. Fine striations also appeared in the latter. Effects of hydrogen are reasonably ascribed to the cause of premature fracture before round-shape dimples form by substantial growth of voids. The reduced roughness of the fracture surface by hydrogen shown in Fig. 7.4 is consistent with the decrease in the crack growth resistance by hydrogen shown in Fig. 6.15 for low-carbon ferrite–pearlite steel of similar compositions.

QC surface in Fig. 7.5(b) is an extension of dimple fracture, but QC surface as an extension of intergranular fracture shows a significantly different morphology, as shown in Fig. 7.10. The latter usually appears in hydrogenated martensitic or bainitic high-strength steel. The morphologies manifest deformation microstructure to form the crack surface, naturally varying with steel microstructures.

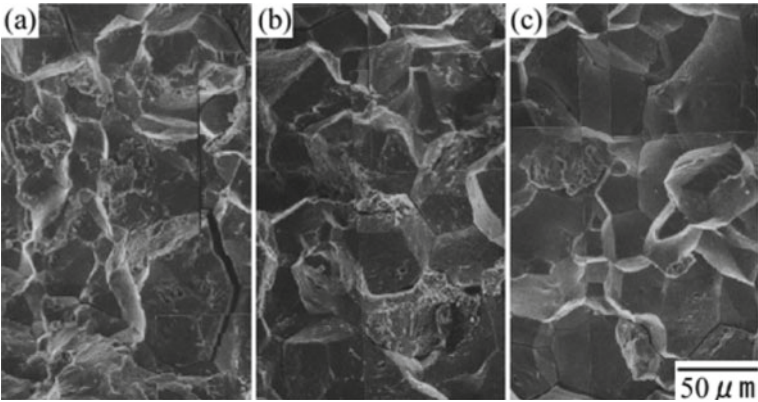
Fig. 7.6 Tensile-fracture surfaces of medium-carbon martensitic steels under hydrogen charging. Manganese contents: (a) 0.5, (b) 1.0, and (c) 1.5% (Nagumo et al. [26])

The evolution of IG fracture depends on the compositions of steel. Figure 7.6 shows fracture surfaces of medium-carbon Mn–Cr–Mo martensitic steel at slow-elongation rate tensile tests under simultaneous hydrogen charging [26]. The compositions of the steels were similar except Mn contents of 0.5, 1.0, and 1.5%. The specimens were plates of 2 mm in thickness and 10 mm in width without a notch. Simultaneous hydrogen charging was conducted by cathodic electrolysis in a 3% NaCl aqueous solution containing 0.5 g/l NH_4SCN at a current density of 5A/m^2 . The tensile properties of the three steels were similar when hydrogen was absent, but a significant degradation appeared in hydrogen-charged specimens with increasing Mn contents.

Fractures under hydrogen charging were always initiated near the corner of the specimen, with IG fracture mode prevailing. Fine tear patterns were frequently observed on IG surfaces, but the surface was smoother for higher Mn contents. Chemical etching of the IG surface with saturated picral revealed tear markings along martensite lath boundaries. The average roughness of the fracture surface, measured using scanning laser microscopy, decreased with increasing Mn contents, as shown in Fig. 7.7 [26]. The roughness corresponds to the dissipated plastic energy on the crack growth. Lower roughness implies lower resistance to the crack advance, and the smooth IG surface can be a crack path with minimal energy dissipation.

Compositional dependence of hydrogen degradation in high-strength martensitic steel exhibiting IG fracture is presented in Figs. 7.6 and 7.7. The compositions of the steels were similar except Mn contents, and the slow-elongation rate tensile test was under simultaneous hydrogen charging [26]. A crucial issue concerning IG fracture is the involvement of plasticity in embrittlement. A useful tool to detect lattice defects is to utilize tracer-hydrogen, and the amount of absorbed tracer-hydrogen represents the densities of trap sites. Figure 7.20 [26] shows the amounts of hydrogen absorbed to saturation in specimens given various amounts of strain. The amounts for the three steels are almost the same when unstrained. On the other hand, a substantial increase by straining appeared more pronouncedly for higher manganese contents. As described in Figs. 3.2 and 3.10, TDA gives information about the nature of strain-induced defects.

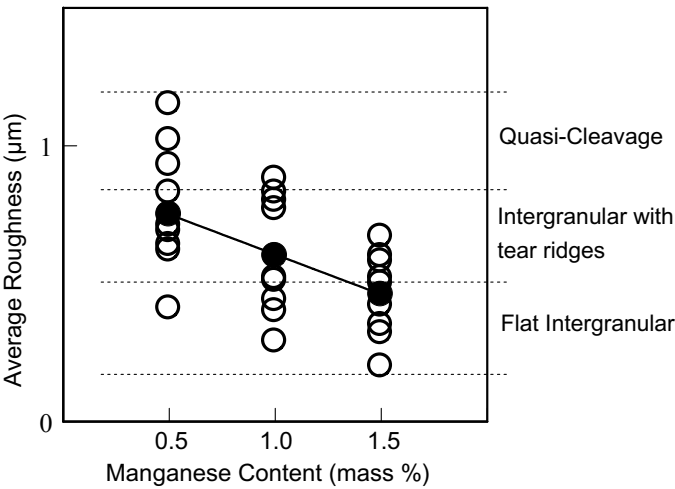
Fig. 7.7 Average roughness and patterns of fracture surfaces shown in Fig. 7.6 (Nagumo et al. [26])

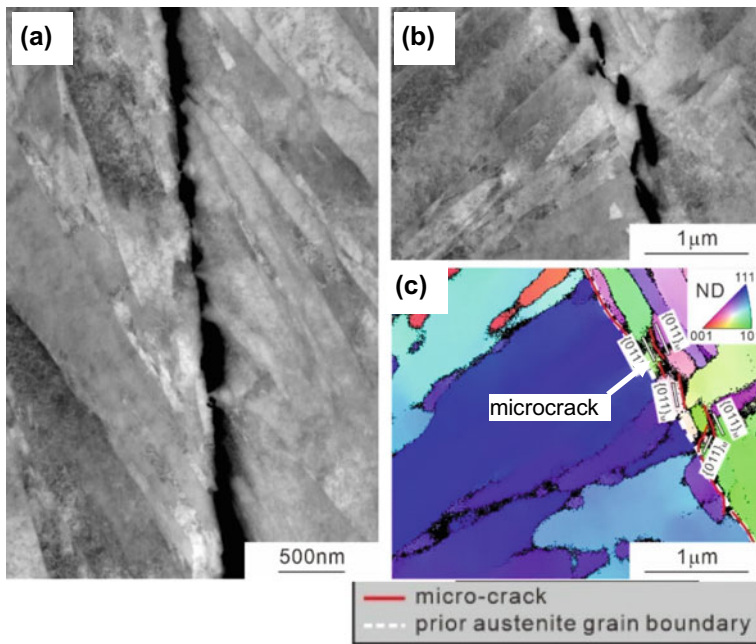
Fig. 7.8 (a), (b) Backscattering electron images and (c) Electron backscattering diffraction orientation map of the tensile-fractured Fe-0.2%C martensitic steel (Shibata et al. [29])

Shibata et al. examined a cross-section of a tensile-fractured specimen of as-quenched and hydrogen-precharged 0.2% C martensitic steel [29]. Figure 7.8(a) and (b) are backscattering electron (BSE) images of a microcrack present beneath the tensile-fracture surface, and Fig. 7.8(c) is the electron backscattering diffraction (EBSD) orientation map around the area (b). Several micro voids likely coalesced and propagated along $\{011\}$ planes, slightly away from the prior austenite grain boundary.

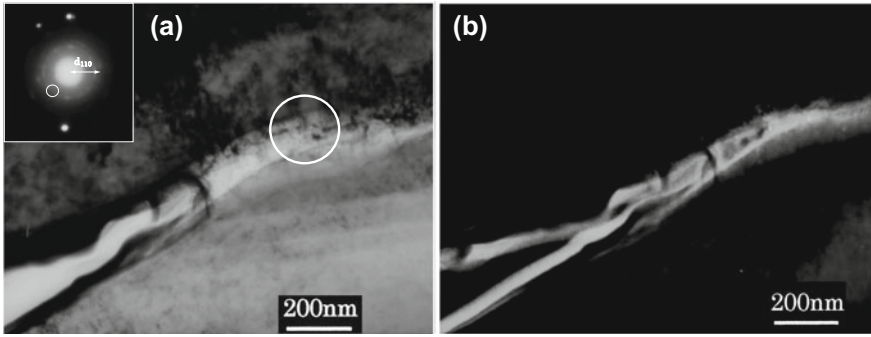
Fig. 7.9 (a) Featureless zone revealed by transmission electron microscopy in front of a small side crack formed on an iron specimen tensile-fractured under concurrent hydrogen charging. (b) The dark field image of the encircled area in (a) from a halo ring in selected electron diffraction (Nagumo et al. [32])

A subject of concern is the role of plasticity. Alternatively, a highly disordered microstructure was revealed on the fracture surface of a hydrogen-charged iron [32]. Plate specimens of a 0.06%C ferritic steel of 310 MPa in tensile strength were tensile fractured under concurrent cathodic hydrogen charging in a 3% NaCl+ 3 g/l NH₄SCN aqueous solution at a current density of 10 A/m². The hydrogen-charging condition was fairly mild, and the elongation to fracture was still as high as 19% in the presence of hydrogen. The fracture surface and the subsurface area were examined by transmission electron microscopy (TEM) using a focused ion beam (FIB) technique for the sample preparation.

The selected electron diffraction (SAD) from the fracture surface showed halo patterns, and the lattice image of the surface layer showed disordered distributions of atoms. The thickness of the layer was less than 1 μ m, and the dislocation densities in neighboring areas were very high, forming cell structures. Similarly disordered, amorphous-like layers of about 50 nm in thickness were occasionally observed along dislocation cell walls at about 1 μ m below the fracture surface. In the above experiments, many short cracks were present transverse to the tensile axis on the side surface of the fractured specimens. Similar to the subsurface area, a featureless zone existed in the crack front, as shown in Fig. 7.9 [32]. The SAD pattern in the insert showed halo rings similar to that at the subsurface, and the dark field image clearly showed the presence of amorphous-like structures in the crack front. The featureless zone of a few 100 nm in length was within the plastic zone. Amorphization just below the tensile-fracture surface was also reported for hydrogenated Type 316L steel [33].

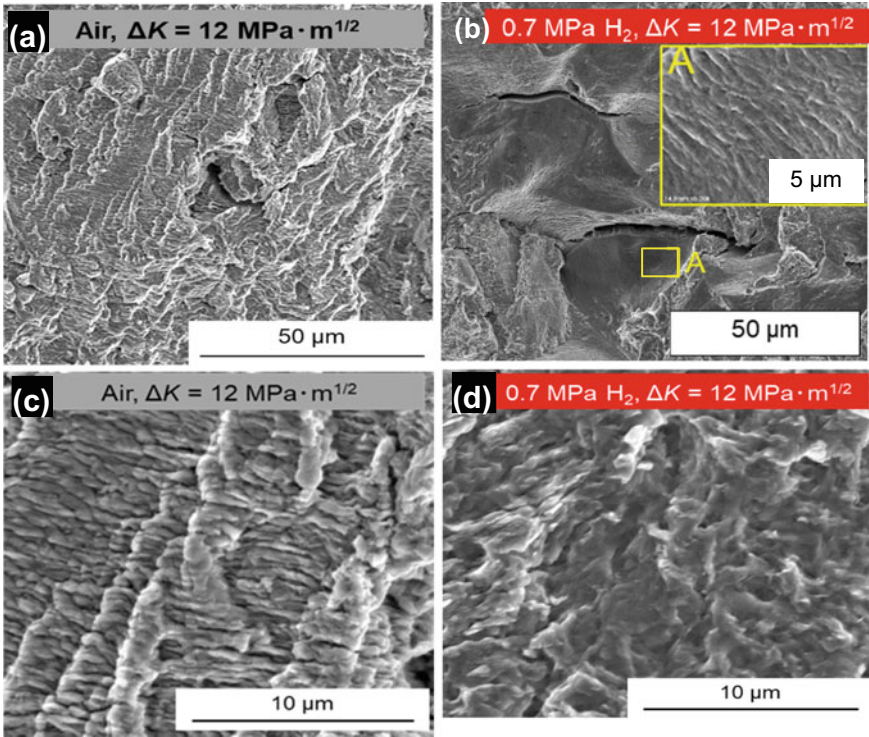
Fig. 7.10 Fatigue fracture surface of pure iron (a), (c) in air and (b), (d) in 0.7 MPa H_2 (Ogawa et al. [36, 37])

Figure 7.10 by Ogawa et al. [36, 37] compares fracture surfaces of pure iron in the air, (a) and (c), and 0.7 MPa hydrogen, (b) and (d), at ΔK of $12 \text{ MPa}\cdot\text{m}^{1/2}$. ΔK of $12 \text{ MPa}\cdot\text{m}^{1/2}$ was in Stage II in Fig. 6.21, before the onset of hydrogen acceleration in 0.7 MPa hydrogen. The FCG rates there were the same in the air and 0.7 MPa hydrogen, as shown in Fig. 6.21, but the fracture surfaces were substantially different. The surfaces are classified as QC. (Notice a broad range of the term “QC”, referring to Fig. 7.5.) A high magnification shown in Fig. 7.10(c) in air exhibits QC covered with narrow ductile striations of the spacing more than one order of magnitude larger than

the apparent da/dN . On the other hand, Fig. 7.10(b) in 0.7 MPa hydrogen exhibits the fracture surface consisting of IG-like shallow facets mixed with ductile tear patterns and striations. The inset in Fig. 7.10(b) shows fine striations on an IG-like facet. A high magnification in Fig. 7.10(d) shows a part of irregular flaky units without distinct striations.

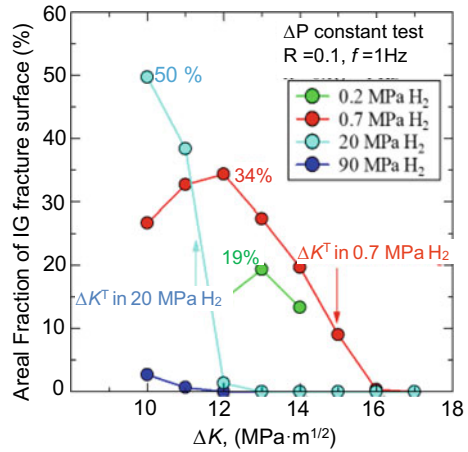
Fig. 7.11 Area fraction of IG fracture surface of pure iron in high-pressure H₂ as a function of ΔK (Ogawa et al. [36])

The hydrogen acceleration of the FCG rate was associated with change in the fractographic morphologies. An interesting result was that the area fractions of IG facets on the fracture surfaces were a function of ΔK values in the transition range, as shown in Fig. 7.11 [36]. The area fraction of IG decreases during the transition from Stage II to Stage II' and falls to almost zero at the late Stage II' in 0.7 and 20 MPa hydrogen. Accordingly, IG fracture per se is not the cause of a high FCG rate. For pure iron, the FCG rates in Stage II' were almost the same in 0.7 and 90 MPa hydrogen, and fracture surfaces of fairly flat and fine striations of irregular directions were similar.

The fracture morphology of specimens at ΔK of 17 MPa \cdot m^{1/2} was generally QC according to Fig. 7.11, but the crack growth rates were in 90 MPa H₂ > 0.7 MPa H₂ > air. Hydrogen localizes plastic deformation in front of the crack, likely increasing the local density of damage. The involvement of plasticity in IG fracture, as a type of brittle fracture, is generally considered minor. However, in pure iron fatigue-fractured at ΔK of 10 MPa m^{1/2} under 20 MPa hydrogen, transmission electron microscopy (TEM) of the region just beneath the IG fracture surface revealed dislocation cell structures, as shown in Fig. 7.14 [36]. The cell size was fine, less than 1 μ m, at closer sites to the fracture surface, and nanovoids were occasionally observed, indicated by yellow arrows, within or close to cell walls.

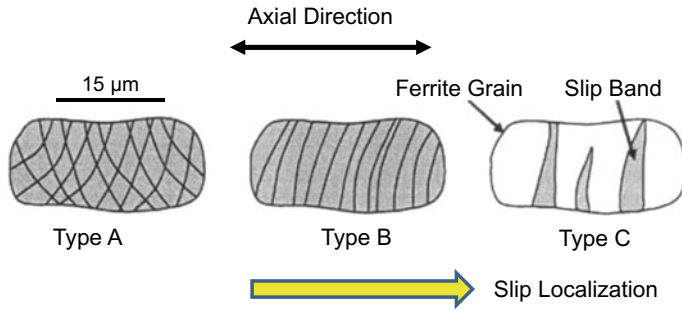
Fig. 7.12 Schematic illustrations of three types of slip bands at the notch root on 0.45% carbon ferrite-pearlite steel specimens subjected to rotational bending fatigue (Uyama et al. [46]. Reprinted with permission from John Wiley & Sons)

Effects of hydrogen on the morphology of slip bands were examined precisely for a 0.45% C steel with ferrite and pearlite structures subjected to rotational bending fatigue tests at 45 Hz using shallow-notched specimens hydrogen-precharged by immersion in 20% NH_4SCN aqueous solution at 313 K [46]. Slip band morphologies at the notch root, observed using a laser microscope for replicas of microstructures, were classified into three types, as illustrated schematically in Fig. 7.12 [46]. The fraction of ferrite grains of Type C with discrete localized slip bands was 49% in hydrogen-charged specimens after 6×10^5 fatigue cycles at 230 MPa, while Type C was not present in uncharged specimens. Also, about 20% of the crack initiation sites were along slip bands in hydrogen-charged specimens, while almost all were at grain boundaries in uncharged ones. The results demonstrated hydrogen-enhanced slip localization and the crack nucleation therein. Degassing by aging hydrogen-charged specimens at room temperature for 270 h substantially reduced the fraction of Type C grains after fatigue tests.

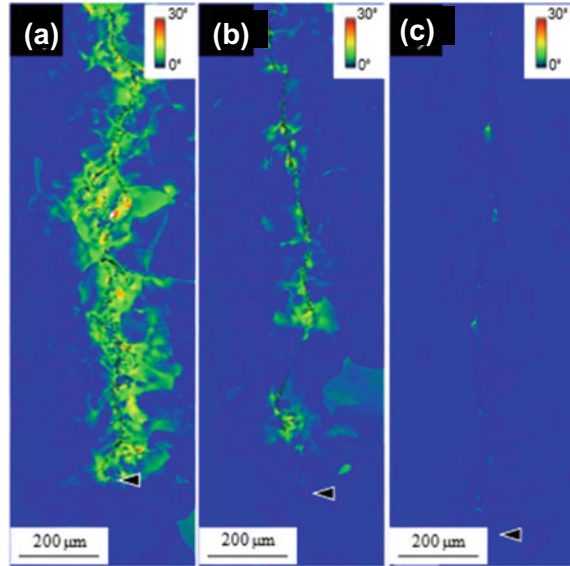
Fig. 7.13 GROD map, showing the rotation from the average crystal orientation, around fatigue crack in iron, in (a) air, (b) 0.7 MPa H₂, and (c) 20 MPa H₂. The arrowheads indicate the crack tip positions (Birenis et al. [35])

Birenis et al. examined a mid-thickness cross-section along the crack path of pure iron specimens subjected to fatigue tests in laboratory air and high-pressure hydrogen [35]. As a measure of the magnitude of local strain, Birenis et al. employed the grain reference orientation deviation (GROD), i.e., the rotation angle of each grain from the average crystal orientation in electron backscattering diffraction (EBSD) analysis. Figure 7.13 shows GROD maps along the cracks propagated in air and hydrogen gas in ΔK -constant fatigue tests at ΔK of 17 MPa \cdot m^{1/2} [36]. The crack runs from the upper to the lower side in the middle part of each map. The crack front is indicated by an arrow. Reduction in the width of the plastic zone, i.e., enhanced strain localization, by hydrogen is evident.

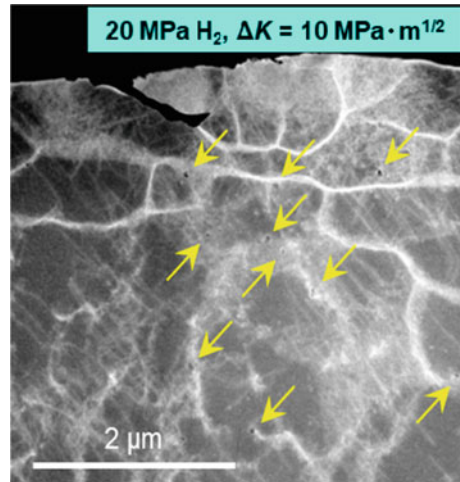
Fig. 7.14 Transmission electron micrograph of an area beneath the fatigue-fracture surface of pure iron in 20 MPa H_2 . Yellow arrows indicate nanovoids (Ogawa et al. [36])

Refined dislocation cell structures just beneath the fracture surface imply that hydrogen increases the energy density ahead of the crack tip. A high energy density and the associated deterioration of the material ahead of the crack tip must promote fracture at the crack tip. Which of the enhanced strain localization or the energy density is original is a vital issue for understanding the function of hydrogen to

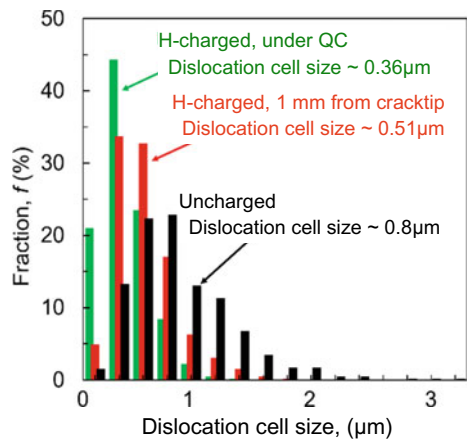
Fig. 7.15 Size distributions of dislocation cell near the crack tip in low-carbon ferritic steel tensile-strained to 24% with/without H-charging (Okada et al. [50])

At the initial stage of 3% strain, dislocations are linear while curved and tangled in the hydrogen-uncharged and hydrogen-charged specimens, respectively. At 20% strain, well-developed dislocation cell structures formed in both specimens without and with hydrogen charging. The cell is likely low energy dislocation structures, and the cell size tended to be smaller in the hydrogen-charged specimen than in the uncharged specimen. Figure 7.15 compares the statistical distributions of the cell size at 24% strain [50].

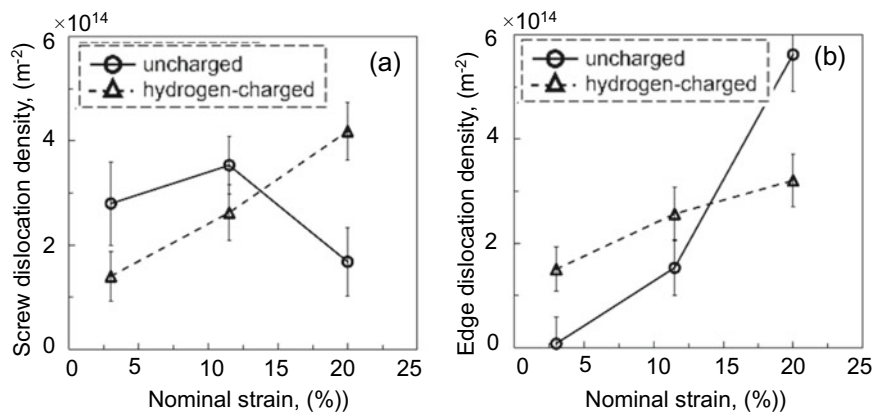
Fig. 7.16 Fractions of (a) screw and (b) edge dislocation densities of the uncharged (solid lines) and hydrogen-charged (broken lines) low-carbon steel as a function of nominal strain (Okada et al. [50])

Further, STEM images with different diffraction vectors under two-beam conditions revealed the nature of dislocations. It was concluded that almost all of the straight dislocations in the uncharged specimen ($\varepsilon = 3\%$) had a significant screw component. The fraction of the screw component increased in the later stage of deformation in hydrogen-charged specimens, as shown in Fig. 7.16, while a certain number of dislocations that form cell boundaries are excluded [50]. Okada et al. deduced that these straight dislocations would be the origin of the tangled dislocation

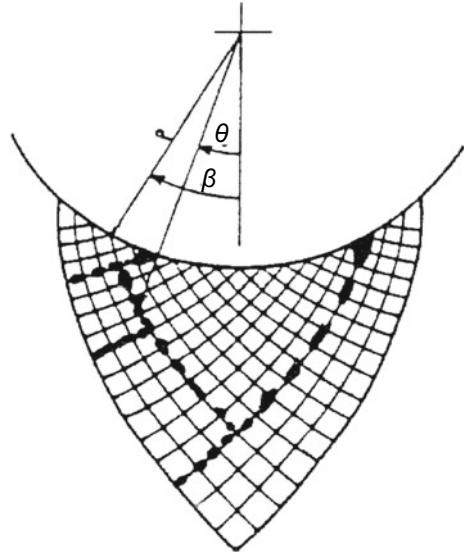
Fig. 7.17 Schematic show of logarithmic spiral slip traces for circular notch root and the formation microcracks (Onyewuenyi et al. [47])

The appearance of rugged surface shear bands at U-notch bend tests of spheroidized AISI 1090 steel indicated the onset of flow localization or plastic instability [47]. Hydrogen promoted the evolution of surface rumpling and reduced the critical strain for the onset of plastic instability well before the profuse void formation in bulk. Internal small crack nucleation following surface rumpling was along characteristic slip traces, as shown in Fig. 7.17 [47]. Criteria for the onset of plastic instability are derived from material constitutive relations. The critical principal notch surface strain observed at the onset of plastic instability was in good agreement with the calculated values for a U-notched bend specimen [47]. However, for a U-notched bend test of hydrogen-charged AISI 4340 steel, the critical notch-root strain at the crack initiation was nearly constant for three different notch-root radii of specimens [48]. Constitutive relations, such as yield stress and work-hardening rate, are generally insignificant as hydrogen effects. Then, it was deduced that hydrogen promoted plastic instability and that a combination of hydrogen concentration and total stress

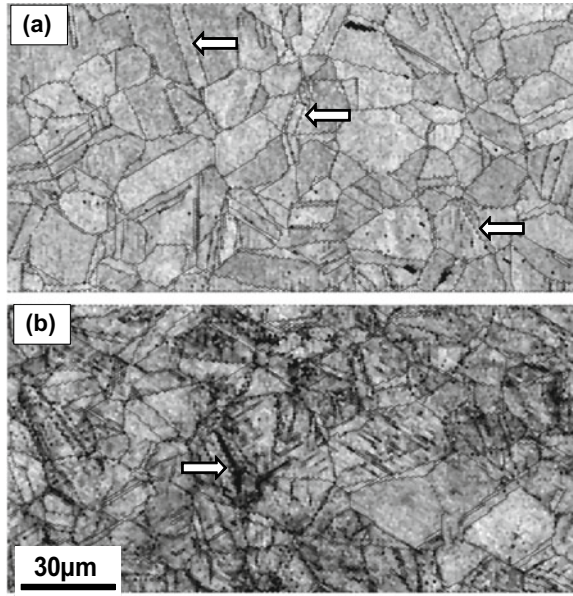
Fig. 7.18 Image quality (IQ) maps of EBSD for hydrogen-charged Type 304 austenitic stainless steels tensile-strained to (a) 5% and (b) 24%. Arrows indicate annealing twin boundaries (Hatano et al. [13])

Effects of hydrogen on inducing lattice distortion are prominent when plastic straining has been or is simultaneously applied to the specimen. The image quality (IQ) in EBSD analysis represents the crystallinity of the diffracting area, and dark contrast results from lattice distortion. Figure 7.18 [13] shows IQ maps of hydrogen-charged Type 304 austenitic stainless steel given a tensile strain of 5% or 24%. The maps show lattice distortion with increasing strain more pronounced in regions close to grain boundaries than in bulk. The average strain separately obtained from Kernel average misorientation (KAM) maps, a measure of the orientation difference between neighboring areas, was reasonably lower for the specimen strained to 5% than that for 24%. However, a preferential strain localization appeared in hydrogen-charged Type 304 steel at a strain as low as 5% [13]. Annealing twins were often observed within grains, as indicated by arrows in Fig. 7.18, and twin boundaries tended to become blurred with increasing strain, implying distortion of areas near the interface of twin bands.

Nibur et al. postulated that hydrogen-enhanced localized plasticity (HELP) causes strain discontinuities at obstacles and void nucleation. However, deterioration of crystallinity along twin boundaries shown in Fig. 7.18 for Type 304 steel is viable as the precursor of void nucleation. An issue is again which of the enhanced plasticity or the strain-induced generation of vacancies (HESIV) has hegemony for the function of hydrogen in promoting failure.

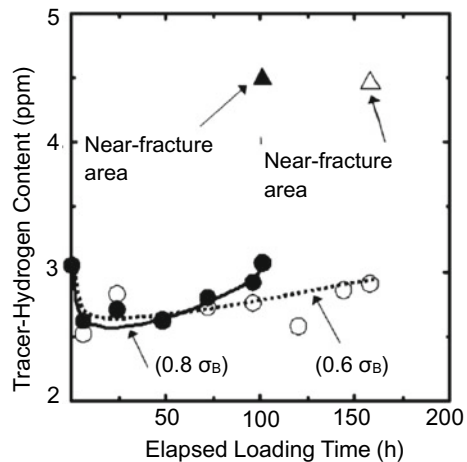
Fig. 7.19 Amounts of tracer-hydrogen introduced to martensitic steel bar specimens subjected to sustained loading at 0.6 or 0.8 of the tensile strength in 20% NH_4SCN aqueous solution at 323 K (50 °C). Δ and \blacktriangle denote fractured specimens (Doshida et al. [59]. Reprinted with permission from The Iron and Steel Institute, Japan)

Similarly, lattice defects generated during delayed fracture tests were evaluated using tracer-hydrogen introduced into specimens subjected to fatigue cycles. Tracer-hydrogen was introduced into specimens interrupting loading and degassing at 303 K for 168 h at the unloaded state. Figure 7.19 [59] shows the amounts of tracer-hydrogen introduced to fine-grain 0.32% C martensitic steel specimens subjected to sustained loading in 20% NH_4SCN aqueous solution at 323 K. The applied stress was 60% or 80% of the tensile strength, and both levels were apparently within the elastic range.

In Fig. 7.19, the amount of tracer-hydrogen, i.e., hydrogen absorption capacity, initially decreased and then gradually increased with increasing loading time. In fractured specimens, the portions near the fracture surface showed substantially high tracer-hydrogen contents, as indicated by Δ and \blacktriangle marks. The high values are due to concentrated strain near the fracture surface, likely associated with crack propagation, but the gradual increase before fracture is consistent with the strain-induced creation of vacancies and its concern with fracture. The initial decrease might be due to the reconfiguration of dislocations in martensite associated with hydrogen entry

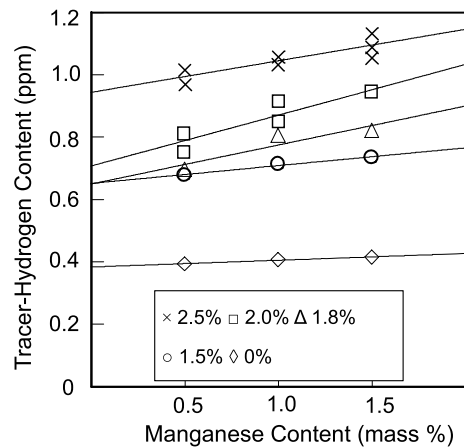
Fig. 7.20 The amounts of hydrogen absorbed to saturation in specimens given various amounts of prestrain. The three martensitic steels with different Mn contents are used for Figs. 7.6 and 7.7 (Nagumo et al. [26])

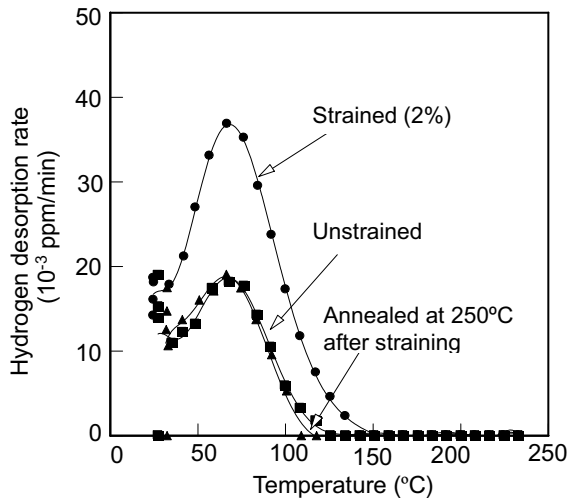
Fig. 7.21 Thermal desorption profiles of tracer-hydrogen introduced to 1.5% Mn steel specimens, unstrained, prestrained to 2%, and annealed at 250 °C (523 K) for 1 h after straining (Nagumo et al. [26])

Figure 7.21 [26] shows TDA curves of tracer-hydrogen introduced into three states of the 1.5% Mn specimens, i.e., unstrained, strained to 2%, and annealed at 523 K for 1 h after straining. The increase in the amounts of tracer-hydrogen totally disappeared by annealing the strained specimen at temperatures as low as 523 K, indicating that lattice defects that interact with tracer-hydrogen are vacancies rather than dislocations. Thus, the origin of the effect of Mn contents is reasonably ascribed to the density of strain-induced vacancies. Precipitation of carbides along martensite boundaries was present, but quantitative differences in microstructures that specify the three steels were not definite. Related degradations of tensile properties are described in Sect. 8.1.4 concerning Fig. 8.11

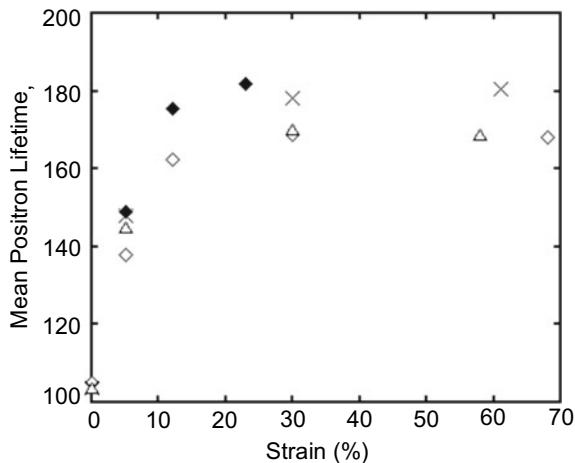
Fig. 7.22 Mean positron lifetimes of strained austenitic stainless steels: \diamond : SUS304, \blacklozenge : H-charged SUS304, \triangle : SUS316L, \times : H-charged SUS316L (Hatano et al. [13])

was applied to identify the type of lattice defects generated during tensile straining of hydrogenated Type 304 steel. Figure 7.22 [13] shows the mean positron lifetimes τ_m of Type 304 and Type 316L steels given tensile strain with and without hydrogen charging to 30 mass ppm. Hydrogen charging enhanced the increase in τ_m with increasing strain. The strain-induced increase in τ_m implies the creation of lattice defects that have longer τ_m than the bulk. Successive isochronal annealing of strained materials showed a monotonic reduction in τ_m with increasing annealing temperatures [13].

The annihilation temperature corresponds to vacancy clusters, and the difference in hydrogen effects between Type 304 and Type 316L is reasonable to ascribe to the creation and clustering of strain-induced vacancies. The results are consistent with PAS measurements for iron [60]. However, the observed τ_m is a weighted average of multiple lifetime components, as described in Sect. 3.2.2. The contributions of dislocations and vacancies to τ_m for iron deformed with and without hydrogen precharging are tabulated in Table 3.5. Deformation microstructures are further described in Sect. 8.3.4.

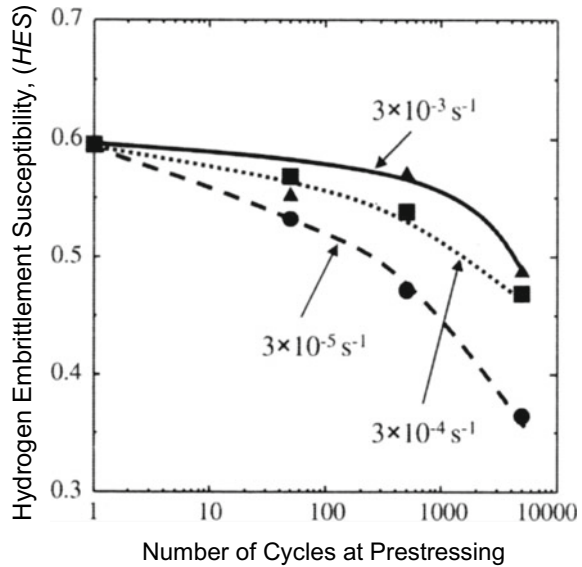
Fig. 7.23 Hydrogen embrittlement susceptibility (HES) on tensile tests of martensitic steel specimens applied cyclic prestressing at various strain rates (Doshida et al. [61])

Effects of cyclic prestressing on HES are shown in Fig. 7.23 [61] for increasing numbers of prestressing cycles at various strain rates. Cyclic prestressing enhances HES, i.e., hydrogen degradation, more pronouncedly by increasing the number of cycles and reducing the strain rates. Damage introduced by cyclic prestressing was then examined using hydrogen as the tracer. Tracer-hydrogen was introduced to saturation to cyclically prestressed specimens after exposing prestressed specimens at 323 K for 168 h to delete hydrogen present at the prestressing stage. External stress was not applied when introducing tracer-hydrogen under the same condition as the initial charging. The amounts of tracer-hydrogen increased with the number of stress cycles in both $[\sigma]$ and $[\sigma + \text{H}]$ specimens. The difference between $[\sigma + \text{H}]$

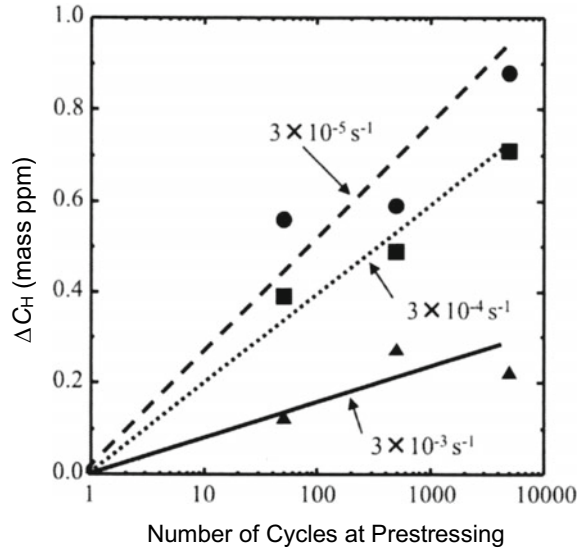
Fig. 7.24 Hydrogen enhancement of the strain-induced increase in the hydrogen absorption capacity, ΔC_H , on tensile tests of martensitic steel specimens after cyclic prestressing at various strain rates (Doshida et al. [61])

The magnitude of ΔC_H increased with cyclic stressing more pronouncedly with lower strain rates, as shown in Fig. 7.24 [61]. The increase in ΔC_H with decreasing strain rate is consistent with Fig. 6.4b in Sect. 6.1.1.2 for tensile tests. It indicates that cyclic stressing accumulates damage prior to the tensile tests. The tracer-hydrogen thermal desorption profiles showed a single peak centered at about 393 K, and ΔC_H humped the higher-temperature side of the TDA peak, implying vacancy clusters as described in Sect. 3.2.3.2. An approximately linear correspondence exists between HES and ΔC_H [60].

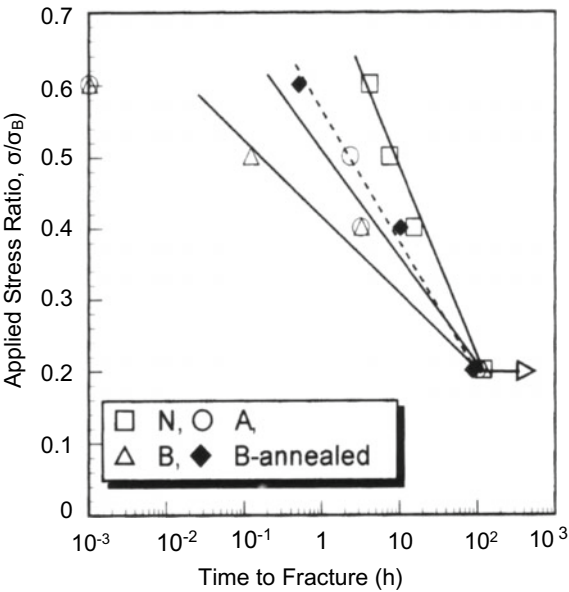
Fig. 7.25 Delayed fracture diagrams for prefatigued Si–Cr martensitic steel. □: N (without pre-fatigue), Δ : B (prefatigued close to failure), ◆: B (annealed at 200 °C for 1 h after pre-fatigue), ○: A (prefatigued to about one half of fatigue life) (Nagumo et al. [62])

An experiment that demonstrated the effects of prefatigue on following sustained loading delayed fracture tests is shown in Fig. 7.25 [62] for the Si–Cr martensitic steel used for Fig. 6.16. Stress cycling (prefatigued) was applied by rotational bending for cycles about a half (Treat-A) of or close (Treat-B) to the fatigue life at the applied stress amplitude level of 640 MPa [62]. The two types of specimens were successively subjected to sustained-loading delayed fracture tests in 20% NH_4SCN

aqueous solution at 323 K. Specimens without prefatigue (Treat-N) were also tested for comparison. The fracture of specimens given prefatigue for cycles close to the fatigue life, Treat-B, occurred substantially earlier. However, annealing the fatigued specimens at a temperature as low as 473 K for 1 h reduced the degradation caused by prefatigue. The results indicate that damage accumulated during prefatigue plays a function in failure common to that created during sustained loading and that damage introduced by prefatigue is mostly vacancies without forming flaws such as voids and cracks.

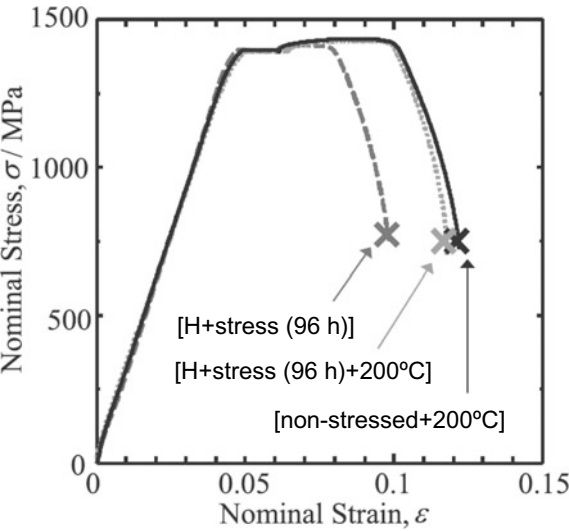
Fig. 7.26 Tensile curves of high-strength martensitic steel specimens. [H+ stress (96 h)]: Initially sustained-loaded in 20% NH₄SCN aqueous solution for 96 h at 50 °C (323 K), [H+ stress (96 h) + 200 °C]: Annealed at 200 °C (473 K) after sustained loading, [non-stressed + 200 °C]: Annealed at 200 °C (473 K) without sustained loading. All specimens are degassed at room temperature before tensile tests (Doshida et al. [61]. Reprinted with permission from The Iron and Steel Institute, Japan)

Inversely, damage accumulated in sustained loading deteriorated tensile properties following the sustained loading [62]. Specimens of 5 mm in diameter of high-strength martensitic steel, 1433 MPa in tensile strength, were initially sustained-loaded at a constant stress of 80% of the tensile strength, apparently within the elastic range, for 96 h in 20% NH_4SCN aqueous solution at 323 K. After the sustained loading, hydrogen was completely removed at 303 K for 168 h, and then, some specimens were annealed at 473 K for 2 h. The two series of specimens are denoted as [H+ stress (96 h)] and [H + stress (96 h) + 200 °C], respectively. Also, specimens without sustained loading but annealed at 473 K were prepared with the notation of [non-stressed + 200 °C]. Stress-strain curves at tensile tests are shown in Fig. 7.26 [61]. It is to be noticed that a substantial degradation appeared for the [H+ stress (96 h)] series, although hydrogen was absent at the time of tensile testing. The almost complete recovery for the [H+ stress (96 h) + 200 °C] series indicates that vacancy-type defects, created during sustained loading without forming irreversible voids or cracks, cause the degradation.
