Self-Launching Sailplane Pilot's Assn.

NEWSLETTER

MAY - JUNE 1991

Published Bi-Monthly by SLSPA, Inc. // Pete Williams, President and Editor // Jim Culp, Vice President // Issue # 20 Vol III

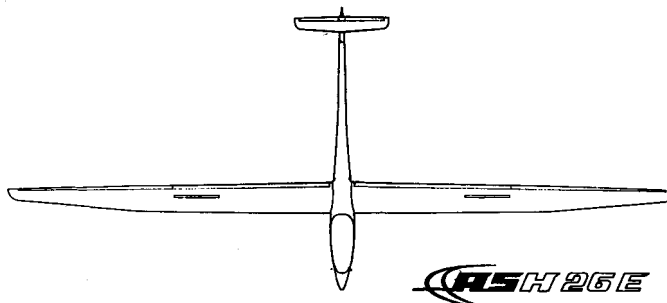
SCHLEICHER ANNOUNCES 18 METER SELF-LAUNCHER.....

According to a late release via Peter Selinger from Gerhard Waibel, an all-new 18 meter design called the ASH 26E is in development. Both fuselage and wing designs are completely new. A thickness of 13.4% is reported for the wing with a 14% flap depth. The new ship will be available with or without the engine (type and power unknown at this writing) but the engine hard points will be in every fuselage produced. An L/D of 50:1 is reported at 115 km/h. Empty weight-716 lbs. Max Gross Wt. 1,289 lbs. Vne=174mph. Wing load at max TOW- 50kg/m2.
