Auxiliary-powered Sailplane NEWS

The Official Publication of the Auxiliary-powered Sailplane Association, Inc.

Volume XIV Issue #87

July-August 2002

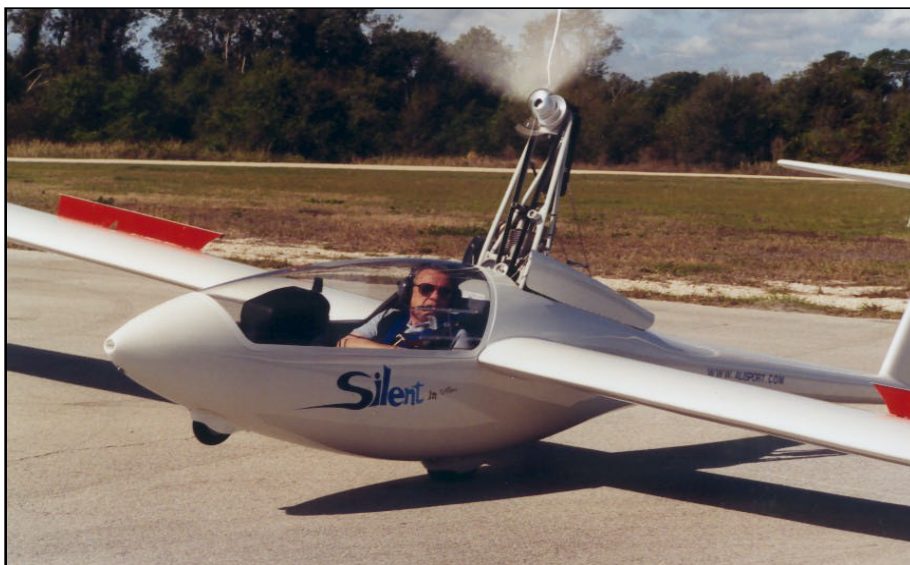
ASA member Don Pollard taxiing out for a self-launch in Alisport's 12-meter Silent IN. Don's comments about his flight to Leo Benetti-Longhini, the US sales representative: "For sometime I have hoped there would be a self-launch sailplane that was affordable with good soaring capability for sport flying. The "Silent" is the answer. It is fun to fly. The control harmony is excellent. The flaperons are great to use for pitch control running under a cloud street. I think the "Silent" will bring more people into soaring safely without all the hassle of tow planes and crews on standby." *There are approximately 30 INs flying worldwide. More details on this new light powered glider on page 3.*

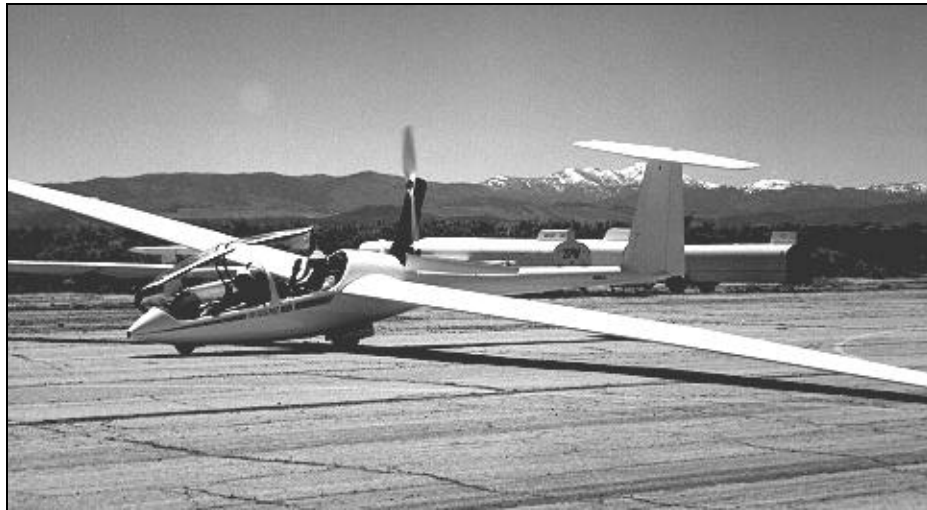
Seen above is Mike Moore taxiing out on May 11, 2000 at the Minden-Tahoe Airport for his first launch in his new DG-505MB. Pete Williams is the checkout pilot in the rear seat. Mike has since sold this ship to ASA member Bob Moos of South Hadley, MA who took delivery at Minden April 10, 2002. *Photo by Charm Williams*

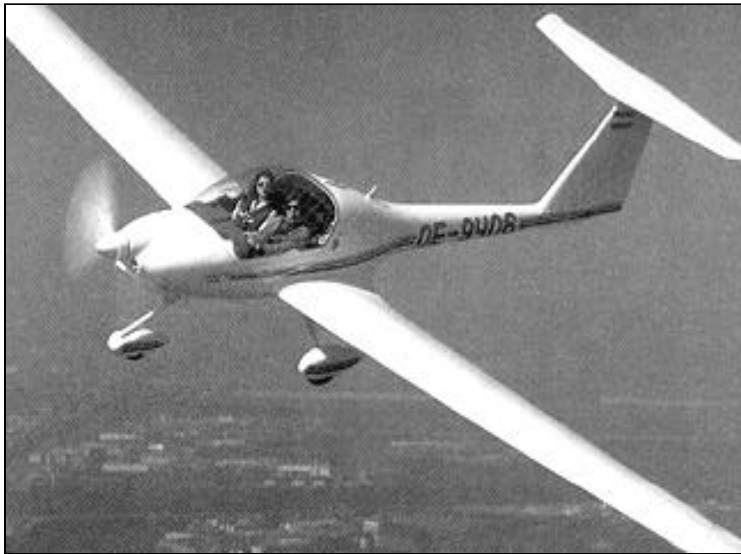
Diamond Aircraft's Katana XTreme HK 36TC. Seen here is the tricycle version. Engine off glide ratio is 27:1. Power on cruise is 108kts. Powerplant: 81hp 4-stroke Rotax 912A. The "Turbo" version has a Rotax 914F with 115hp output. More Info: Diamond Aircraft Industries (Canada) 888-359-3220

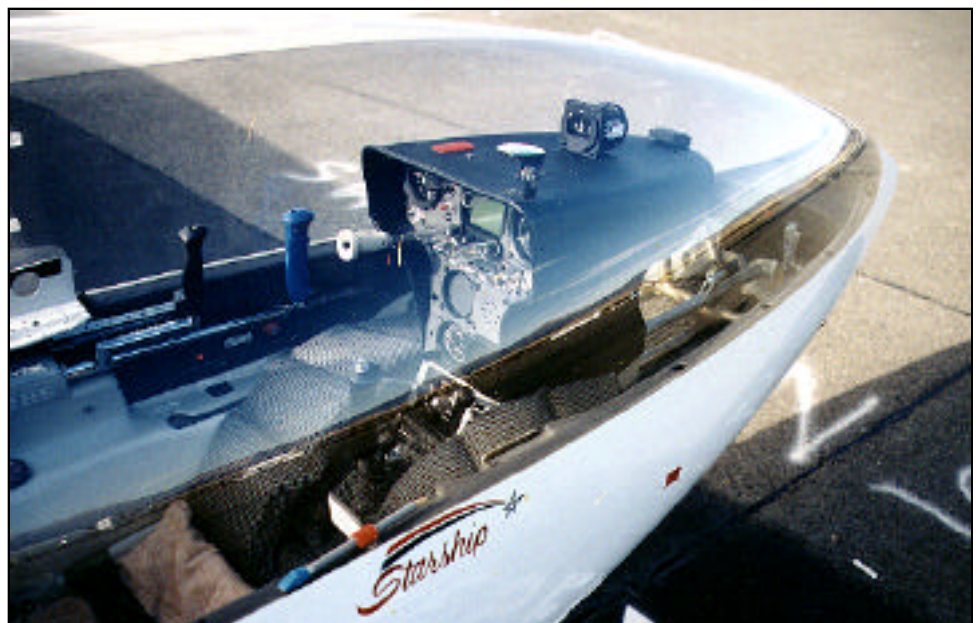
Cockpit and instrumentation layout of today's modern self-launcher. This includes standard flight instruments, GPS Flight Director with moving map and up to 100 tasks stored in the computer, digital and mechanical variors, electric turn and bank indicator, 720 channel VHF radio, transponder and engine control panel. Seen here is a DG-800B.

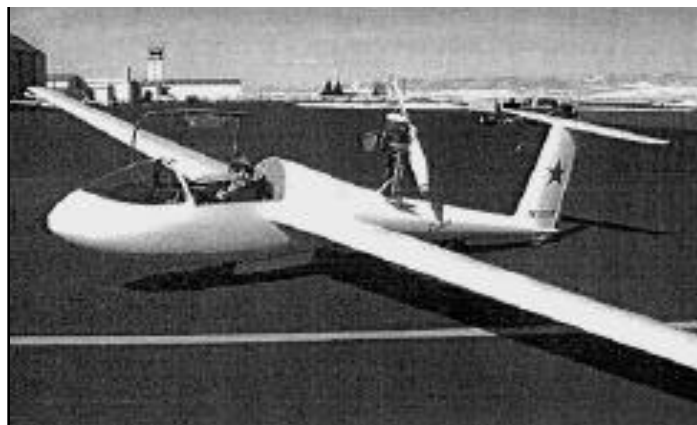
AviaStroitel's AC5M "Russia" Self-Launcher

The motor deployment system is entirely mechanical, relying on a pair of slide handles to open the bay doors, deploy the motor and close the doors again in less than five seconds. If, for some reason, the motor fails to start in flight you just put it away and become a glider again- you aren't stuck with a severely compromised glide ratio; there is no reliance upon battery power, electric motors, relays or circuits.

Its a sailplane that can take off by itself. That's it. All that AviaStroitel promises is a simple, well-built glider with honest mid-range cross country performance that doesn't need a tow plane. Simplicity is the overall goal, even as the number of parts has increased. The motor itself was chosen for its small number of parts and good power-to-weight ratio; it is a complete, self contained unit with its own battery, battery charging system, electric start, automatic decompression valve and fully electronic ignition with infinite variable timing.

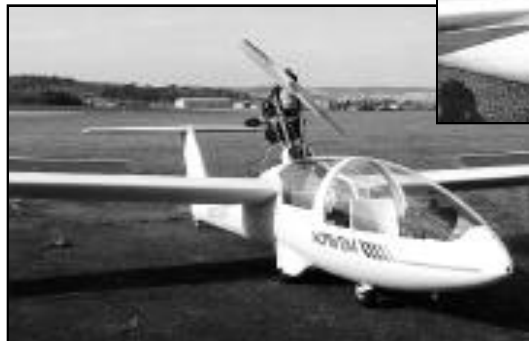
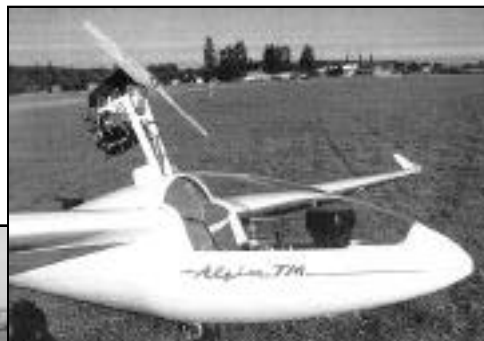
Other TeST Selflaunchers:
Right: TST-3. Below: 2-place TST-8

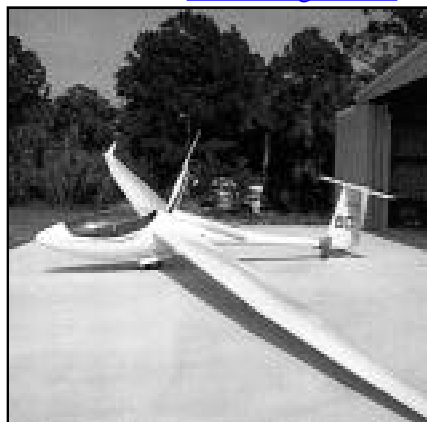
DG-505MB Carburetor Throttle Coupling Alert

Bob Moore reported a near mishap when a DG-505MB on takeoff from the Richland Washington Airport experienced a power loss at about 200 ft. The pilot made an immediate turn back toward the field and managed to land safely within the airport property. The cause was the coupling that slaves the two carburetor butterfly valves came loose resulting in only one carb being controlled by the throttle cable. Bob recommends 505MB pilots should carefully check the integrity of this coupling before every flight.

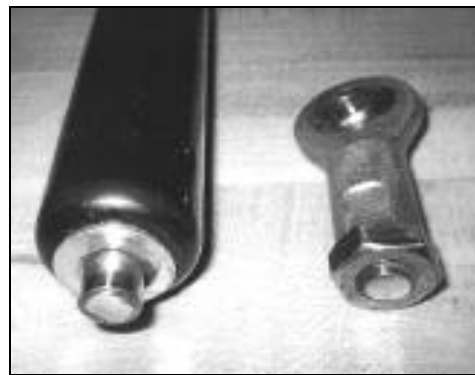
Engine Bay Gas Strut Failure

The gas strut in my DG-808B serial # 156 failed at the rod end at 3 hours engine time after a climb to 3000 agl. There was a loud snap then the strut shaft retracted into its cylinder. The engine traveling light came on when the engine was brought back to idle. The engine wasn't really retracting but the mast had just moved back just enough to trip the upper limit switch. The replacement strut is from the same manufacturer but its ball fitting is retained in a different manner. The original strut rod was under cut (reduced diameter) between the threaded end and the smooth rod section with a jam nut tightened against the ball fitting (See Image). This rod broke at the undercut reduced diameter. The new rod has no jam nut but is threaded all of the way into the ball fitting and retained with both bonding agent and a roll pin. Submitted by Gary Evans
