# Self-Launching Sailplane Pilot's Association

N E W S L E T T E R

MAY-JUNE 1989

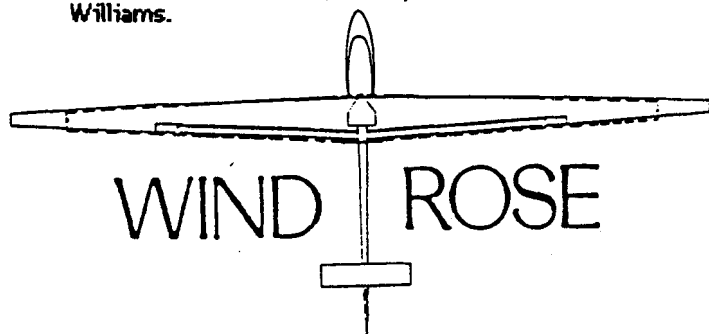
Jim Maupin at Star Rt. 3 Box 4300-37, Tehachapi, CA 93561 has announced a 15 meter version of the Windrose self-launching homebuilt. Three builders are now working on this ship and Maupin reports the wings will retrofit to the basic 13 meter version. The wings use carbon spars and performance is 38:1 at 51 mph. Minimum sink is 1.85 f/s at 46 mph. Climb is 700 fpm using a Rotax 503 with 46hp at 6,500 rpm. Cost is estimated at \$5,225. Plans are \$225.
