PET restoration

E. Berozet

2 January 2020

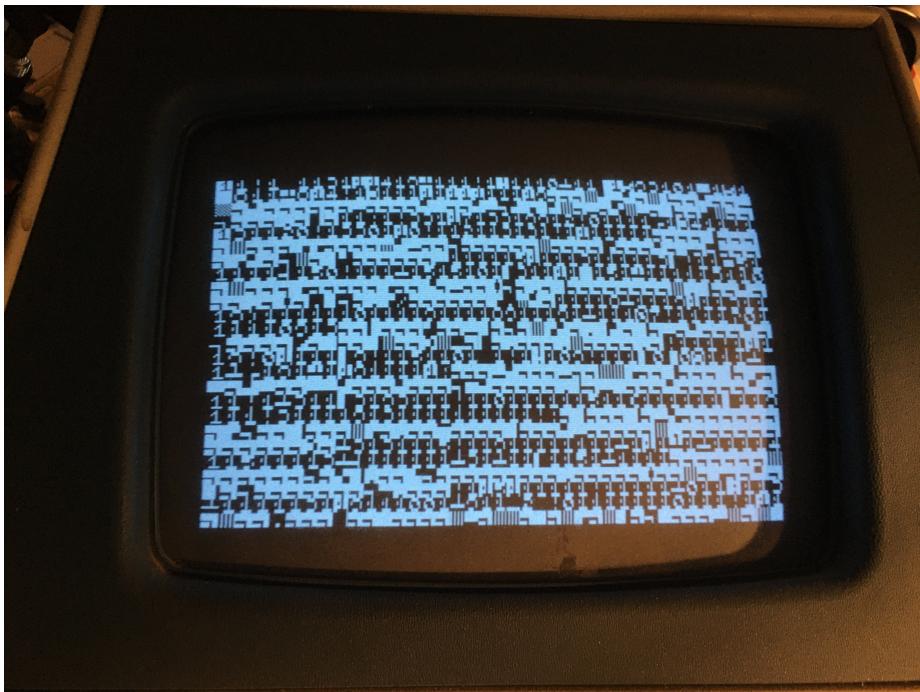
Figure 1: scrambled screen

The current symptom is that the screen is all scrambled. That is, instead of reporting "7167 BYTES FREE" as a healthy PET would, I get a scrambled screen as shown below in Figure 1.

To rectify this problem, I first tried moving RAM chips around. I have the 18 6550 RAM chips (16 for main memory and 2 for video memory) labelled as A through S (omitting "O" because it looks too much like a zero). It turns out that only 6 chips need to be installed in the machine for it to boot. The two video RAM chips and only 4 of the memory chips in locations I1, J1, I2 and J2. Initially, the chips were I1 = A, J1 = B, I2 = C, J2 = D, C3 = E, C4 = F. Changing to S,G,J,K,L,M produced a nearly identical display, suggesting that the problem lies elsewhere. I am starting to suspect ROMs.
