Auxiliary-Powered Sailplane **NEWS**

The Official Publication of the Auxiliary-powered Sailplane Association, Inc.

Issue # 74 Vol. XII

May-June 2000

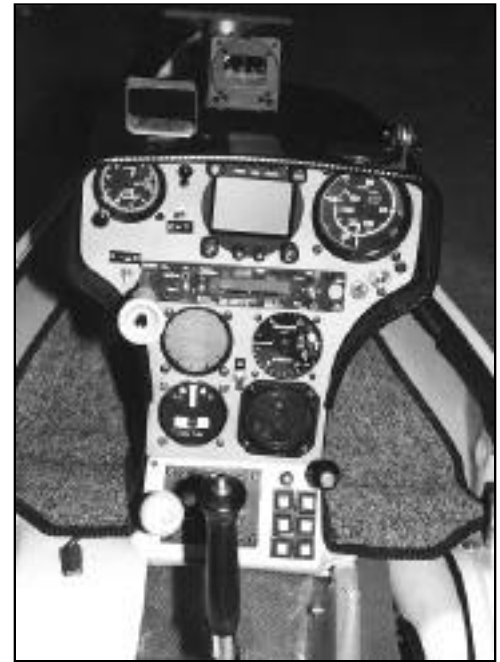
DG-800B Instrument Panel Project

I spent the winter working on configuring and installing a new panel in my Midwest powered DG-800B. It seems the instruments are never exactly where pilots want them to be, so a new uncut panel was ordered. It arrived and one of the first things I have always wanted to do was to change the color from flat black to gray. This was accomplished by lightly sanding the black surface and leaving enough texture to prevent reflections. Gray primer was then used and after sanding, the panel was a medium gray. The instruments now contrast nicely from this surface. Some details: Top row-Altimeter, Climb-Cruise and CHT switches, Filser LCD, Airspeed & Fire Warn Light.#2 Row: Auto-Prime Switch, Engine DEI, TE Switch and Master Engine Switch.#3 Row: Filser Vario & Borgelt Vario. #4 Row: Electric Turn Needle/Ball & Filser Vario Speaker. Switch in the center is for Turn Needle power.The main problem was getting the back of the instruments to not conflict with each other. This entailed some grinding. Would I do this again? Probably not. *Pete Williams*

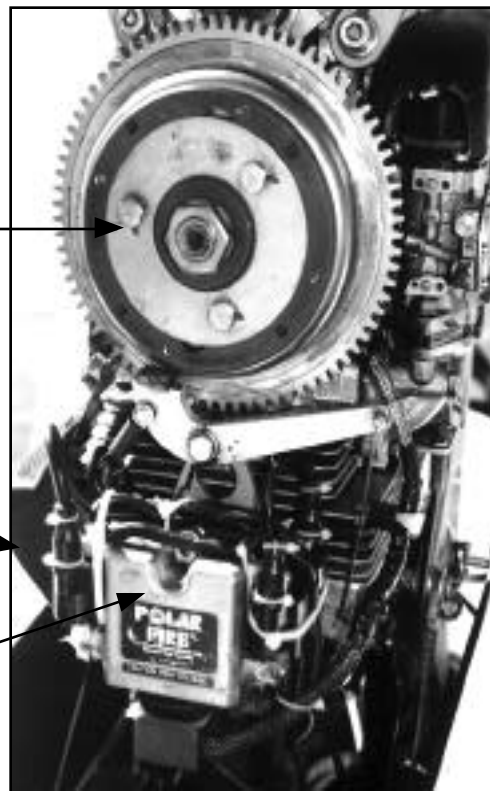
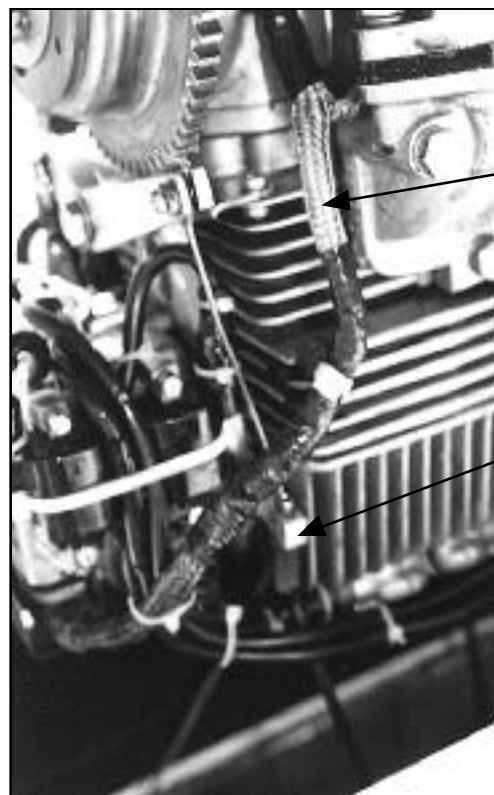
Coil connector wires from boxes to spark plugs

Two Polar Fire Ignition Boxes (or can be Ducati) installed on Rotax 505A

Ignition Cable wire group leading from bottom of each Ignition Box to the ignition coils behind the flywheel. Some metallic RFI sheathing is seen. The wire bundle is secured to the cylinder with a standoff short section of fuel hose. This is a prime vibration area.

Care should be taken to not interfere with the flywheel brake cable.

Siliconed small wires on the bottom of the coil attached to the ignition box

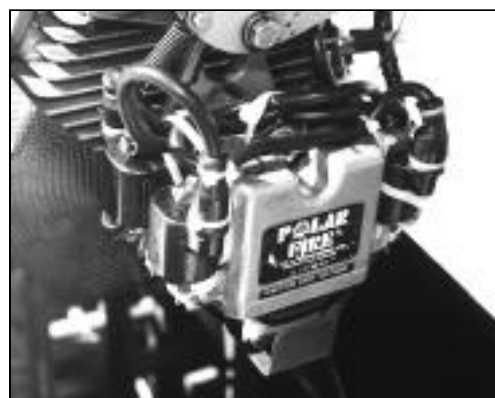
Ignition Box detail showing the exterior coils. Bottom plug to the ignition coil behind the flywheel. The connection wires are screw on to posts both at the box coils and at the spark plug push-on connector cap. Tie-wraps used for security and to minimize the effects of vibration. At the bottom of each coil are small wires that should be covered with Silicone- again, to protect and minimize vibration

Plug Connector at bottom of Ignition Box. The metal guard must be removed to unplug the connector.

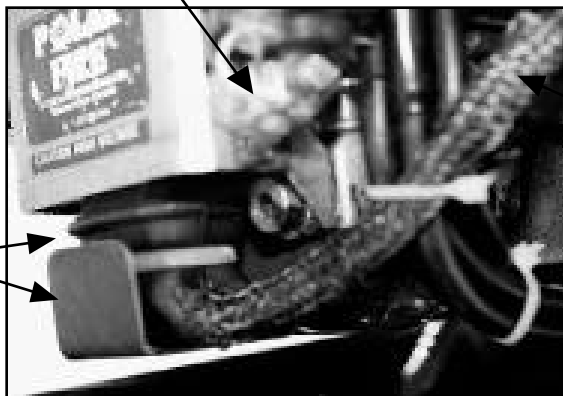
Wire bundle cable is seen arcing up to the right on the way to the coils behind the flywheel.

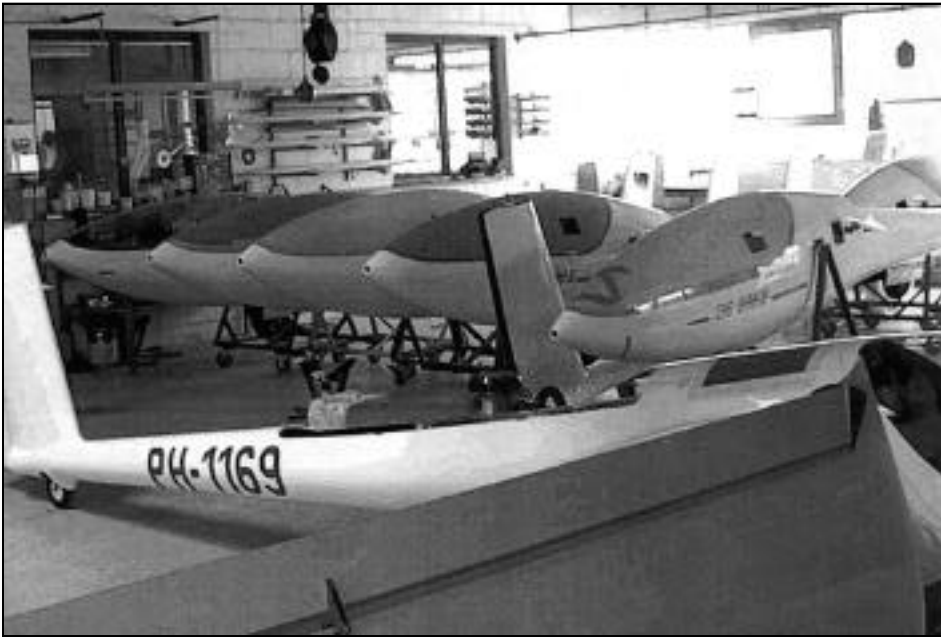
Production line at the DG factory showing seven DG-800Bs in process. DG will be building a new production facility on an airfield site to facilitate flight test and production rate. As of this newsletter, approximately 200 DG-800Bs have been or are in the process of being produced. DG photo.
