Schleicher ASH-24E Rotax Powered Sustainer Sailplane

Self-Launching Sailplane Pilot's Assn. **N E W S L E T T E R**

MARCH-APRIL 1992

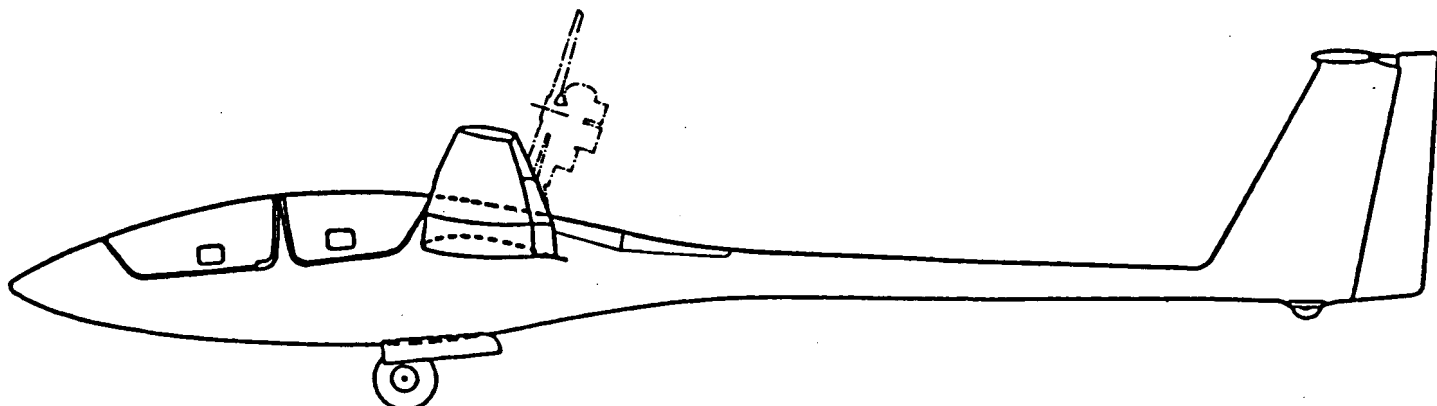
This 2-place ship is powered with a Rotax 277 2-cycle engine producing 24 hp at standard conditions S/L. Empty weight-1047 lbs/Gross-1653 lbs. The engine has a gear box reduction of 3:1 and swings a 4.27' propeller. Rate of climb S/L. max. gross wt is 157 fpm. Span-82'; L/D 57:1. Engine is raised and lowered electrically. Starting is via hand cable in cockpit. Controls & instruments include; Prop brake; CHT gauge; RPM Indicator.
