# PET restoration

## Introduction

I've owned my Commodore PET since 1978. For about the last 25 years, the PET hasn't worked due to one or more problems. In 2019, I diagnosed and fixed a problem with the power supply (faulty filter capacitor), but there are still other issues. This document is a record of my attempts to fix up the old PET.

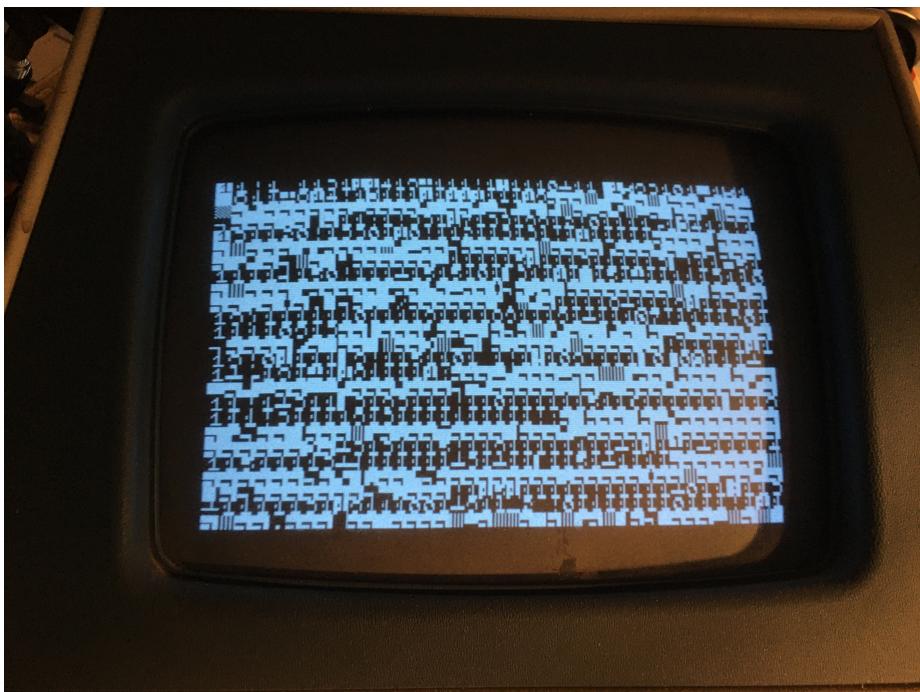
Figure 1: scrambled screen

The current symptom is that the screen is all scrambled. That is, instead of reporting "7167 BYTES FREE" as a healthy PET would, I get a scrambled screen as shown below in Figure 1.

To rectify this problem, I first tried moving RAM chips around. I have the 18 6550 RAM chips (16 for main memory and 2 for video memory) labelled as A through S (omitting "O" because it looks too much like a zero). It turns out that only 6 chips need to be installed in the machine for it to boot. The two video RAM chips and only 4 of the memory chips in locations I1, J1, I2 and J2. Initially, the chips were I1 = A, J1 = B, I2 = C, J2 = D, C3 = E, C4 = F. Changing to S,G,J,K,L,M produced a nearly identical display, suggesting that the problem lies elsewhere. I am starting to suspect ROMs.

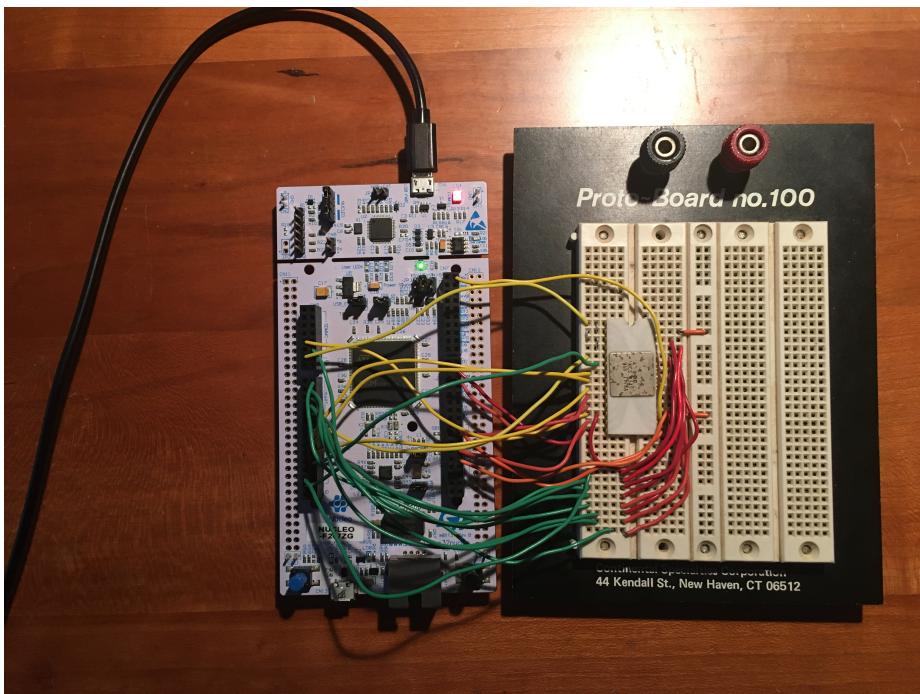
Figure 4: ROM test rig

The actual rig is shown in Figure 4 with one of the ROMs under test.

The ROM test showed problems with two ROMs. The 012 ROM (C800-CFFF) and the 010 ROM (character generator). The symptoms were slightly different

for each. For the 012 ROM, most of the contents were intact but some of the bytes were 0xff. The bytes were always odd addresses starting at 0x41, 0x43, 0x45, 0x47, 0x49, 0x4b, 0x4d, 0x4f and 0x51 and then every 0x80 bytes after those. For the 010 ROM, the problem was that the high half of the ROM was a copy of the low half as though the A10 address line were stuck low. While this test discovered problems with 2 ROMs, there are a number of aspects not tested, including whether all of the CS lines actually work and whether the ROM is too slow (the Nucleo program inserts a 1us pause, while the real timing spec is 350ns). Still, this was fruitful and I may devise a means by which a more common part could be substituted.

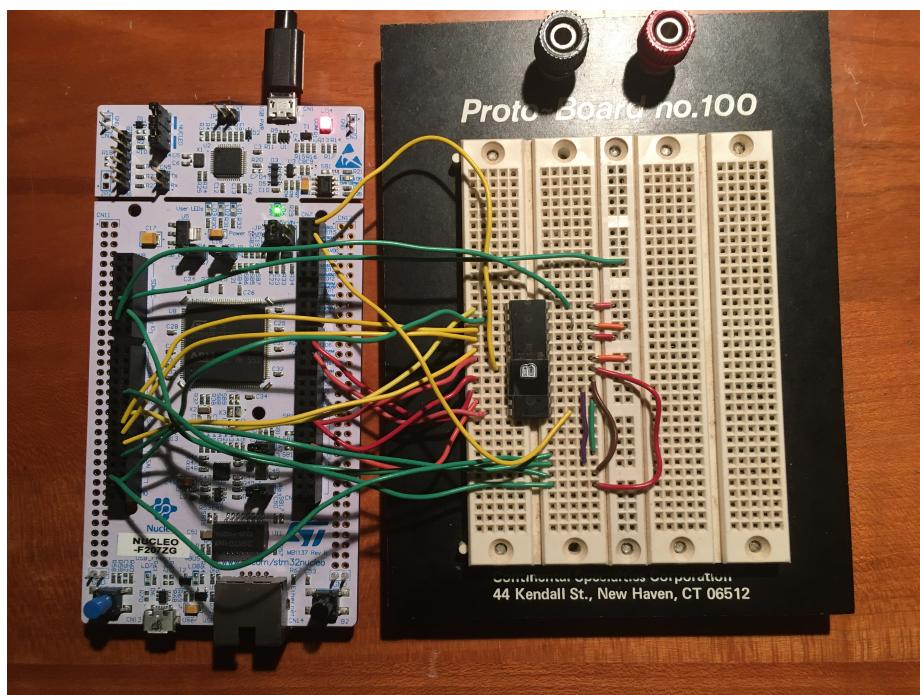
Figure 6: MOS 6550 test circuit

The table below is the circuit I'll use to test the RAM chips. The built circuit is shown below as Figure 6.

Since these are 1K x 4 bit RAM, B and S clearly have some stuck bits. In particular, B seems to have DB2 stuck at 0 for all addresses, and S has all memory stuck at 0x7. Chip I apparently has something of a soft error in that it doesn't show all 1024 bytes bad, but the vast majority of them with 0xb or 0x9 as the content. It might be interesting at some point to decap these and see if it's possible to pinpoint (and maybe even fix?) the precise error on the die.

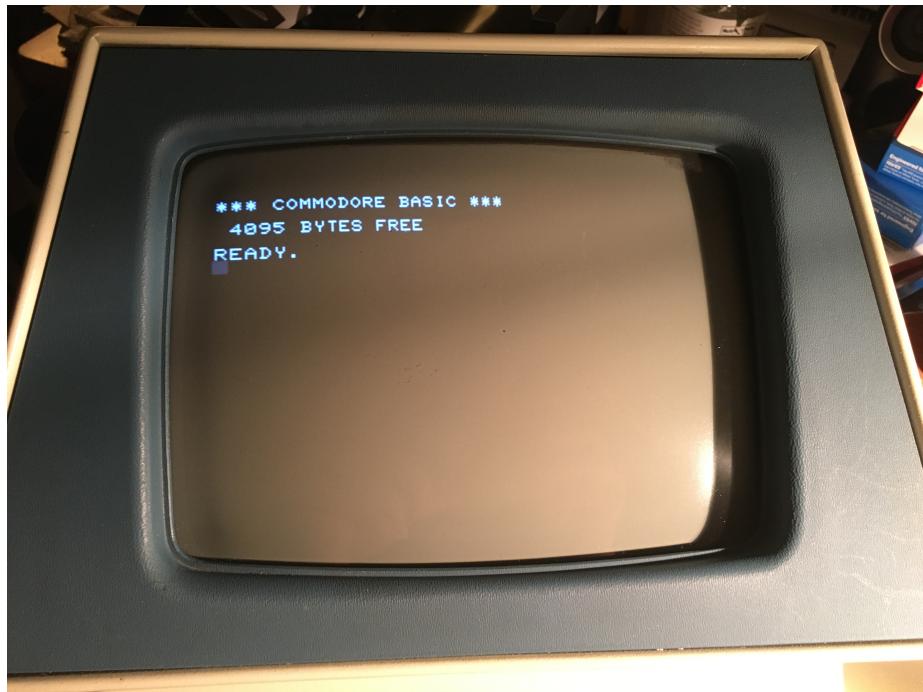
Figure 7: successful boot

After I received my board, I determined that I may have more bad RAM than I thought. In addition to B, I and S, it appears that A, C and possibly G are bad. The machine boots and runs with R, F in the video RAM and K, L, M, N, P, Q, H, J, D, E installed. It reports 4095 bytes free which is consistent with 5K installed. Since it reports 7167 bytes free with 8K installed we calculate  $8 * 1024 - 7167 = 1025$  and  $5 * 1024 - 4095 = 1025$ . Successful boot screen is shown in Figure 7 below.

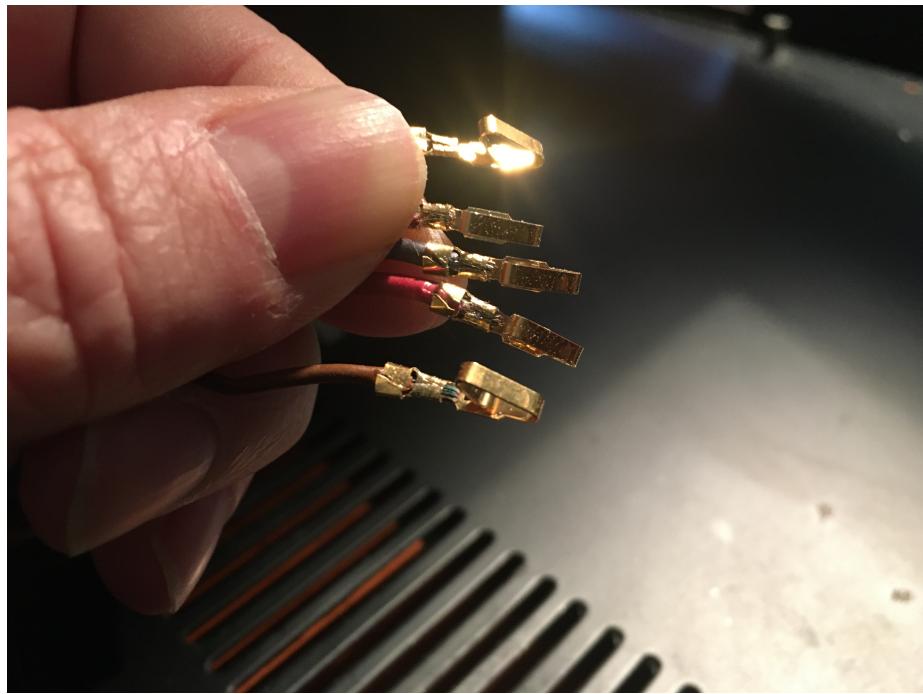
Figure 8: shiny gold connectors

After the machine is on for a few seconds, I noticed a lot of "snow" on the screen and can hear the transformer buzzing. Further investigating, the J8 Molex power connector becomes quite hot on one side, so I took it apart and discovered that the pin 1 connection was both corroded and also had some of the stranded copper wire strands broken, both leading to high resistance. To fix that, I've ordered a replacement connector and pins, this time upgrading to gold plated connectors. The updated gold connectors are shown in Figure 8 below just before being inserted into the Molex connector housing. The connector on the main board was also replaced.

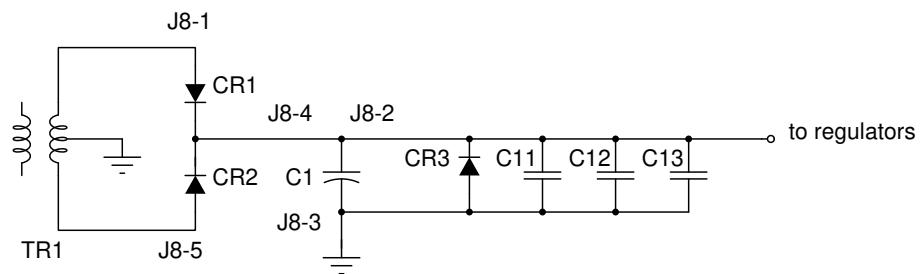
Figure 9: PET power supply partial schematic

The power supply is a simple but robust design. Because it doesn't appear to be explicitly shown in the schematics I have, a reproduced version of the relevant parts of the circuit are shown below in Figure 9. Note that the connections to connector J8 are symmetric, so it doesn't matter which way the connector is attached.
