Service Information Bulletin

Release of wired DX-D 60 Detector

This document announces the release of the wired DX-D 60 detector and VDI detector software with version 3.4 for installations where WiFi is not allowed.

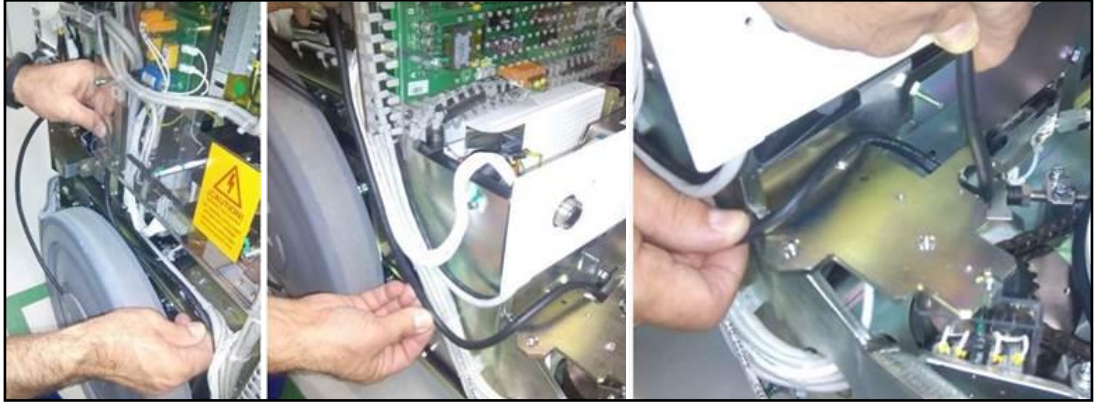
Figure 2

- (5) Route the cable through to the front part of the unit.
- (6) Fix the cable to the harnesses already available.

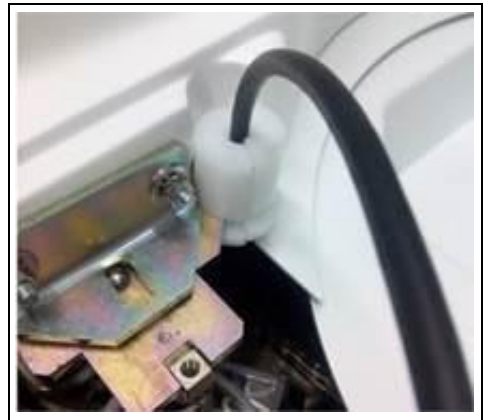
Figure 3

- (7) Pass the cable through the cable relief that is fixed with two screws to the bumper support.

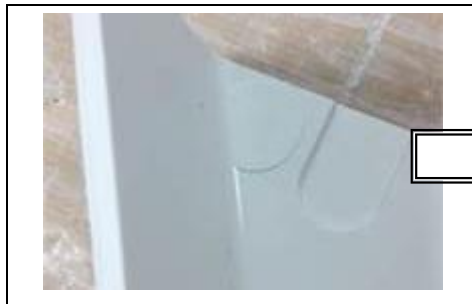
Figure 4

- (8) Open the pre-cut part on the left side of the column base cover. The pre-cut part is marked on the inner side of the cover.
