REPAIR MANUAL

ZENZA BRONICA IND., INC.

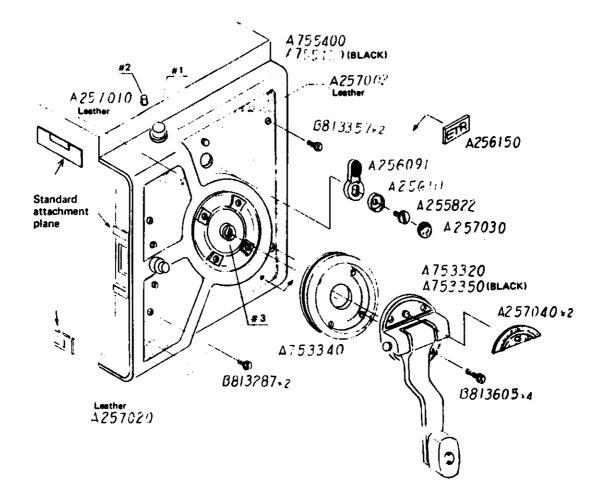
1. Detachment of the Right Side Cover

The crank base covers are deformed rather easily and, therefore, it is recommended that spares always be held on hand for exchanging.

- 1) Strip off two crank base covers (A257040) which are fixed to the surface of the crank base casting (A753320) with bonding agent and then loosen four fixing screws (B813605). Finally, detach the perts up to the crank ring set (A753340).

2) Strip off the leatherette on the multi-exposure lever (A256091), loosen the fixing screw and then detach the multi-exposure
- 3) Strip the leatherette from around four screws or two B813357 and two B813287, loosen these four exposed screws and, finally, detach the right side cover (A755400).

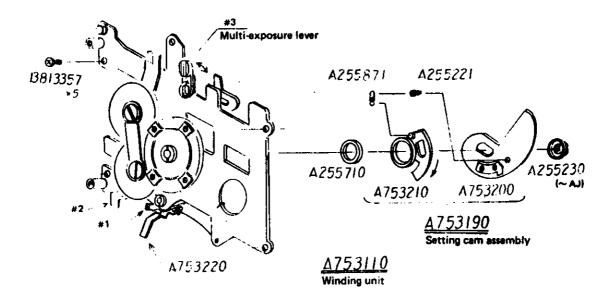
3. Multiple Exposure is not Possible

The multiple exposure mechanism is activated by setting the multi-exposure lever (#3) or rotating it in the clockwise direction, which disconnects gears on the body side from those on the film back side, so that the film is no longer advanced with film winding crank action. At the same time, although the film is no longer being advanced, the multiple exposure mechanism stops the film winding and shutter charging action and permits shutter release when operations are completed on the body side only. If multiple exposure is not possible, when set in the above manner, but becomes possible when the multi-exposure lever (#3) is reversed once (to normal single exposure operation) and then re-set for multiple exposure, the movement of the winding auxiliary plate (A753210) is defective. Winding is not possible, in the first instance because the winding claw (#1) engage the setting cam (A753200) even after the shutter is released.

1) Detact the right side cover. loosen five 8813357 screws and take out the winding unit (A753110).

1) Detact the right side cover loosen five B813357 screws and take out the winding unit (A753110).
2) Detach the cam holding nut (A255230) and then detach the setting cam assembly (A753190). Finally, replace with a new setting cam assembly.

3) When reattaching the winding unit in the body, see that the winding stopper lever (A753220) and #2 engage with the F. (film) release unit. (See Exchanging the Film Release Unit on page 8.)

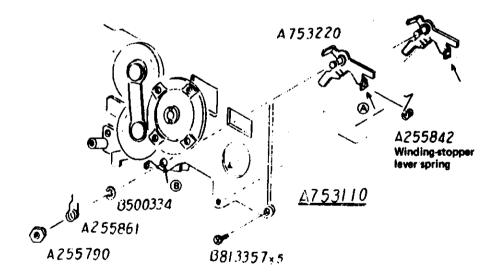
4. Winding Action does not Stop: Winding Stopper Lever Spring is Unhooked

Loed a test roll film in the film back and manipulate the winding crank (and advance the film and charge the shutter) for taking the first frame. Then, detach the film back and chack whether the F. (film) release pin (A260990) is protruding up to the front and of the F. release cylinder A (A260952) (see page 33). If the pin is not protruding correctly, correct according to "Film Back — 6. Winding Action does not Stop".

Minding Action does not Stop".
 Detach the right side cover. If the winding stopper lever spring is unhooked, it will be quite all right to hook it up once more but since it is liable to get unhooked again, it is recommended that the following repair be undertaken.
 Loosen five B813357 screws and detach the winding unit (A753110).
 Loosen the winding stopper claw spring holder (A255790) with the special screwdriver (A255790-AJ), take off the snap ring "type E" (850034) and, then, detach the winding stopper lever (A753220).
 Obtain a new winding stopper lever replacement part (which has a round opening in the place indicated by the (A) arrow) and assemble it into the body. When using the new replacement part, however, enlarge the opening on the winding base plate assembly, as indicated by (8) arrow, to 2 mm diameter.
 Refer to page 8 for reattachment of the winding unit.

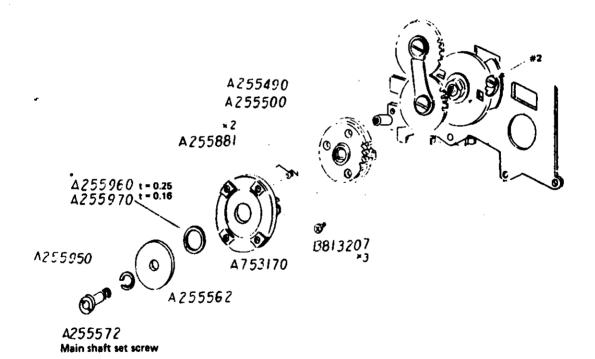
5. Winding Crank is very Loose: Main Shaft Setscrew is Loose

Strip off the crank base covers (A257040) and check whether the B813805 screws are loose or not. (See page 1.)

1) if looseness in the winding wheel (A753170) can be corrected by tightening the main shaft setscrews (A255572), detach the setscrew, apply Loc-Tite to the threeds and re-tighten the main shaft setscrew securely once more.

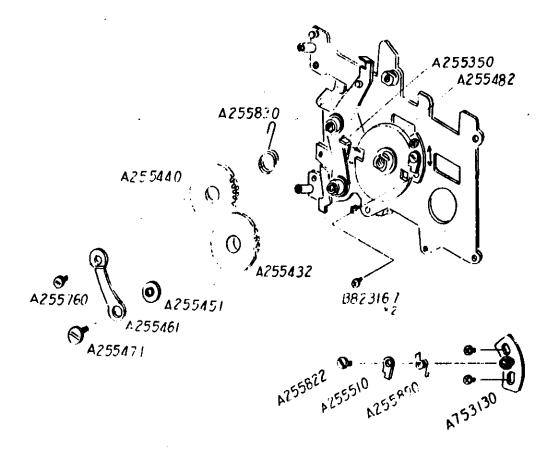
6. Winding Action is not Possible: Transmission Geer is Cracked

If the cracked transmission gear (A266432) is a white-colored plastic one, exchange it for a metal replacement part.

1) Loosen the connecting gear screw (A266760) and left hand gear arm screw (A266471), detach the upper connecting gear arm (A266461) and exchange the transmission gear.

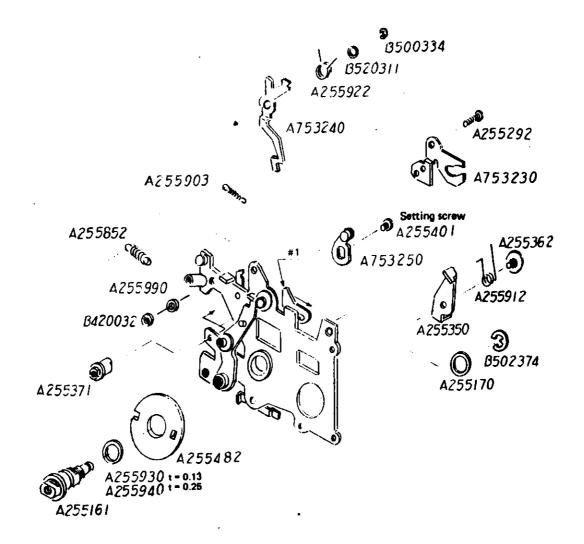
8. Multiple Exposure is not Possible: Setting Screw is Loose

The multi-exposure lever (see page 1) rotates the multi-set lever (A753250) via the multi-lever axis (A255371) and, thereby, pushes the multi-exposure link (#1) forward or in the direction of the lens.

1) The setting screw (A255401) should be fixed securely with Loc-Tite.

2) Exchange the multi-operating lever spring (A255922) when it is unhooked, if its hooking section is deformed.

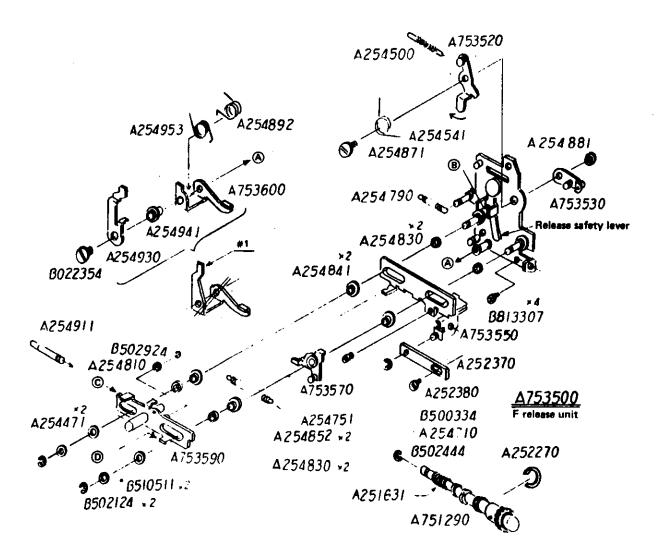
9. Exchange of the Film Release Unit

- F. release unit with an old type winding safety lever (#1) attached should be exchanged completely for a new type one, in order
- P. release unit with an old type winding serety lever (#1) attached should be exchanged completely for a new type one, in order to prevent deformation of the wind stopper pawl (A261391).
 First, detach the winding base plate assembly, then detach the shurter button stopper ring (A262270, B502444) of the shutter release button set (A751290) and the snap ring (B500334) of the shutter release link (A252370), loosen four B813307 screws and, finally, detach the F. release unit (A753500).
 Keep the following points in mind when attaching the winding base plate assembly, after attachment of the replacement F.

- release unit.
 3) The upper release safety lever (A255350, see page 7) must fit into (8).
 4) The multi-operating lever (A753240, see page 7) must engage (C).
 5) The winding stopper lever (A753520, see page 4) must engage (D).
 6) The holding claw (A753570) engages the F. release roller (A254810) while the shutter release button is being depressed and prevents the return of the upper F. release plate (A753590) so that there is time for the F. release action to take place. If the holding claw does not engage the F. release roller, then bend the upper F. release lever (A753520) in the arrow-indicated direction.

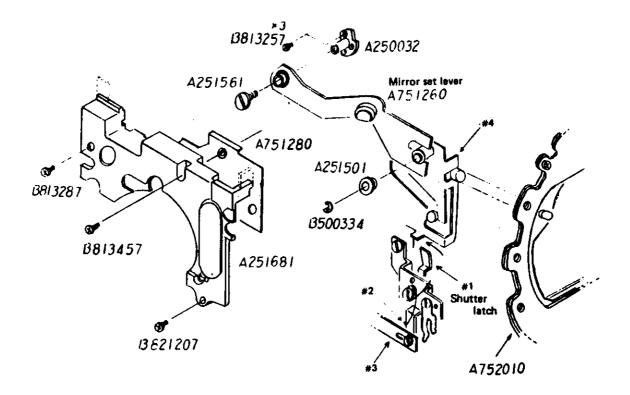
10. Mirror is not Charged: Bent Mirror Set Lever and/or Faulty Action of the Shutter Latch

- Reflex mirror swings back up immediately upon completing the film winding crank action.

A bent set lever is caused by mistakes made during the insertion of the lens. If the film winding crank action is heavy, when assembling the set lever, therefore, do not force the action. (Refer to page 15" Lens Cannot be Detached".)

1) Check action of the shutter latch (#1).

2) Next, loosen screws B813287, B813457 and B821207 and then detach the light baffle cover (A251881). (The old type light baffle cover also has a protrusion, as indicated by the broken-line part, and, therefore, it will be necessary to loosen the top frame (A755200), also, in this case. Refer to page 19.)

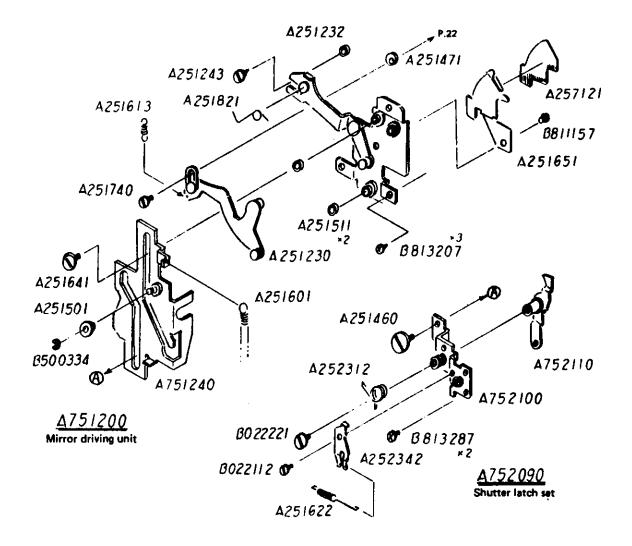
11. Shutter Blades do not Open (I)

The shutter blades close down completely when the shutter release button is depressed, while, at the same time, the reflex mirror swings up. Then, the light-tight plate (A751100) also swings up, followed by the shutter blades reopening and, after the required amount of time, closing completely once more. Should the shutter blades not reopen after the light-tight plate swings up, resulting in an unexposed frame, it should be repaired in the following manner.

1) Exchange the right operating-ring spring (A251601) since it has been strengthened by increasing its wire diameter to 0.26 mm.

2) Exchange the shutter operating ring unit (A752010) (see page 11).

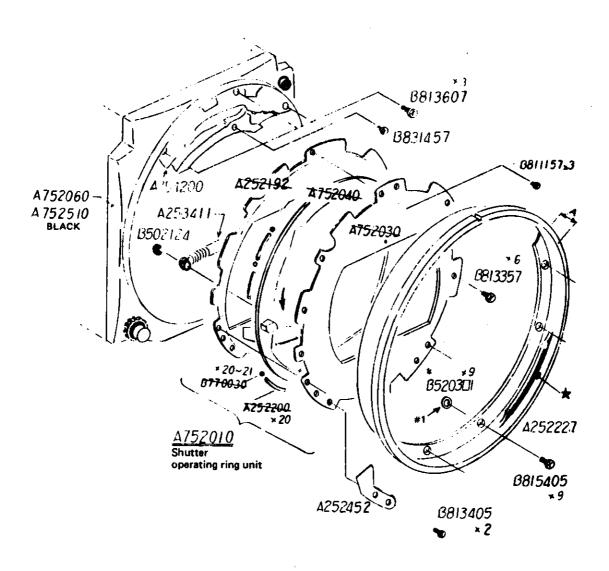
13. Shutter Blades do not Open (II): Rotation of the Shutter Operating Ring Unit is Heavy

With lens detached, check rotation of the S. (shutter) operating ring unit (A752010) in the errow-indicated direction white maintaining pressure on the shutter release button, if the rotation is not smooth but feels tight or seems to be catching, it should be repaired in the following manner:—

1) Loosen nine 8815405 screws and detach the lens mount (A252227). Since the focus adjustment weshers (#1) differ in thickness, they must be properly identified so that they can be returned to their original positions when reassembling.

2) Loosen two 8813405 screws, three 8813607 screws, one 8831457 screw and six 8813357 screws.

3) Detach the left side cover (see page 12), unhook the operating-ring spring (A253411) and exchange the S. operating ring unit. Use a spring with 55 turns.

Adjust distance from standard attachment plane (surface) to the star-indicated (*) position on the lens mount to 79 mm ±0.03. (Use tooling lies CT-301, 302 and 303.)

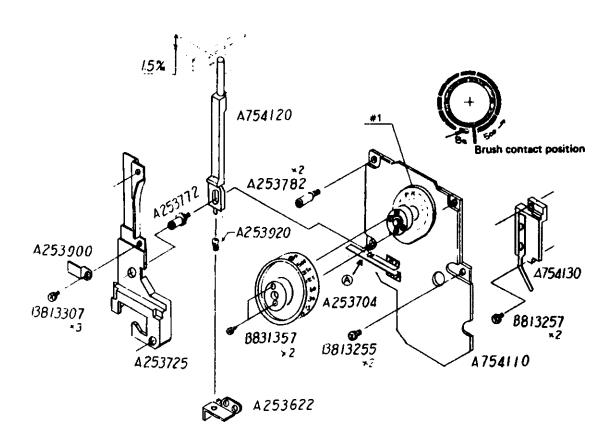
15. Shutter Speed Becomes 1/500 Second

1) Is the AE changeover rod protruding 1.5 mm above the top frame?

2) Is it possible that the switch of the shutter circuit is OFF?

If not, rehook the spring (A253920) to adjust.

Confirm ON/OFF operations of the switch by pushing the tip of the AE changeover rod. If OFF, bend the contact plate (A) to make the necessary adjustment.

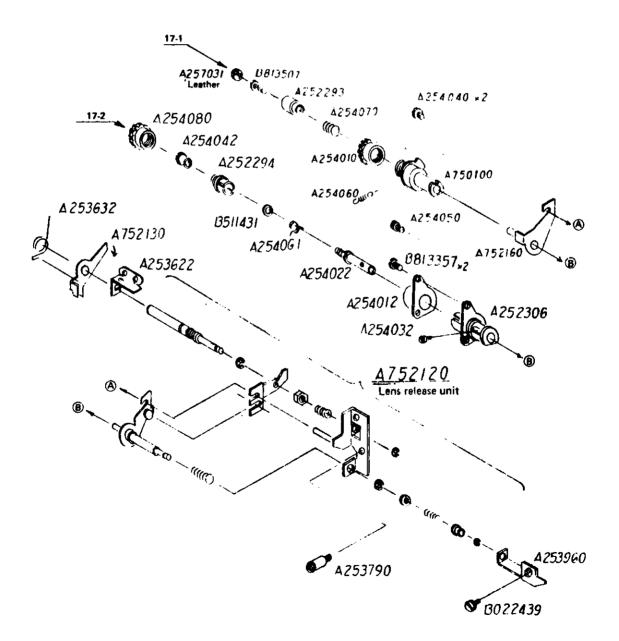
17-2 Lens release button is not covered.

17-1 Lens release button has leatherette covering.

Turn the film winding crank fully and charge the shutter. Rotate and depress the lens release button (A254080), Detach the lens.

To repair defects in the 17-1 system, change completely to the new 17-2 system.

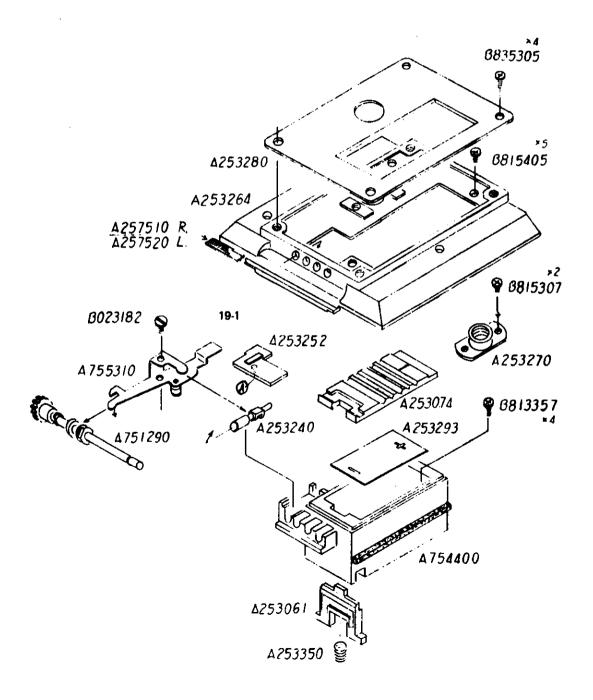
19. Shutter Release Button does not Return

The speed-grip shutter release rod (A253240) is jammed in the hole on the bottom cover (A253264).
 The release lever (A755310) is on top of the release rod (A751290) and disengaged.
 The lower F. (film) release plate (A753550) is on top of the release safety laver (see page 8) and, therefore, disengaged.

1) Exchange the MD (motor drive) connector cover (A253252) for a new part in which a protrusion has been added at the section indicated as (A) in the drawing. When making the exchange, however, attach liners with bonding agent, eliminate looseness in the speed-grip shutter release rod and, at the same time, sligh the rod properly to the hole on the bottom cover.

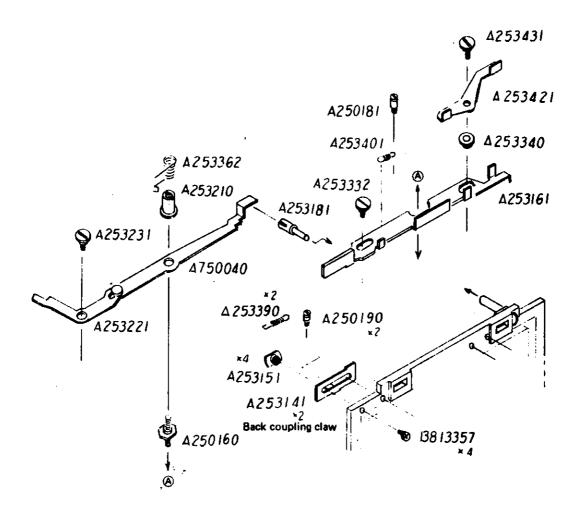
Back coupling claw (A253141) does not slide laterally and, therefore, becomes bent when pressed by the back coupling link on the film back side.

CAUTION: When the dark slide is inserted fully into the film back, the dark slide connecting pin (A253181) is pressed by the dark slide, which results in the dark slide safety latch (A253221) pushing the lower F. release plate (A753550) and preventing depression of the shutter release button.

1) Exchange the back coupling claw the coupling claw guide (A253151). Apply Loc-Tite to the B813357 screw and fix securely.

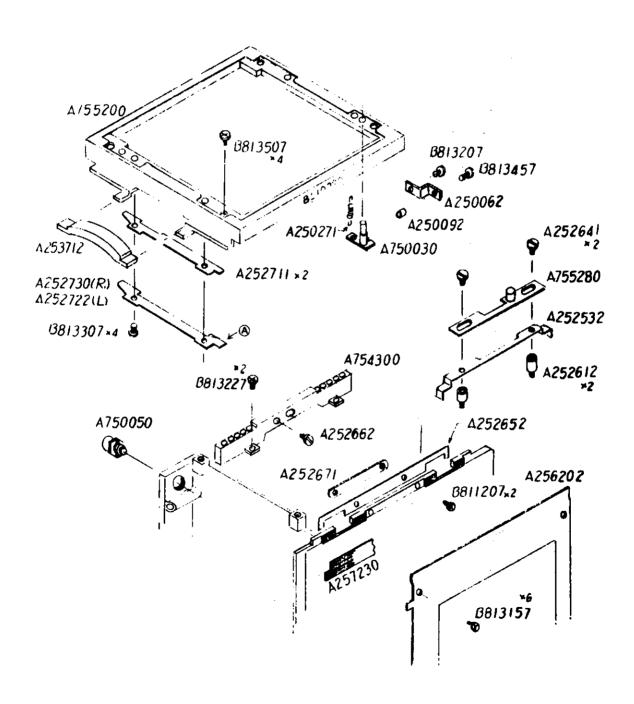
22. Waist-Level Finder cannot be Attached: Mount Springs are Bent

The finder cannot be attached because the finder mount spring (A252722) is deformed at point A.
Loosen the left and right side covers, detach the top frame (A755200) and exchange the finder mount springs.

CAUTION:
The part of the top frame with numbers engraved on it should not protrude above the standard attachment plane (surface).
Align the finder tock pin (A750030), AE changeover rod (A754120) and hole.

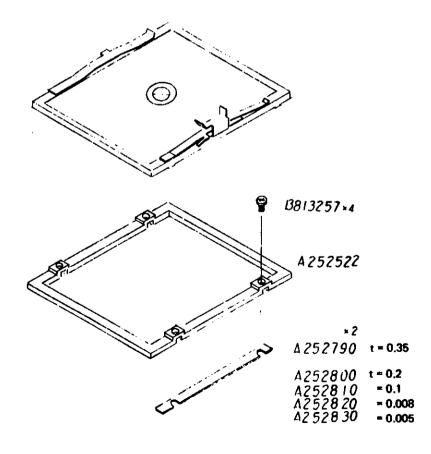
23. Adjusting the Focus of the Focusing Screen

CAUTION:
The 45° position of the reflex micror and the adjusting liners inserted under the freme gate have already been precisely adjusted in the factory and, therefore, should not require adjustments. Confirm that they are really out of alignment before making the above adjustments.

1) Coincide the reflex mirror to the 45° position (see page 23),
2) Adjust the height of the frame gate by increasing or decreasing the adjusting liners inserted below the frame
3) Loosen four screws and adjust the height of the frame gate (A252522) by increasing or decreasing the number of adjusting liners inserted under the frame gate.

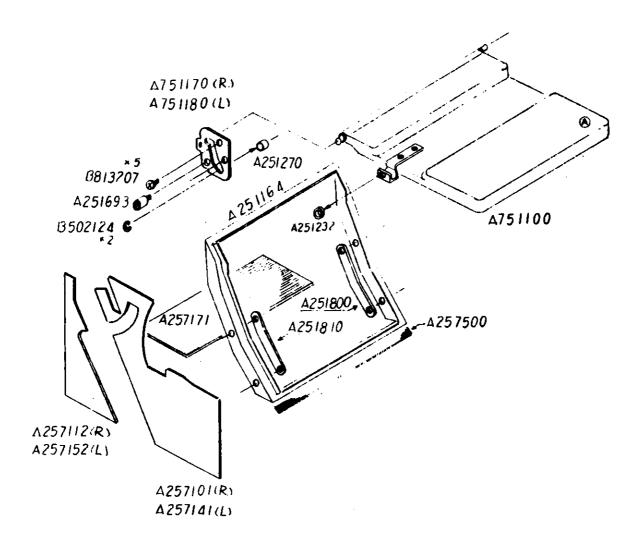
24. Reflex Mirror Light-Tight Plate

Light to the film plane is shut out by the rear light-tight frame (A251164) and the light-tight plate (A751100).

1) If the leading end of section (A) on the light-tight plate is not contacting the mirror frame, when the light-tight plate is in the up position, then exchange the spring (A251821, see page 10).

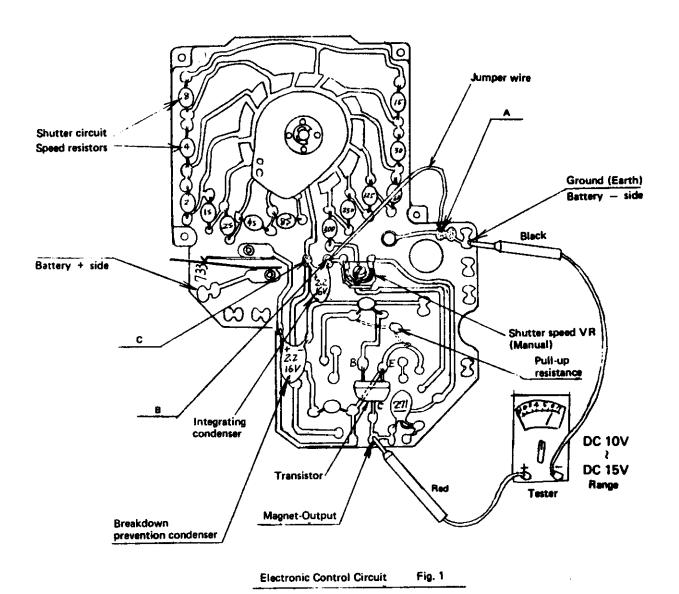
The shutter remains open at all shutter speeds or at the slow 15 to 85 speeds when the shutter is released with the electronic flish unit connected to the camera but returns to normal operation upon detaching the electronic flash unit.

The breakdown prevention condenser is not supplied for repair purposes but the circuit board can be exchanged completely, Defects run about one per thousand.

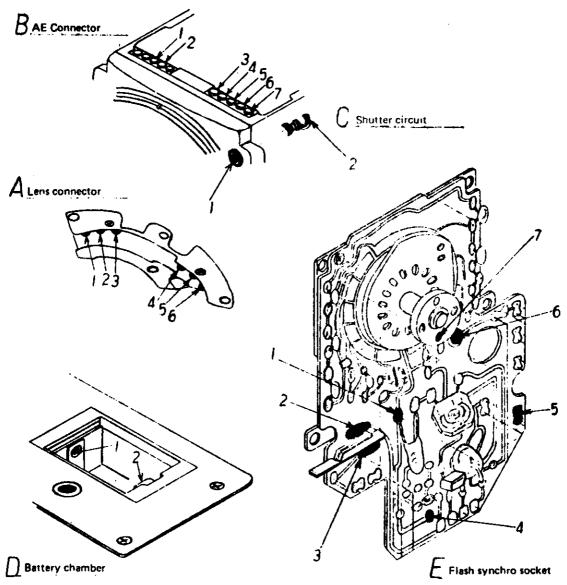
b) Pull-up resistance 8.2 kilo ohms:

Voltage is about 6.3V when the battery is still new. The shutter remains open while the battery voltage is high but returns to normal operations when the voltage falls to 5V.

The pull-up resistor is also not supplied for repair purposes but the circuit board can be exchanged completely. Defects run about one per 150.

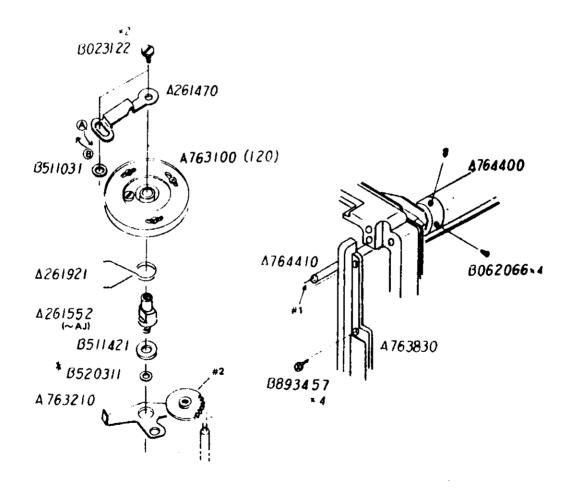
Pointers on Assembling the Counter Roller Shaft A

- Exchange in the following manner, when the pin (#1) of the counter roller shaft A (A764410) is broken.

1) Tighten four B062066 setscrews at the height required for properly engaging the pin (#1) and gear (#2) of the counter lever (A763210).

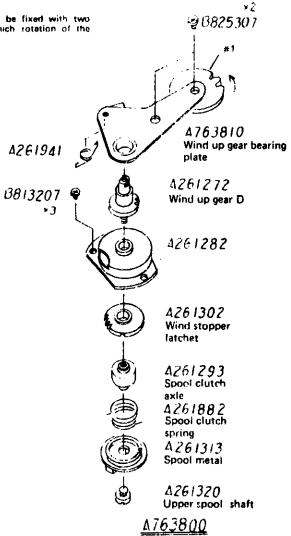
Hold the wind-stopper ratchet from rotating and rotate the wind-up gear A (#1). The upper spool shaft should rotate but the spool metal should not, in this case, if the latter also rotates at the same time, the trouble may be due to:—
1) Deformed grooves of the dividing plate and dividing auxiliary plate.

21 Bent wind stopper pawl.

3) Broken pin of the counter roller shaft A, etc.

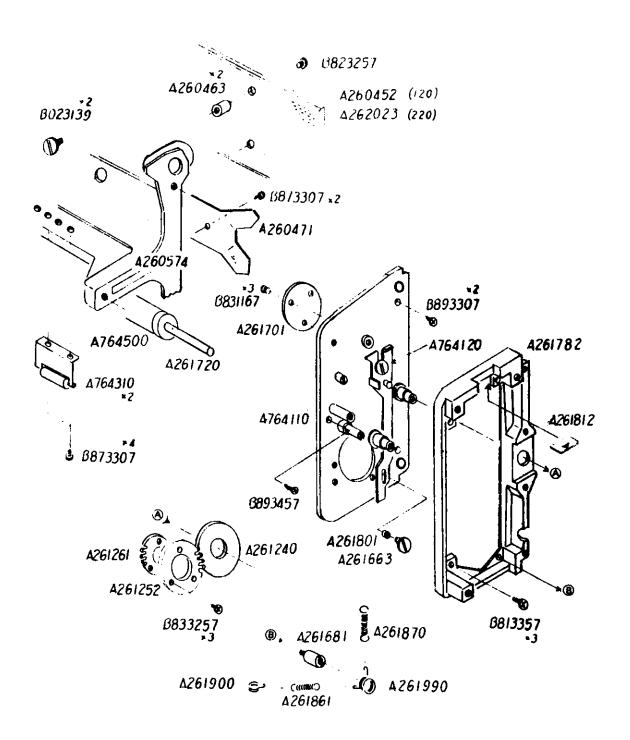
4) Assembly of the pressure plate with its top and bottom sides reversed will result in contact with the frame counter roller A and B (A764400 and A764500) and, therefore, it should be assembled properly.

- Exchange all plastic wind-up geer B's (A261252) for metallic parts.
 Pressure plate (220) (A262023) is stepped on both sides.
 The exchange of the pressure plate to which the pressure plate pin (A260463) is riveted also requires exchange of the pressure
- plate pin.

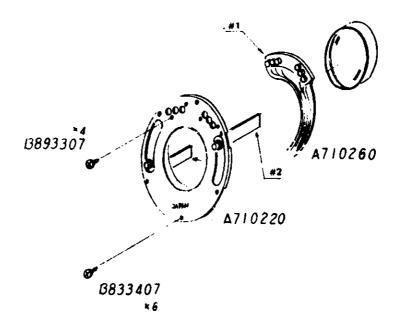
(1) Shutter Blades do not Open (when the Shutter Release Button is Depressed)

Check rotation of the setting ring unit (A710220). After setting the unit, press the locking lever (A210213) on the side of the beyonet mount and then return the setting ring unit. If it feels tight or seems to catch, then it should be exchanged.

- Loosen six B833407 screws.
- Loosen four B893307 screws and detech the printed circuit board (#1).

Attach the printed circuit board to the replacement setting ring unit with the four B893307 screws which were deteched in 2)
- above.

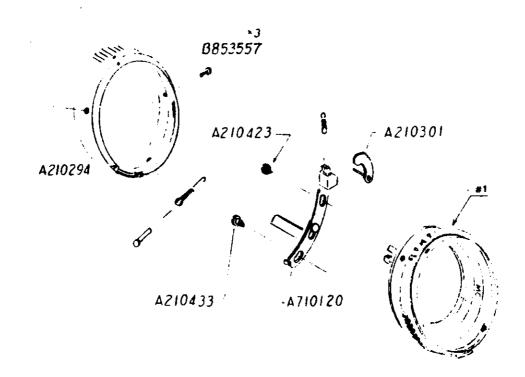
The shutter assembly is manually stopped down, by pressing preset lever (A210301) which, in turn, pushes preset arm set (A710120). Repair in the following manner (when the preset arm set does not move):—

1) Loosen three 8853557 screws and detach the aperture ring block (#1).

3) Loosen A210423 and A210433 screws and detach the preset arm set.

4) Since a change has been made in the surface painting of these three parts (in 3, above), they should all be exchanged for new replacement parts in this case.
