★Aries2 / Virgo2

Symptom: Cannot start up, Screen stays black.

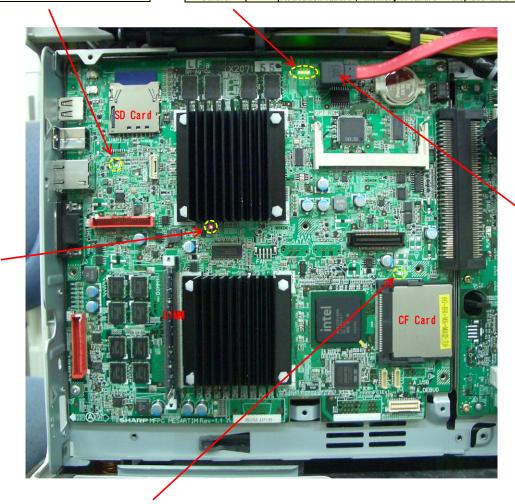
HDD unit: Confirmation of connecting condition

The LED blinks severely at the time of power on because access to the CF card is executed frequently.

- The LED keep lightening: Failure to access CF card -> Replace the CF card / PWB.

- The LED never lightening: Activation failure -> Replace DIMM / PWB.
