Hydronic Site with Hot Water Failure not resetting

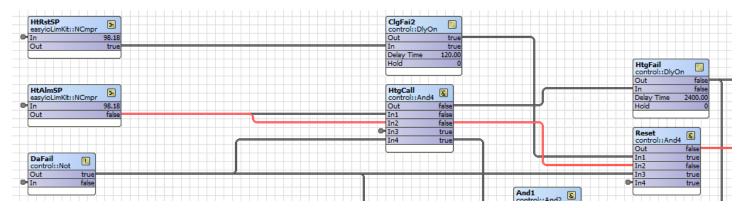
The problem with the hot water failure not clearing comes from the HtClAlm folder and the inputs to the Reset block:

HtAlmSP will only be true if there is reason for a heat alarm, and if there is reason for a heat alarm then the controls should not reset.

The problem is the link highlighted in red which may have been modified for a water valve site.

The second input to HtgCall originally linked from Heat / And4.Out.

When that link is restored the reset functions correctly:
