SERVICE BULLETIN

SERVICE BULLETIN		No.: MSB-98E33-501	
		Date: 1998-11-15	<Model> (EC,EXP)L200 (K60,70)
Subject:	CORRECTION OF PART NUMBER OF PINION HEIGHT GAUGE SET'S COMPONENT PART		<M/Y> 97-10
Group:	FRONT SUSPENSION	Draft No.: 98SY070111	
CORRECTION	OVERSEAS SERVICE DEPT	 T.NITTA - VICE GENERAL MANAGER QUALITY INFORMATION ANALYSIS

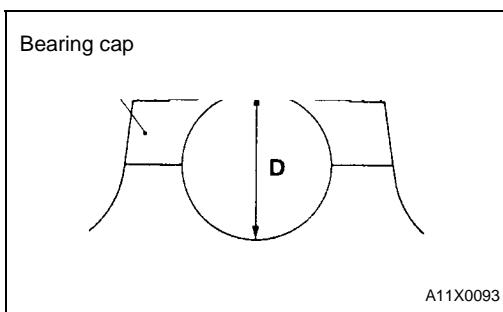
**<Correct>**

7. Remove the special tools (MB991170, MB990904)
8. Use a micrometer to measure the special tool in the places (B,C) shown in the illustration

<Incorrect>
