Multi-Rail Isolated Power Supply Monitoring System

Capstone Design Documentation

Michael Capotosto

Rev. ET450-W6

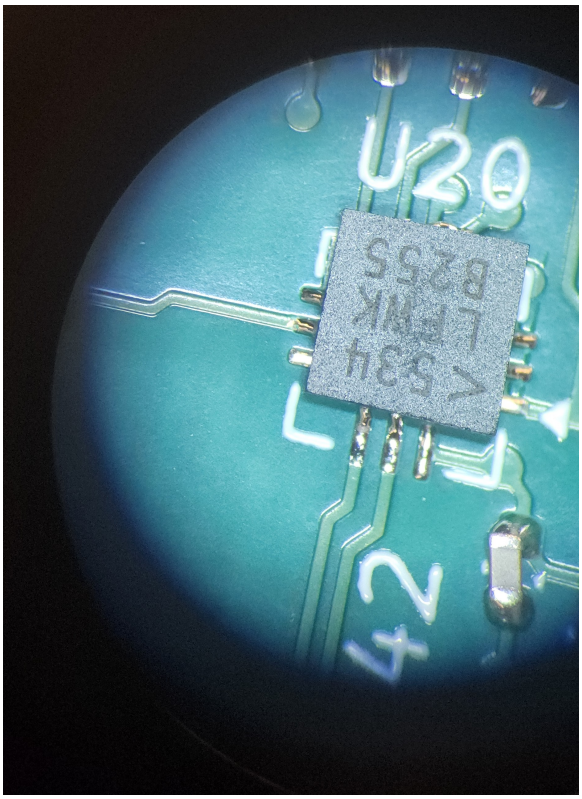
Only one notable finding was found, U20 was shifted off the pads, with the exposed pad in the center having 'snapped' to pins 4/5/6. The board was reworked via hot air prior to power being applied to correct this. No other defects were found on visual inspection.

Figure 9.8: The PMIC, U20, was found to have not been properly aligned when soldered initially, requiring rework to re-center the component.

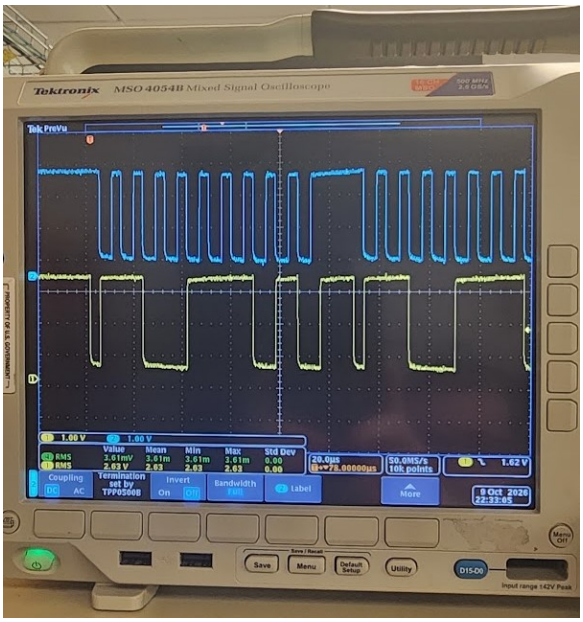
With the sensor board disconnected, I was able to observe clock and data transmissions, with NACK visible on the 9th clock as below:

Figure 9.9: I2C messages on Arduino shield cable driver output, with sensor board disconnected, NACK bit on 9th clock pulse

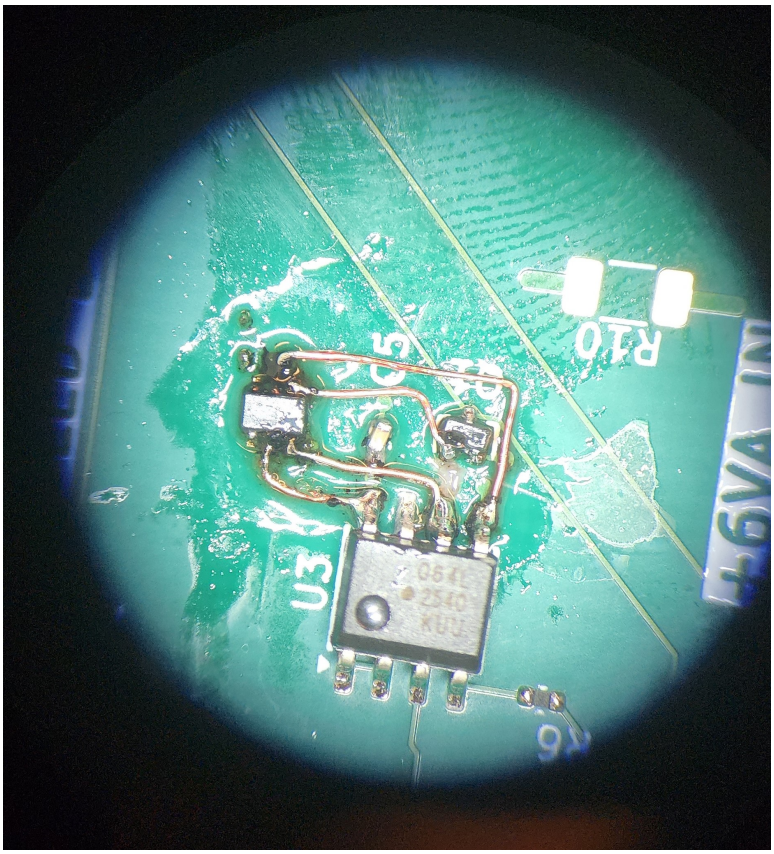
At this stage, I focused my attention around the PMIC's $\overline{SDAO}$ signal...Measuring the input pin of the optocoupler, I observed the line was being held high! This was expected behavior for I2C, except the selected part was designed to have an inverted SDA output!

Figure 9.10: SC70-6 package inverter epoxied to the board, and 32awg bodge wires added, with cut trace, between optocoupler output and FET gate

The bodge required cutting or and lifting the trace between the iso and the fet's gate, and adding short jumper wires between the existing circuit, the inverter input, and the fet gate. Power and ground were also provided to the inverter by tying into the optoisolator's 3.3V digital supply (via it's Pin 8, and the ground via pin 4).

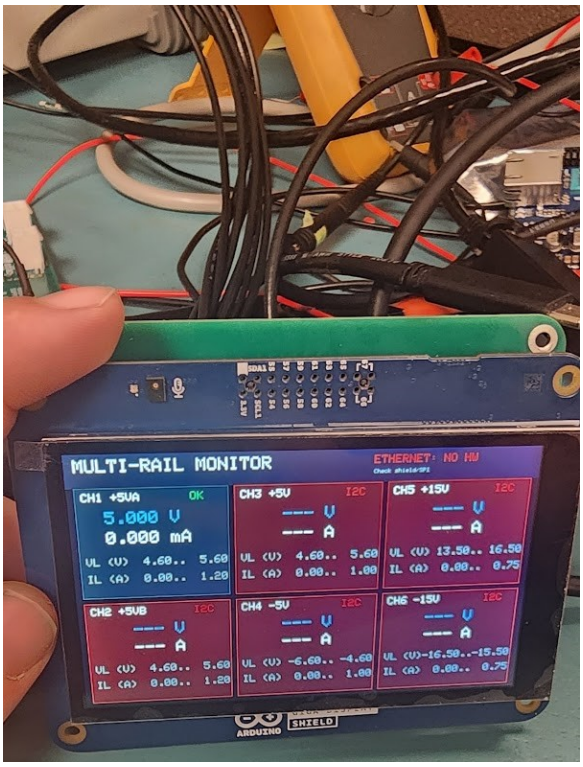
Figure 9.11: Communication is now working for the +5VA channel that has had the I2C connection repaired. The other 5 channels have had the FET gate floated (copper traces cut and lifted) from the opto to release the data bus, but have not yet had their inverters installed.

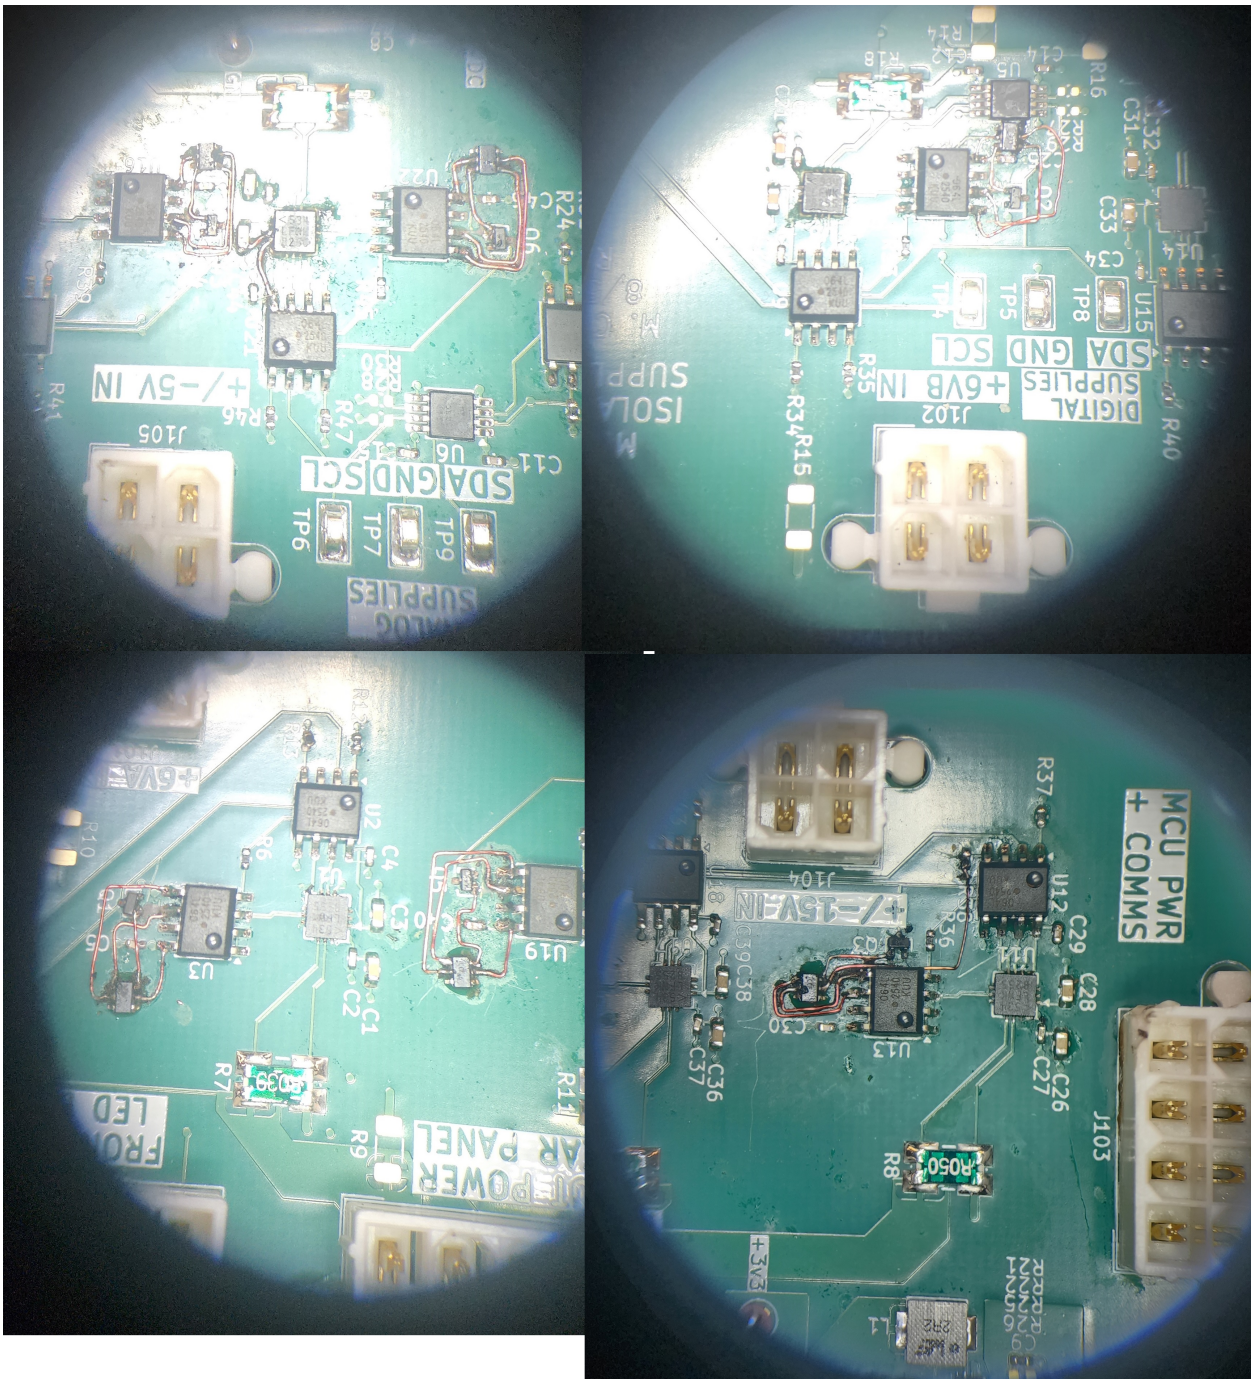
Repairs were carried out on the remaining 5 channels. Additionally, it was found that the +5VA and -5V both had the same I2C address configured; this was modified by removing U20, cutting the traces to the address pins, and running 30awg magnet wire to tie Pin 3 to INTVCC (via U21-8) and Pin 2 to -5V via C43-2. Power was restored and then it was observed to now be working on all 6 channels!

Figure 9.12: Rework is completed for all 6 channels

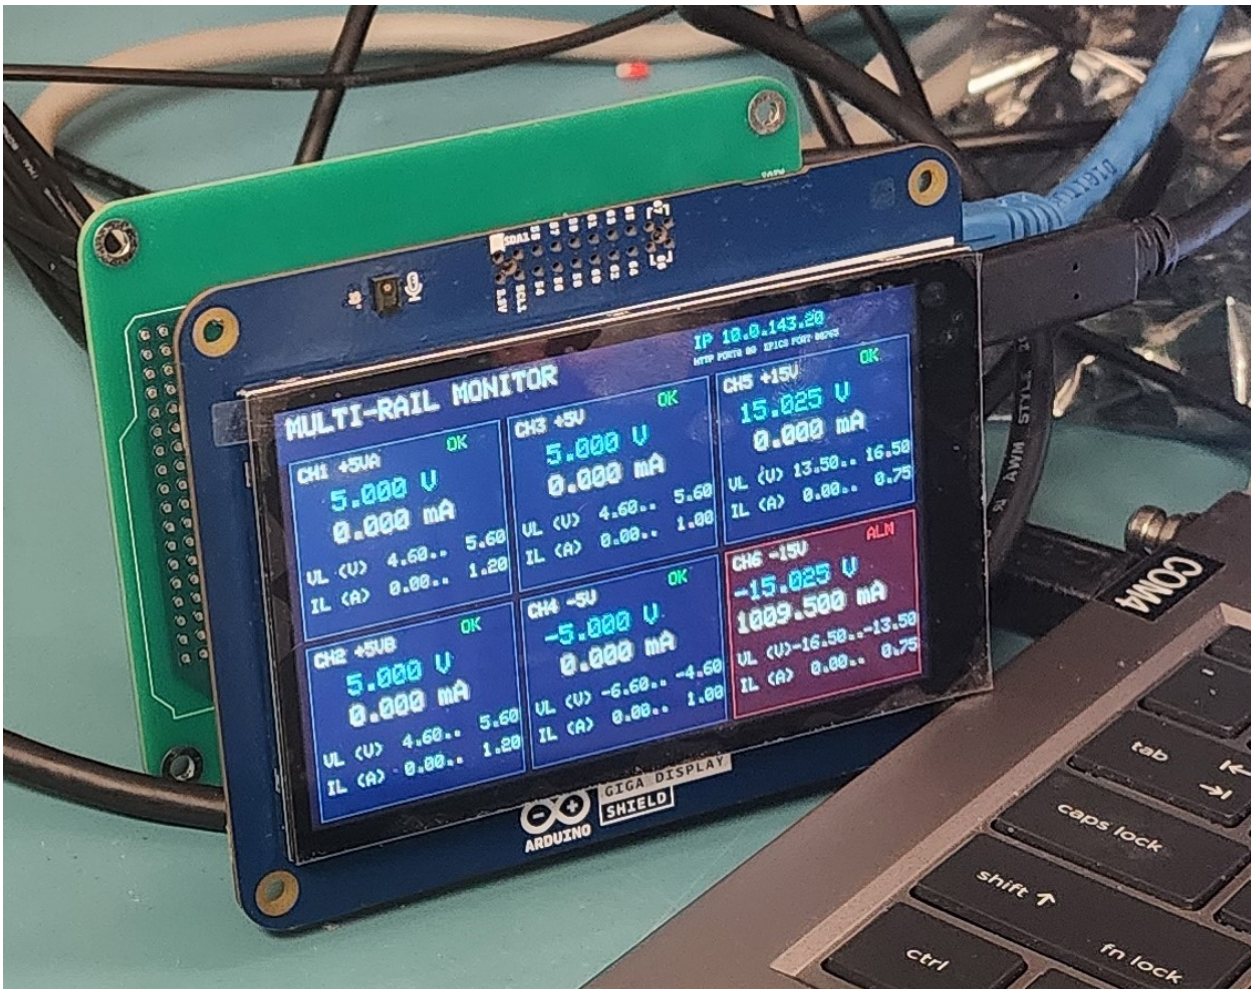
Figure 9.13: All 6 channels now working!
