## E°CONTROL

## Error Messages CNC Controllers xNC55 EXC66 EXC88 EXC880 EXC89

Description of Error Messages and Appropriate Solutions

Version: 08.02.2023

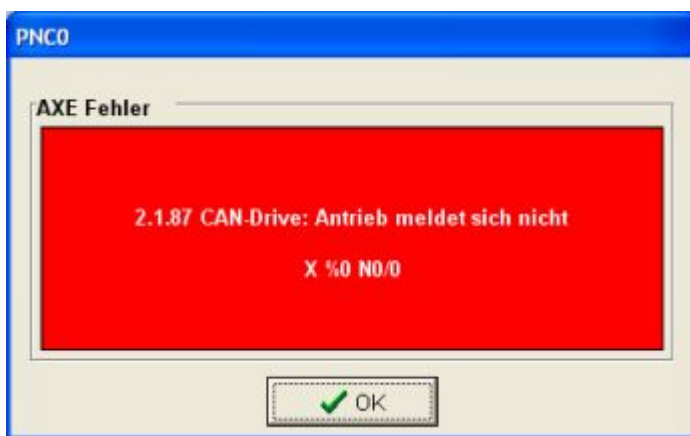
- Axis letter (=X),
- Last position in DIN program: Program number (= %0), block (=N0/0).
- Na/b with a= programmed block number, b = logical block number (line starting with the programmed block number a, beginning with 1)

Example:

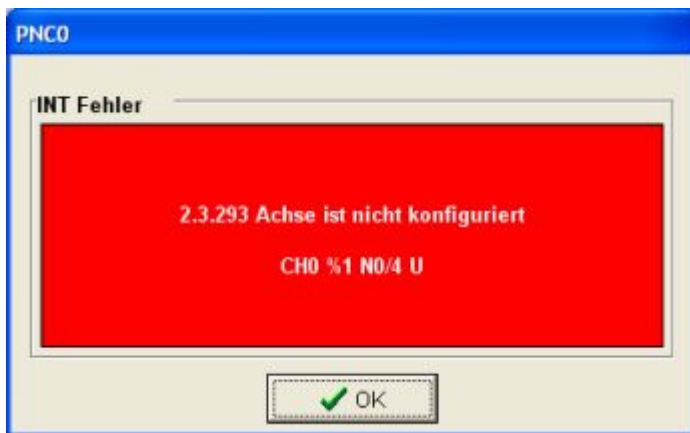
- CNC channel (=CH0)
- Program number (=%0)
- Block (=N0/0)
  - Na/b with a= programmed block number, b = logical block number (line starting with the programmed block number a, beginning with 1)
- Incorrect character / axis letter (=U)

Example:

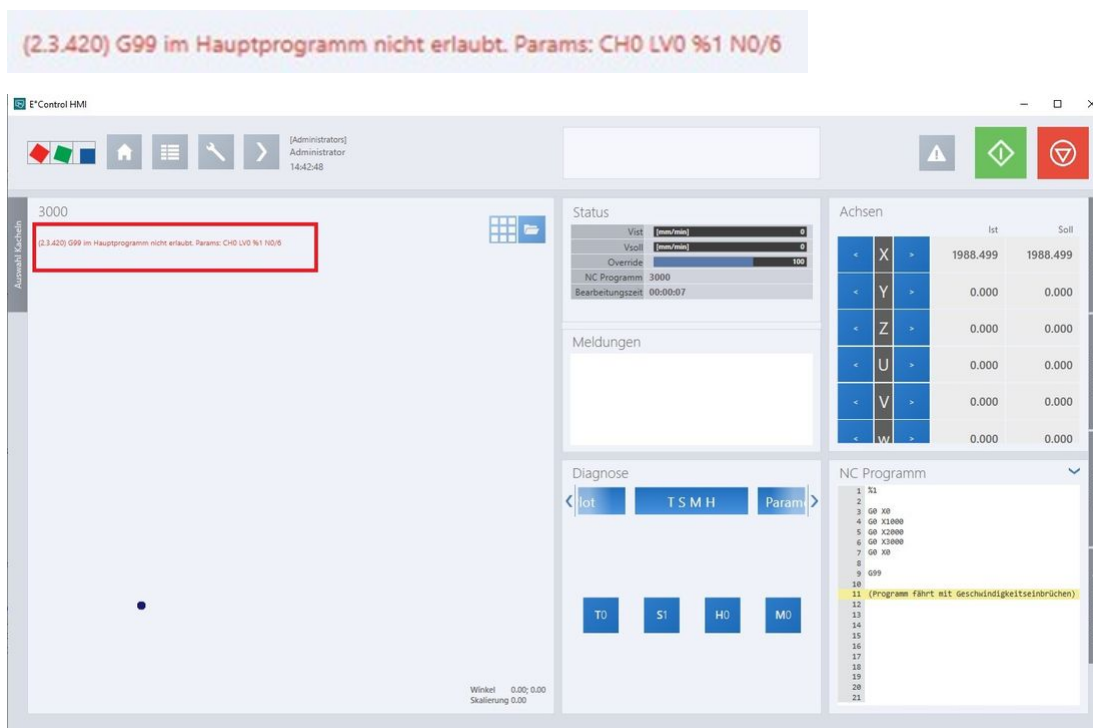
If the error occurs in the Graphic tile of the E°Cut HMI, the cause may be in the configuration parameter UseInternalProgramNumber.

### UseInternalProgNumber

TRUE: The number of the main program (e.g. 1) is used instead of the start program (e.g. 9000).

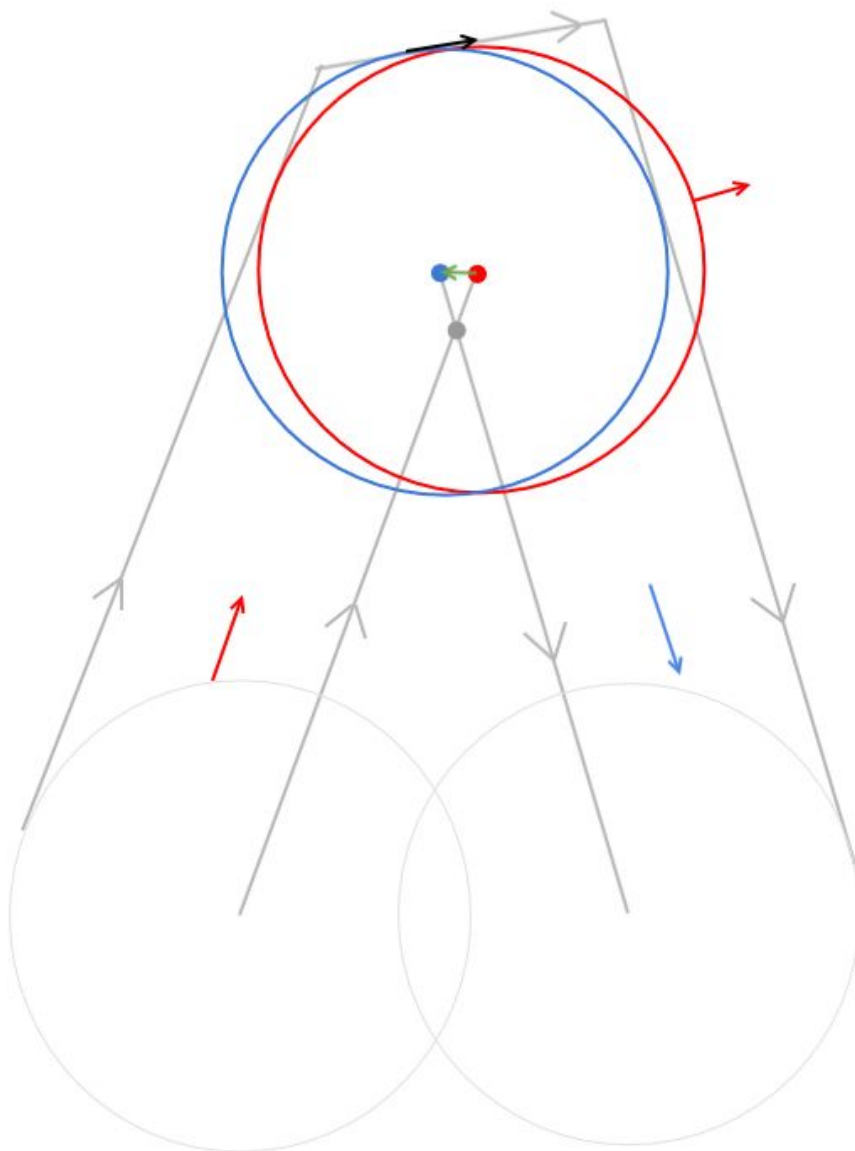
This error is reported if a contour is to be executed with active tool radius compensation and the tool does not fit into this contour. This is determined by a travel direction change of the tool center point (see figure).

In the example, the contour is executed in a clockwise direction along the black arrow. When approaching the corner (tool is shown in red), the tool center point still moves clockwise as well. For the further path (shown in red), the direction would have to be reversed because the corner is too tight, and the center of the tool would move to the left. Due to the changed travel direction, the error is reported.

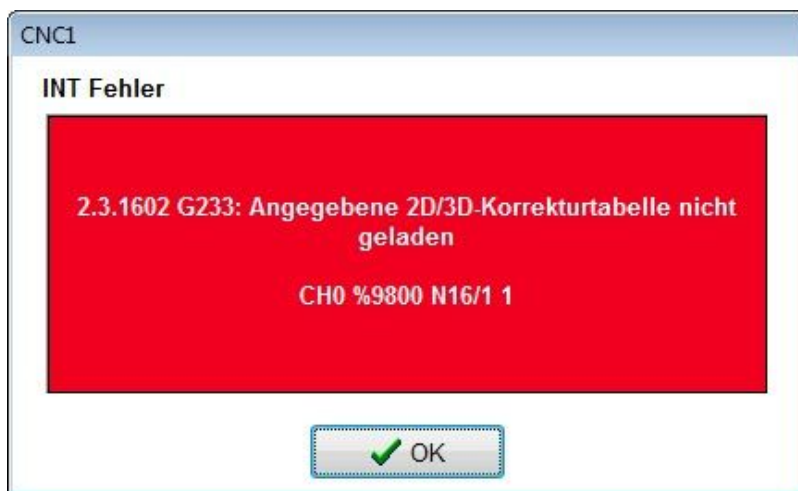
When the G233 was switched on, a correction table was specified for one or more axes which had not previously been loaded into the controller.

The number of the missing compensation table can be taken from the additional information (last number, in the example 1).

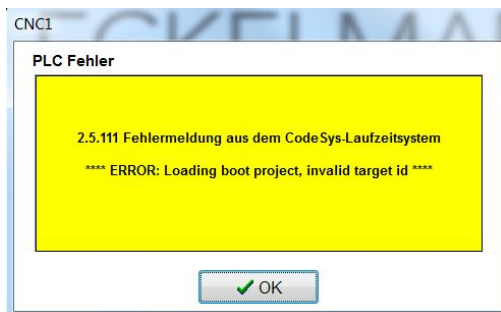
## 2.5.111 Error message from the CodeSys run-time system

The CODESYS runtime system has reported an error. This can have different causes. The additional information contain the error text.

Error cause in the example: The PLC boot project does not match the controller.

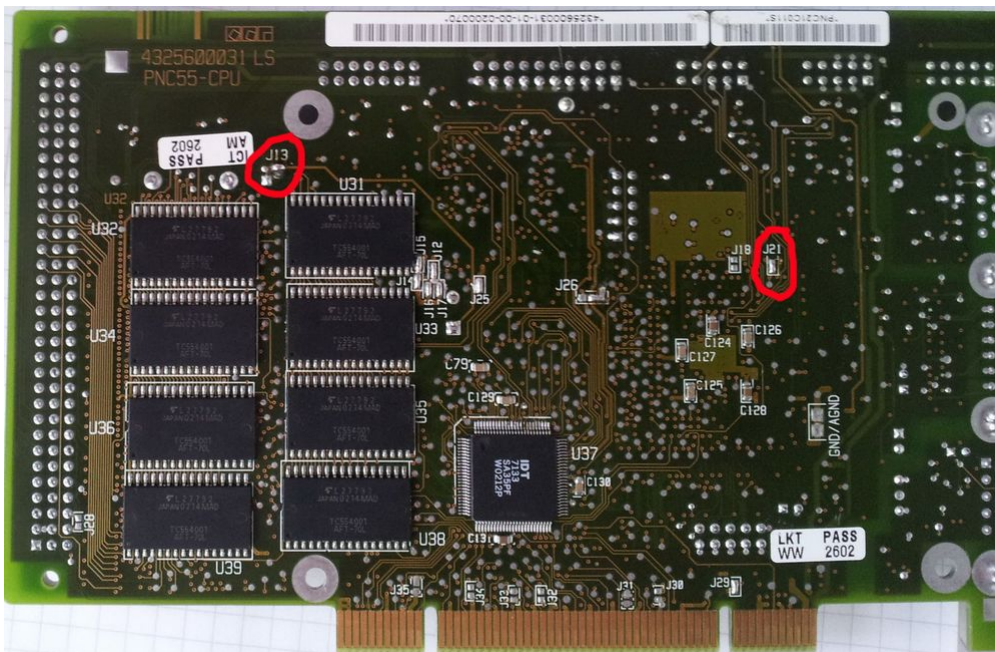
##### Cause PNC55

The solder bridge J21 is missing on the back of the PNC55.

Check if the necessary solder bridges exist on the back of the PNC55 (J13 & J21).

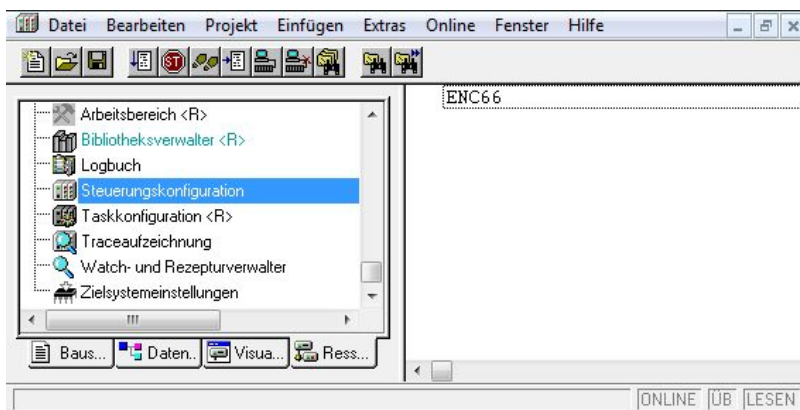
The error message may occur when loading a CODESYS V2.3 PLC project if the controller configuration was empty. The error occurs only between EXC firmware version V2.60beta1 and V2.62.

The following screenshot excerpt shows an empty controller configuration. For example, LBM or other modules are missing.

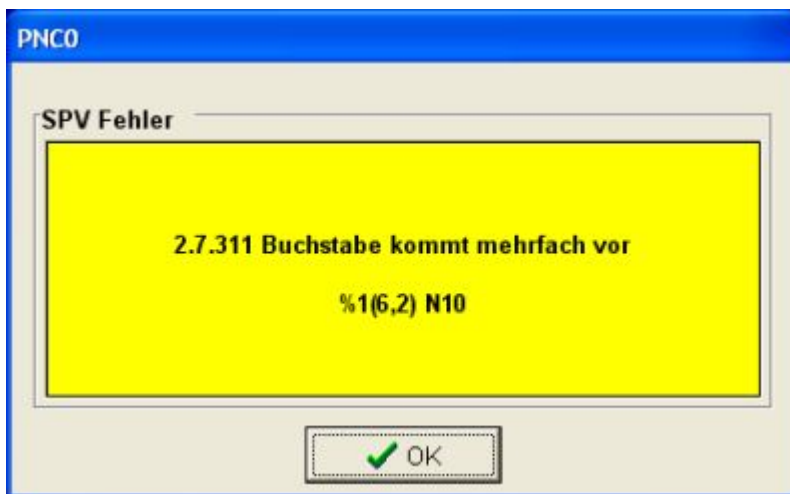
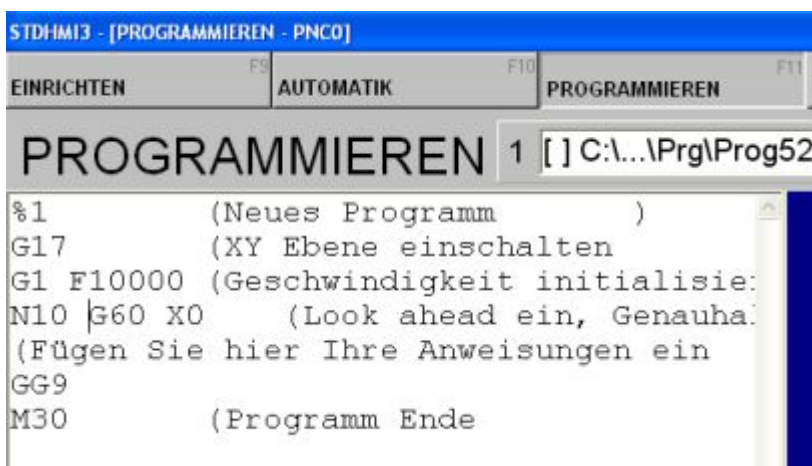
Contents of the additional information:

- Program number (=%1)
- Line No (=%6),
- Column number (=%2),
- programmed block (=%N10)

Cause: Indicates the faulty position in the DIN program from block number N10 up to the next block number. Here the second G is wrong, because there is no function with GG.

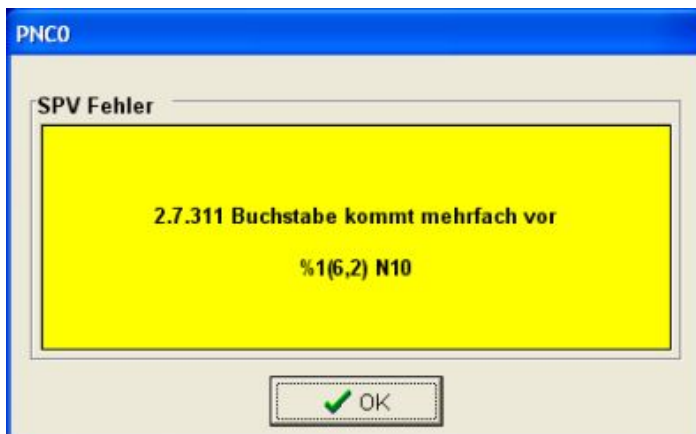
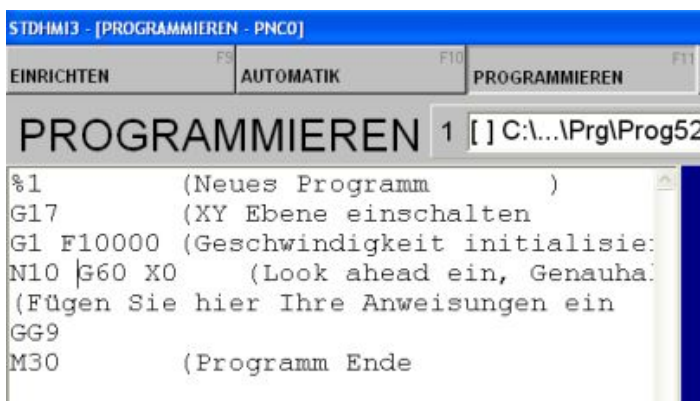
#### Example

The additional information indicates the faulty position in the DIN program from block number N10 up to the next block number. In this case the second G is wrong, because no function with GG exists.

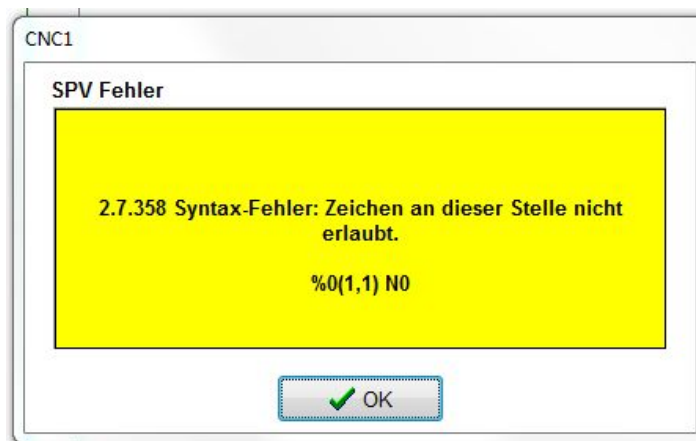
### Example

In the example, a file of a different type was loaded as a DIN program. The very first character is invalid. %0 means that the controller could not yet interpret the program number. (1,1) denotes the first character of the first line. N0 means that no block number was found before the error.

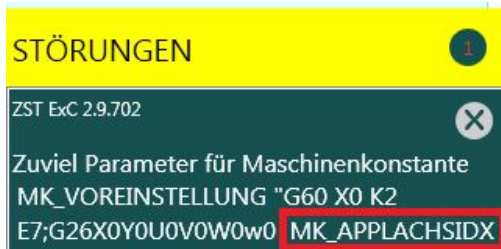
```
MK_VOREINSTELLUNG      "G60 X0 K2 E7;G26X0Y0U0V0W0w0"  
MK_APPLACHSIDX        0,1,2,3,4,5,6,7,8,9,10,11,12,13,14,15,-1,-1;
```

The error message shows the identifier of the next machine constant (in this case MK\_APPLACHSIDX, see red marking):

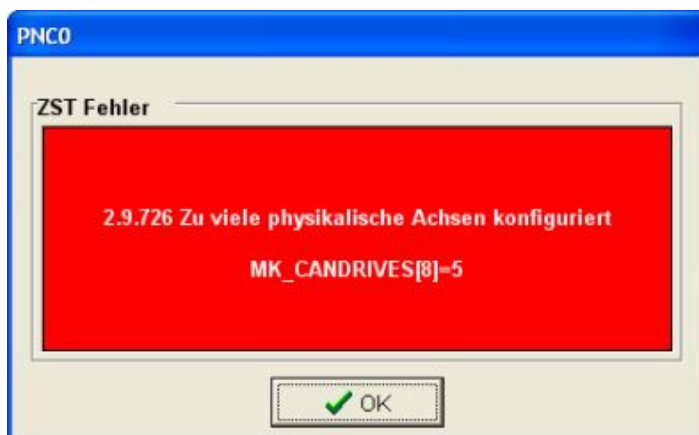
### Example

Contents of the additional information:

incorrect axis index (=8).

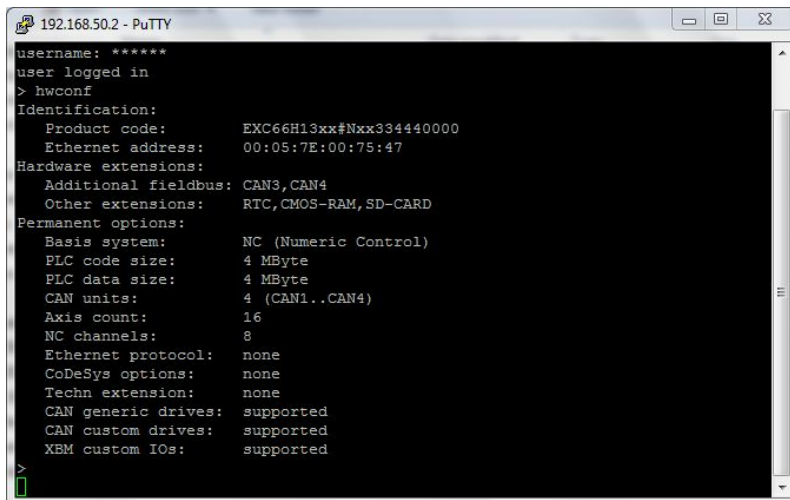
A possible error case with an EXC66

hwconf with error-free controller:

```
192.168.50.2 - PuTTY
username: *****
user logged in
> hwconf
Identification:
  Product code:      EXC66H13xx#Nxx334440000
  Ethernet address:  00:05:7E:00:75:47
Hardware extensions:
  Additional fieldbus: CAN3,CAN4
  Other extensions:  RTC,CMOS-RAM,SD-CARD
Permanent options:
  Basis system:      NC (Numeric Control)
  PLC code size:     4 MByte
  PLC data size:     4 MByte
  CAN units:         4 (CAN1..CAN4)
  Axis count:        16
  NC channels:        8
  Ethernet protocol: none
  CoDeSys options:   none
  Techn extension:   none
  CAN generic drives: supported
  CAN custom drives: supported
  XBM custom IOs:    supported
```

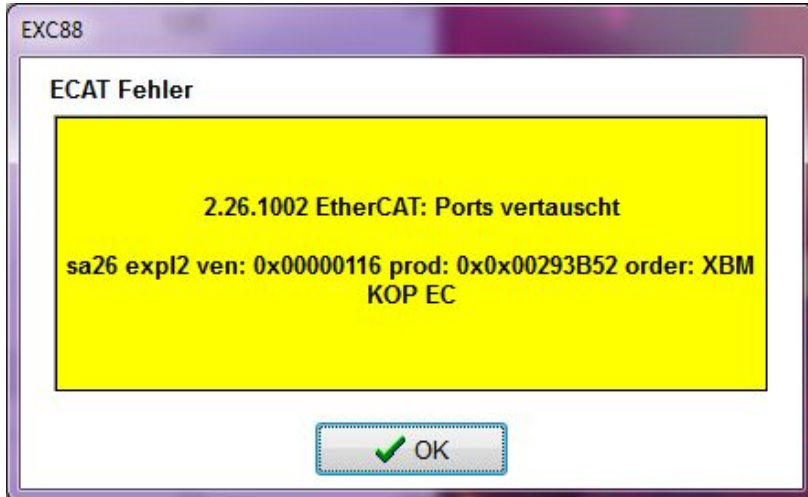
### 2.26.1002: EtherCAT: EtherCAT: ports are mixed up

Complete error message:

#### Description of the individual parameters:

- sa: Topological slave address
- expl: Explicit device address of the slave (if available)
- ven: Vendor ID of the slave
- prod: Product code of the slave
- order: Device designation from the SII of the slave (Device Order Number)

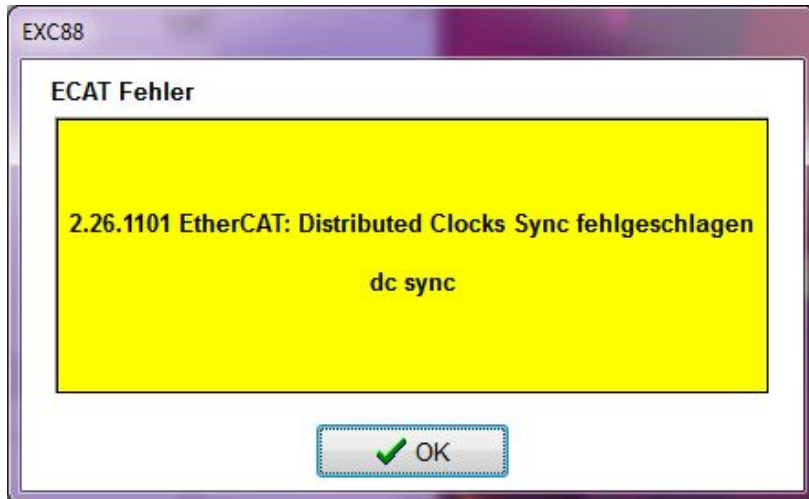
## 2.26.1101: EtherCAT: Distributed Clocks sync failed

Complete error message:

### Cause

The Distributed Clocks synchronization has failed. The maximum permissible sync difference to the reference time was exceeded several times during synchronization and was therefor aborted.

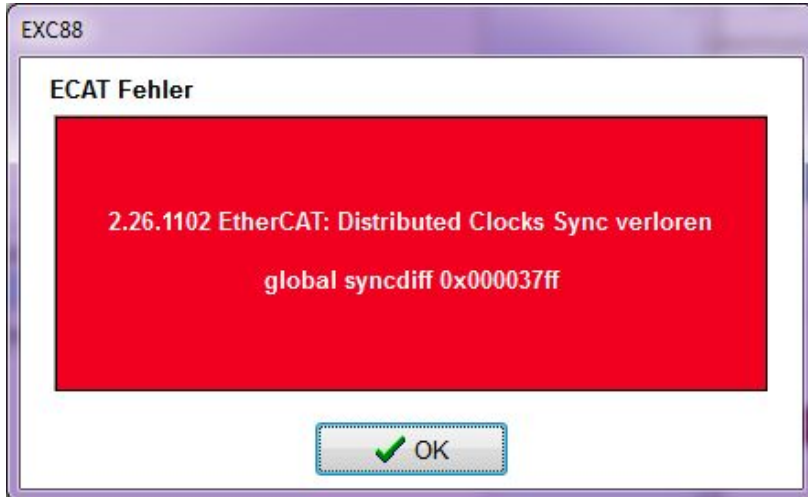
### 2.26.1102: EtherCAT: Distributed Clocks sync lost

Complete error message:

Description of the individual parameters:

- global syncdiff: Maximum value from all slave registers 0x092C in ns

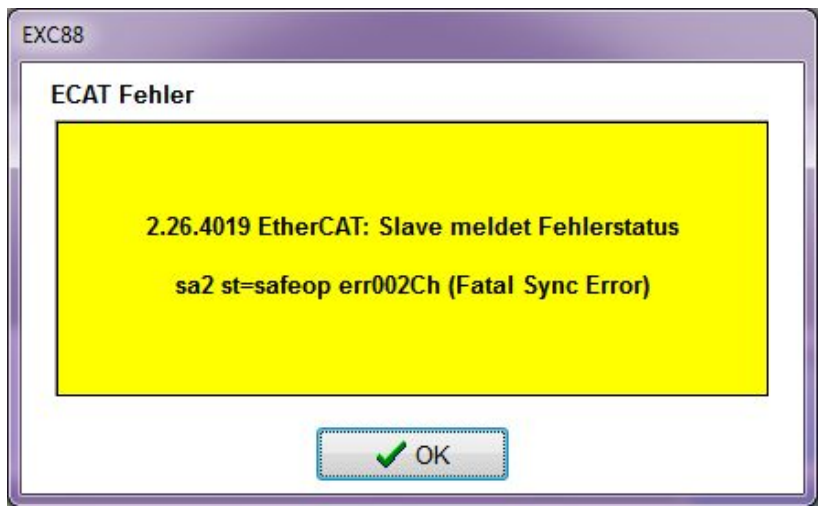
## 2.26.4019: EtherCAT: Slave reported errorstate

Complete error message:

### Description of the individual parameters:

- sa: Slave address:
  - Configuration in the PLC:
    - Normal configurator or Eckelmann CNC axis - > EtherCAT address from the configurator
    - Easy-Master nodes: 200 + position within all Easy master devices in the device tree starting with 1
  - Configuration only by MK:
    - Topological address
- st: Current slave state
- err: Error number from AL status register including plain text description from specification (if known).

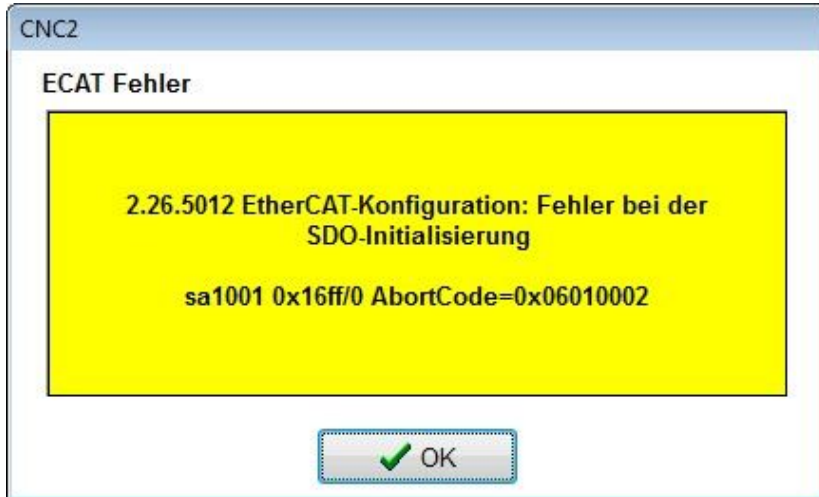
## 2.26.5012: EtherCAT-Konfiguration: Error while SDO initialisation

Complete error message:

### Description of the individual parameters:

- sa: Slave address:
  - Configuration in the PLC:
    - Normal configurator or Eckelmann CNC axis - > EtherCAT address from the configurator
    - Easy-Master node: 200 + position within all Easy master devices in the device tree starting with 1
  - Configuration only by MK:
    - Topological address
- AbortCode:
  - CoE abort code according to CiA 301

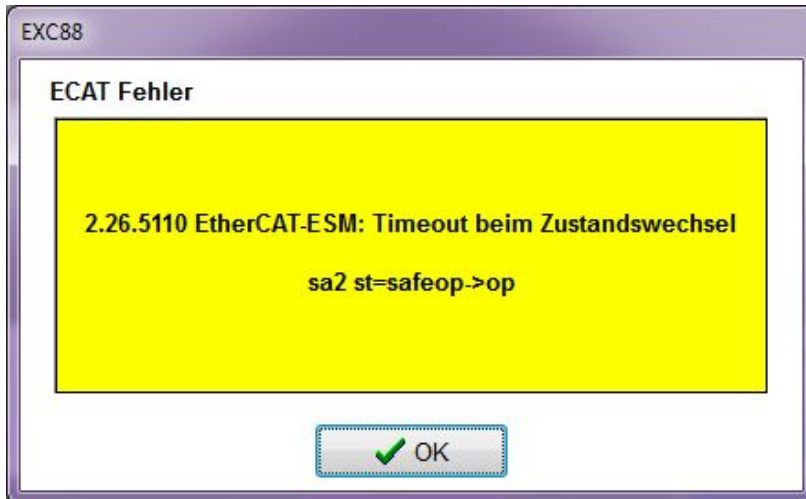
## 2.26.5110: EtherCAT-ESM: timeout while state change

Complete error message:

Description of the individual parameters:

- sa: Slave address:
  - Configuration in the PLC:
    - Normal configurator or Eckelmann CNC axis - > EtherCAT address from the configurator
    - Easy-Master node: 200 + position within all Easy master devices in the device tree starting with 1
  - Configuration only by MK:
    - Topological address
- st: Current slave state -> requested state of the slave where the timeout occurred

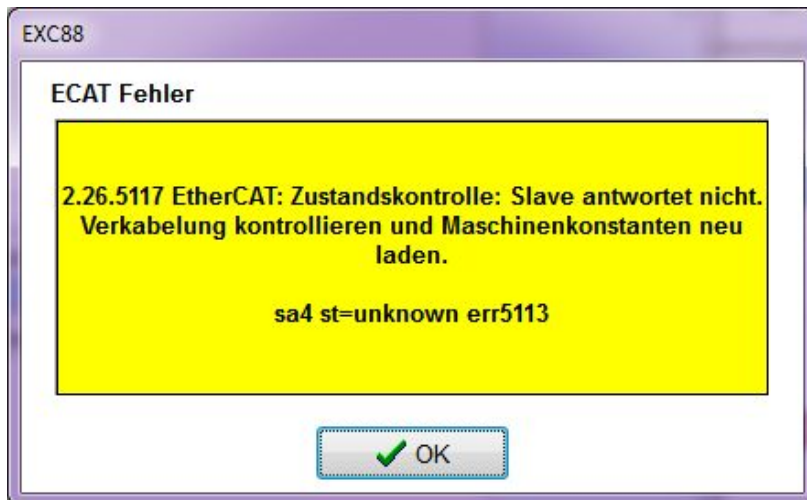
## 2.26.5117: EtherCAT: Statepolling: No response from slave. Check wiring and reload machineconstants/PLC

Complete error message:

Description of the individual parameters:

- sa: Slave address:
  - Configuration in the PLC:
    - Normal configurator or Eckelmann CNC axis - > EtherCAT address from the configurator
    - Easy-Master node: 200 + position within all Easy master devices in the device tree starting with 1
  - Configuration only by MK:
    - Topological address
- st: Current slave state (if known)
- err: Additional information about the occurred error. Error number corresponds to the error from the ecatsubsystem, 5113 e.g. 2.26.5113: EtherCAT-AL: Working counter too low.

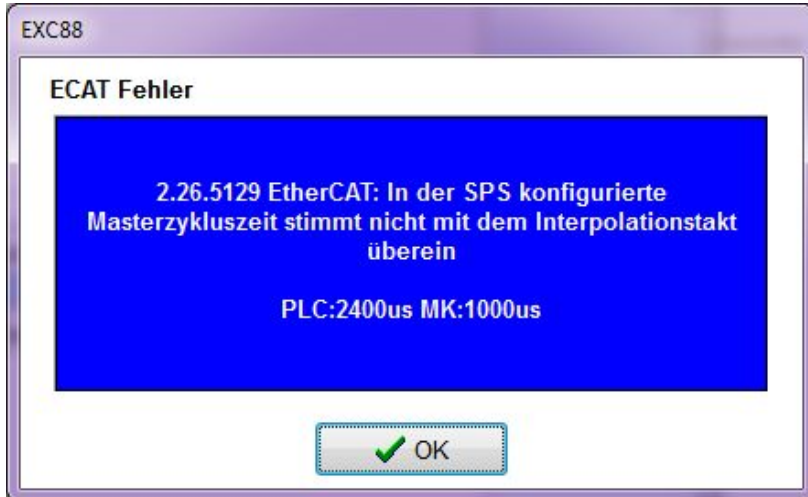
## 2.26.5129: EtherCAT: PLC master cycle time doesn't match to interpolation cycle time

Complete error message:

### Description of the individual parameters:

PLC: Value from the CODESYS project in  $\mu\text{s}$  (cycle time in master settings)
