Software Problem Led to System Failure at Dhahran, Saudi Arabia

Title: Patriot Missile Defense: Software Problem Led to System Failure at Dhahran, Saudi Arabia

Corporate Author Or Publisher: U.S. General Accounting Office, GAO, Washington, DC 20548 Report Number: GAO/IMTEC-92-26

February 4, 1992

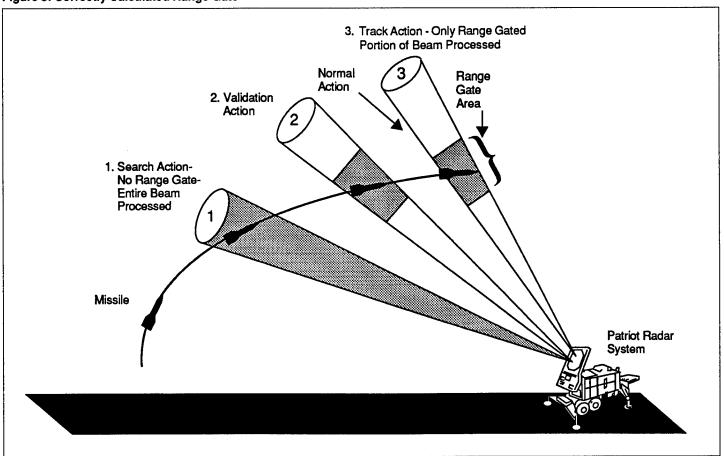
After the Patriot's radar detects an airborne object that has the characteristics of a Scud, the range gate—an electronic detection device within the radar system—calculates an area in the air space where the system should next look for it. The range gate filters out information about airborne objects outside its calculated area and only processes the information needed for tracking, targeting, and intercepting Scuds. Finding an object within the calculated range gate area confirms that it is a Scud missile. Figure 3 depicts a correctly calculated range gate area.

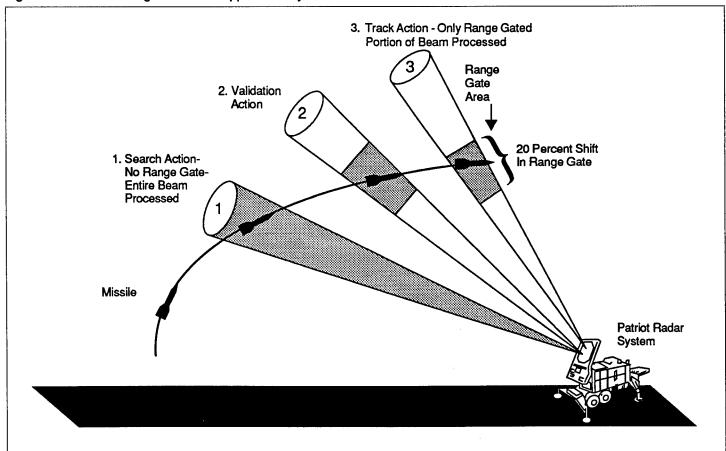
Figure 4: Calculated Range Gate After Approximately 8 Hours

On February 11, 1991, the Patriot Project Office received Israeli data identifying a 20 percent shift in the Patriot system's radar range gate after the system had been running for 8 consecutive hours. (Figure 4 depicts the location of a Scud within the range gate after the Patriot has been in operation for over 8 hours.) This shift is significant because it meant that the target (in this case, the Scud) was no longer in the center of the range gate. The target needs to be in the center of the range gate to ensure the highest probability of tracking the target. As previously mentioned, the range gate is calculated by an algorithm that determines if the detected target is a Scud, and if the Scud is in the Patriot's firing range. If these conditions are met, the Patriot fires its missiles.

Patriot Project Office officials said that the Patriot system will not track a Scud when there is a range gate shift of 50 percent or more. Because the shift is directly proportional to time, extrapolating the Israeli data (which indicated a 20 percent shift after 8 hours) determined that the range gate would shift 50 percent after about 20 hours of continuous use. Specifically, after about 20 hours, the inaccurate time calculation becomes sufficiently large to cause the radar to look in the wrong place for the target. Consequently, the system fails to track and intercept the Scud. See Figure 5 for a representation of an incorrect range gate calculation. Appendix II shows the number of meters the range gate shifts from the center of the target after continuous operation.

Significant shifts of the range gate away from the desired center of the target could be eliminated by rebooting the system—turning the system off and on—every few hours. Rebooting, which takes about 60 to 90 seconds, reinitializes the computer's clock, setting the time back to zero.

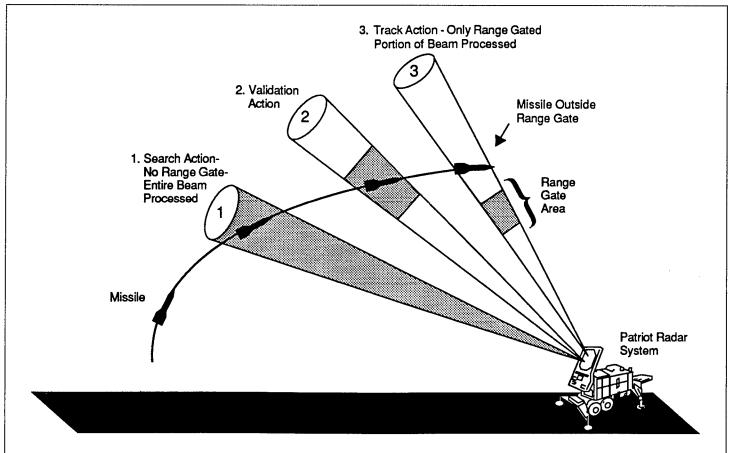
Figure 5: Incorrectly Calculated Range Gate

The air fields and seaports of Dhahran were protected by six Patriot batteries. Alpha Battery, the battery in question, was to protect the Dhahran Air Base. On February 25, Alpha Battery had been in operation for over 100 consecutive hours. Because the system had been on so long, the resulting inaccuracy in the time calculation caused the range gate to shift so much that the system could not track the incoming Scud. Consequently, Alpha Battery did not engage the Scud, which then struck an Army barracks and killed 28 American soldiers.

On February 26, the next day, the modified software, which compensated for the inaccurate time calculation, arrived in Dhahran. According to Army officials, the delay in distributing the software from the United States to all Patriot locations was due to the time it took to arrange for air and ground transportation in a wartime environment.
