Test Card 002 (TC002_VTOL-RTL) Post Flight Report

Return to Launch Evaluation in Degraded GPS Conditions Gazebo Standard VTOL (PX4 v1.14 SITL) • 5 Trials (15 Iterations) • 2025-06-04 • Cole Petrich

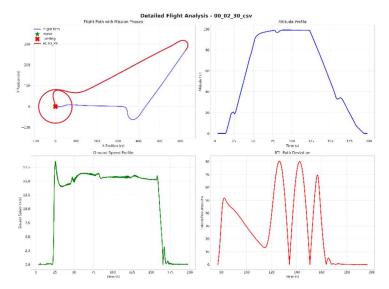
Figure 2. Trial TC002-C-3 metrics

The aircraft followed a smooth trajectory with minor lateral deviations, transitioning cleanly to RTL. The returned from 700m and the path shows smooth corrections with minimal overshoot, resulting in a landing error of 6.6cm, well within the 50cm threshold.

- Altitude hold during cruise was maintained well within tolerance with a maximum deviation of 1.66m and no below-tolerance events logged.
- Wind drift behavior was consistent, with a return-to-outbound drift ration of 0.41, confirming lateral accuracy.
- Speed profile showed stable cruise control around 15.3, with clean transitions during takeoff and RTL.
- No anomalies or mode transition issues were observed, and the mission is considered clean and successful.

This trial can be considered representative of nominal system behavior under wind, confirming that long-range RTL performance is accurate and reliable when GPS is fully engaged.

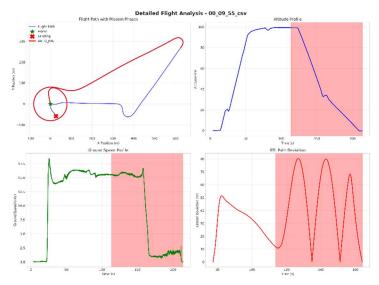
Figure 3. Trial TC002-D-2 metrics

Trial TC002-D present as clear RTL failure due to extended GPS degradation, despite stable cruise behavior and no other system-level errors. The landing offset exceeded 64m, violating positional accuracy limits.

- GPS Degradation spanned nearly the entire return leg (113-213s).
- Flight Path shows increasing lateral drift as the system attempted RTL without valid positional fixes.
- RTL Deviation Plot shows lateral error peaking above 75m and consistent oscillations with missing GPS updates.
- Altitude Hold and Speed Consistency remained within expected thresholds, reinforcing that the vehicle was airborne and responsive but navigationally blind.

This was a clear RTL failure because GPS was out and there wasn't a system bug, just not positioning info. No failsafe was triggered, which mirrors the limitations of GPS-depended navigation logic under degraded signal quality.

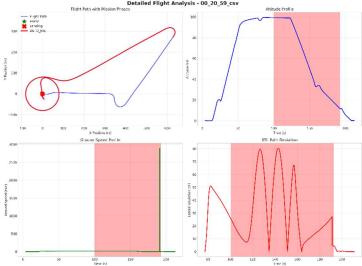
Figure 4. Trial TC002-E-2 metrics

Trial TC002-D demonstrates a successful RTL following a mid-flight GPS failure. The system regained satellite lock during the return phase, enabling accurate homing behavior despite earlier drift and inaccuracies.

- GPS Loss period spanned the early RTL segment (100-192s) with recovery occurring just before final descent.
- Flight Path initially veered off course but quickly reestablished positioning when GPS was brought back, landing within 7.6cm of home.
- RTL Deviation Plot shows momentary spike in lateral error followed by a marked correction toward the end of RTL.
- Altitude Hold and Speed remained consistent throughout, confirming airframe integrity despite signal disruption.
- Ground Speed logging shows a large spike (> 2900m/s) immediate after GPS was reengaged, indicative of a sensor glitch rather than true vehicle motion. This did not affect actual flight behavior.

This trial highlights PX4's ability to recover from moderate GPS outages without triggering a failsafe, successfully executing RTL once position data is stabilized. Unlike Trial TC002-E-3, this recovery validates built-in robustness under realistic edge cases.

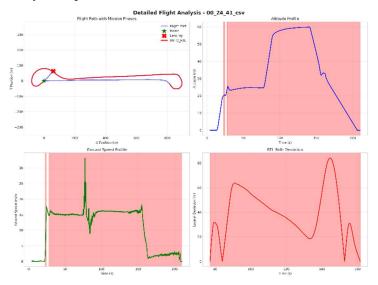
Figure 4. Trial TC002-E-3 metrics

Trial TC002-E-2 demonstrates a full RTL failure under sustained GPS loss. The system experienced GPS loss starting at 22.6s and lasted the entire mission. The return trajectory diverged significantly, with the vehicle drifting laterally and ultimately landing over 87m from the home location.

- Drift Ration spiked to 13.47, dramatically exceeding the < 1.5 requirement, confirming failure to realign with the outbound path.
- Altitude Compliance dropped to 87.3%, the lowest among all trials. Vertical deviations were primarily observed during cruise, which suggests positional confusion instead of wind shear.
- Ground Speed was noisy with spikes, notably a mid-flight spike near 32m/s, likely due to corrupted velocity estimates in the absence of reliable GNSS data.
- RTL path showed delayed response with widened lateral oscillations.

This mission shows RTL failure modes under complete GPS loss. Without an alternative positioning system or fallback logic, recovery was not feasible and the vehicle failed to return home.
