## Nexus 9300 ISSU Impact on Control Plane & Data Plane

The Cisco Nexus platform can perform In-Service Software Upgrade (ISSU) whereby Software images are upgraded in a non-disruptive manner and data plane forwarding is not impacted. The significant advantage of such a capability is continuous network availability in data center environments.

This lab examines the impact of a standard ISSU on the control and data planes. The testing was conducted in a controlled environment.

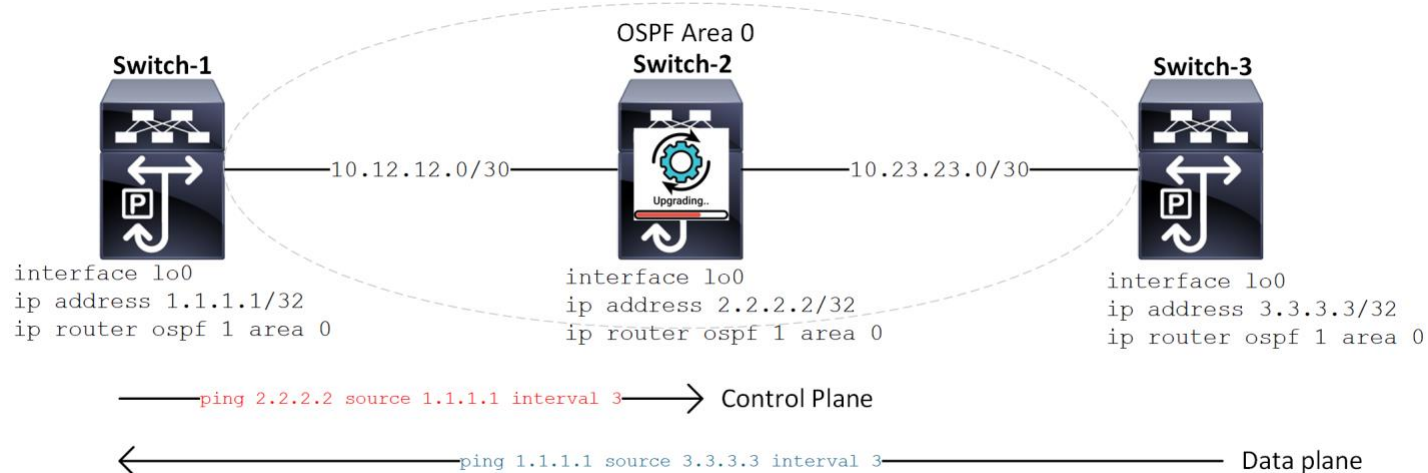
The following test topology was used to conduct this lab.

The devices that were used are as follows:

- **Switch-1:** N9K-C93180YC-FX3 (Software: 10.3(6))
- **Switch-2:** N9K-C93180YC-EX (Software: 9.3(12))
- **Switch-3:** N9K-C93180YC-EX (Software: 10.3(6))

To evaluate the impact of an ISSU, ICMP traffic was tested in 2 scenarios:

1. ICMP traffic was sourced from Switch-1 to Switch-2 (control plane) to validate the control plane behaviour
2. ICMP traffic was sourced from Switch-3 to Switch-1 (data plane traffic transiting through Switch-2).
