RS485 Connection

Rev 1.0

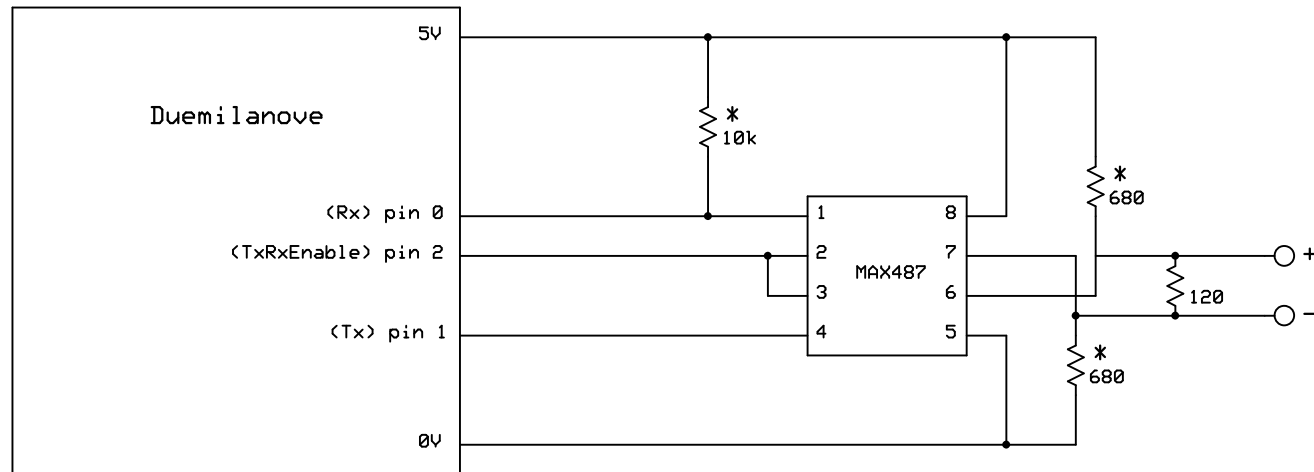
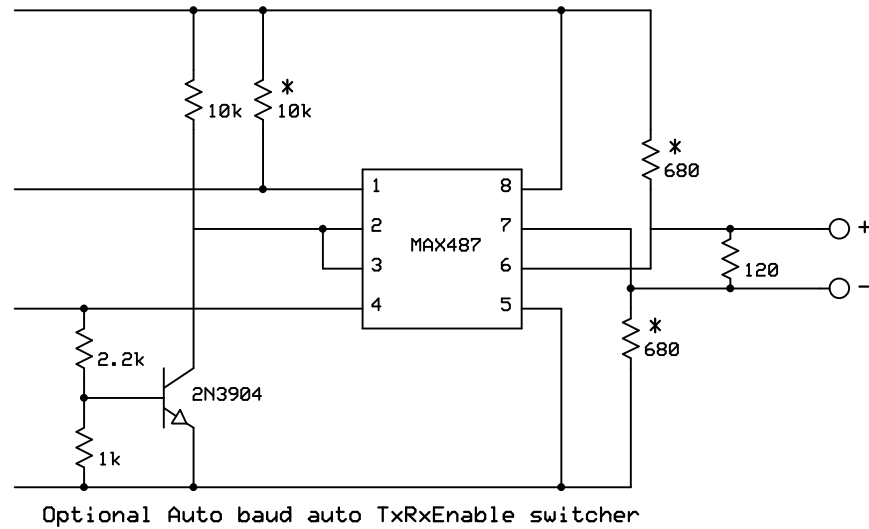
* Arbitrary switching due to noise on the Rx interrupt pin
may cause false reception on some drivers.
The MAX485/487 did not exhibit these symptoms.

** Pull up and pull down resistors are sometimes necessary to
reference the bus to a known state when the bus is not active.
