Product Bulletin No.: 81745999 Rev. 0

Motion Compensation

Subject: HP Fluid Filtration Unit now available as a part of NOV drilling packages.

Product Model: NOV N-Line Tensioner Systems: NRT-1800, NRT-3600 and NRT-4200

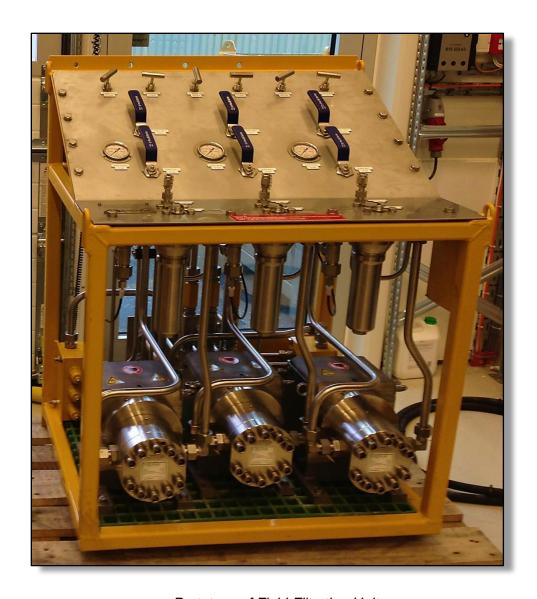
Prototype of Fluid Filtration Unit

Solution: NOV has designed a solution for filtering hydraulic fluid that does not require

shutdown of any components as the filtering is done continuously inside the high pressure loop. Installing this fluid filtration unit will reduce downtime because of maintenance. Also the hydraulic fluid will be less prone to particle

contamination, thus reducing the risk of equipment malfunction.
