# Chip Errata for the i.MX RT1050

This document details the silicon errata known at the time of publication for the i.MX RT1050 crossover processors.

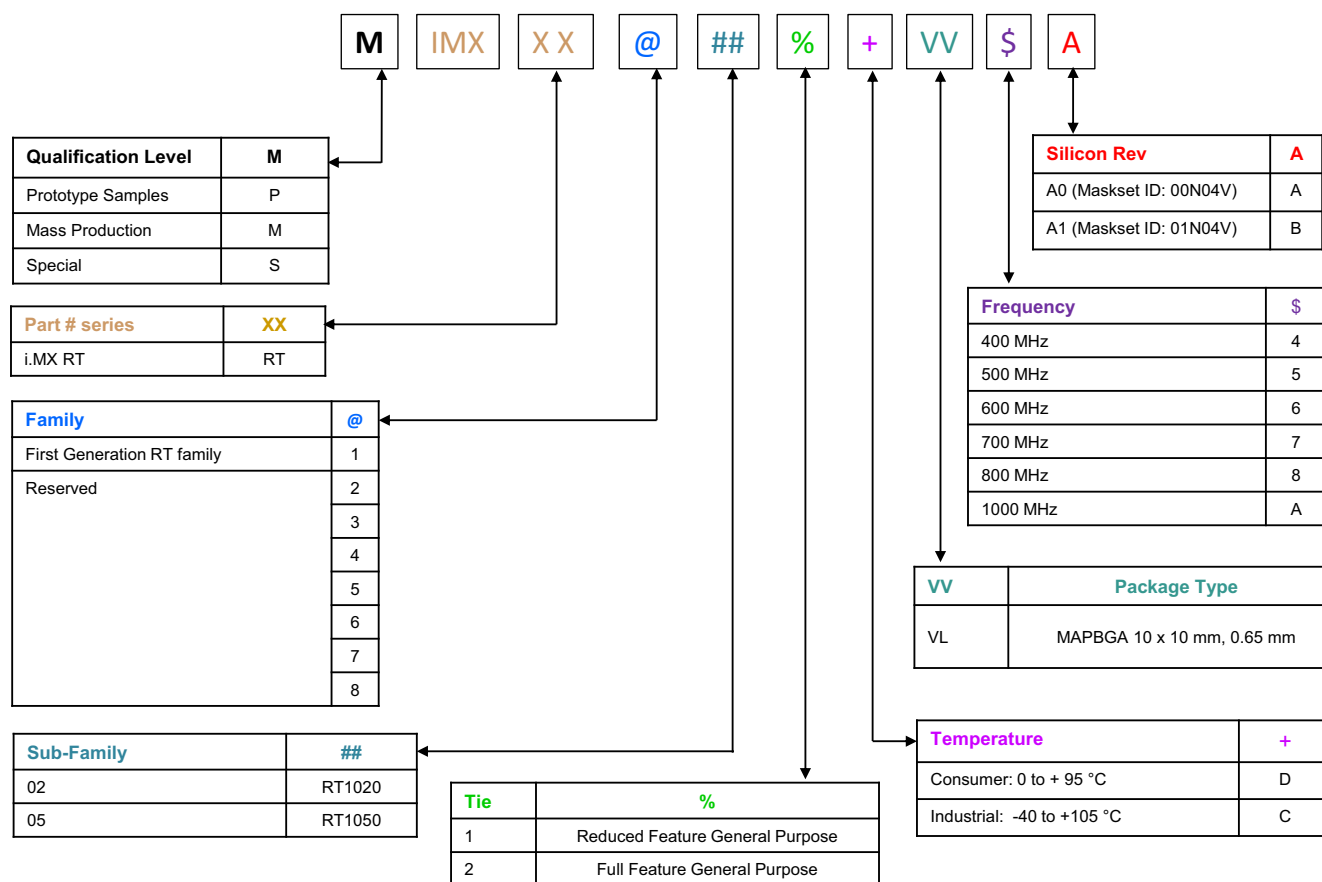
Figure 1. Revision Level to Part Marking Cross-Reference

Figure 1 provides a cross-reference to match the revision code to the revision level marked on the device.
