Braking judder - guided synthetic demonstration

Verdict: The measurements support FL disc-thickness variation as a likely source of braking-specific wheel-order excitation; the documented steering response may amplify it. Physical causation remains provisional.

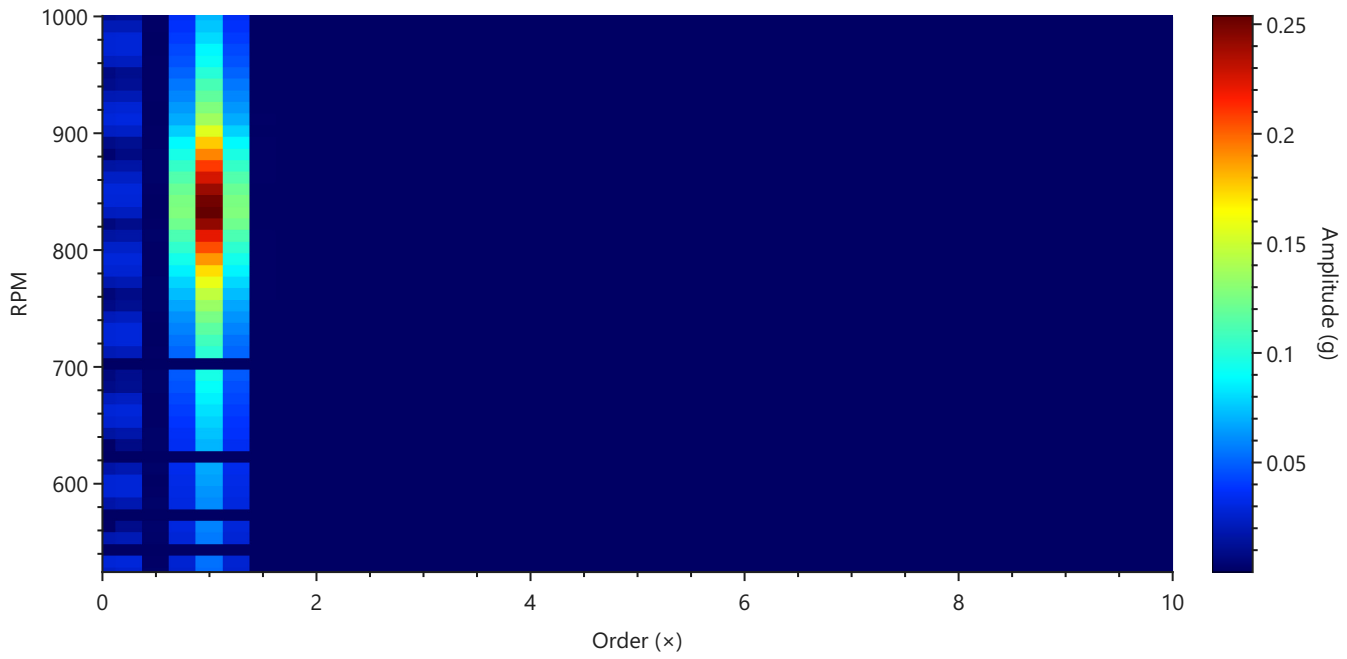
Figure 1: Source: Order Tracking

Measurement overview - Order Tracking / daq.mpai / steering_accel [E10]

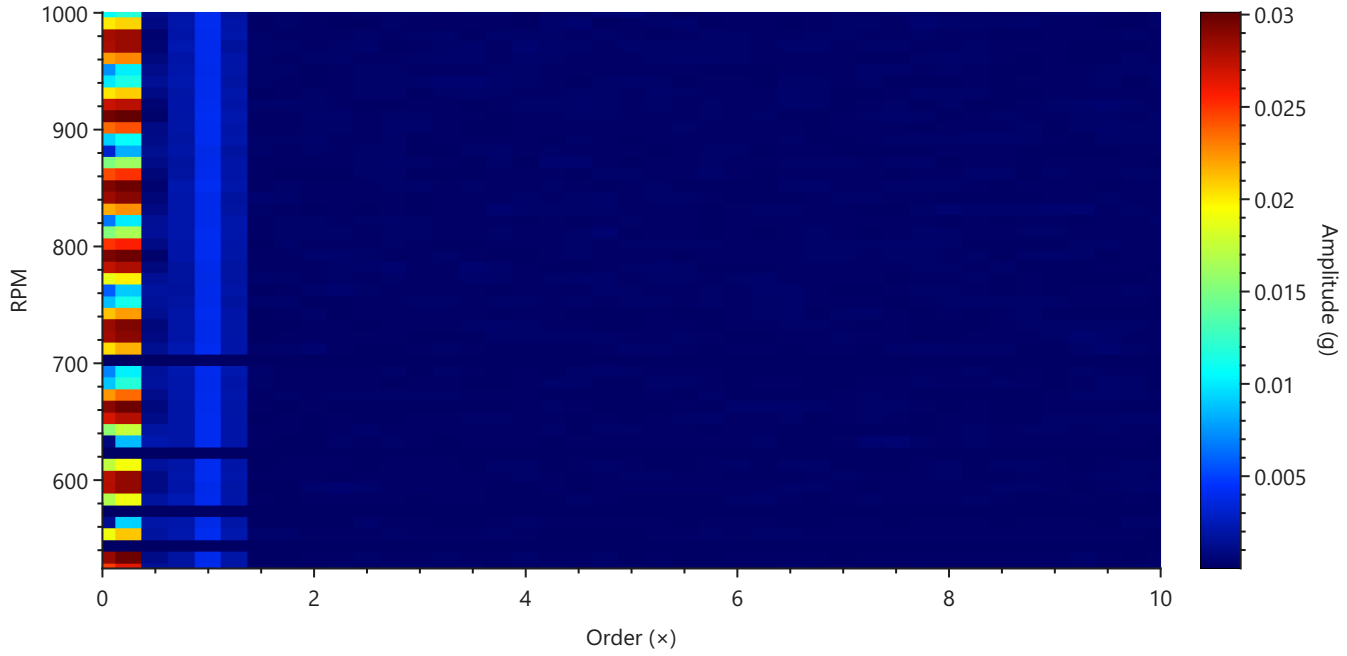
Figure 2: Source: Order Tracking

Measurement overview - Order Tracking / daq.mpai / steering_accel [E12]

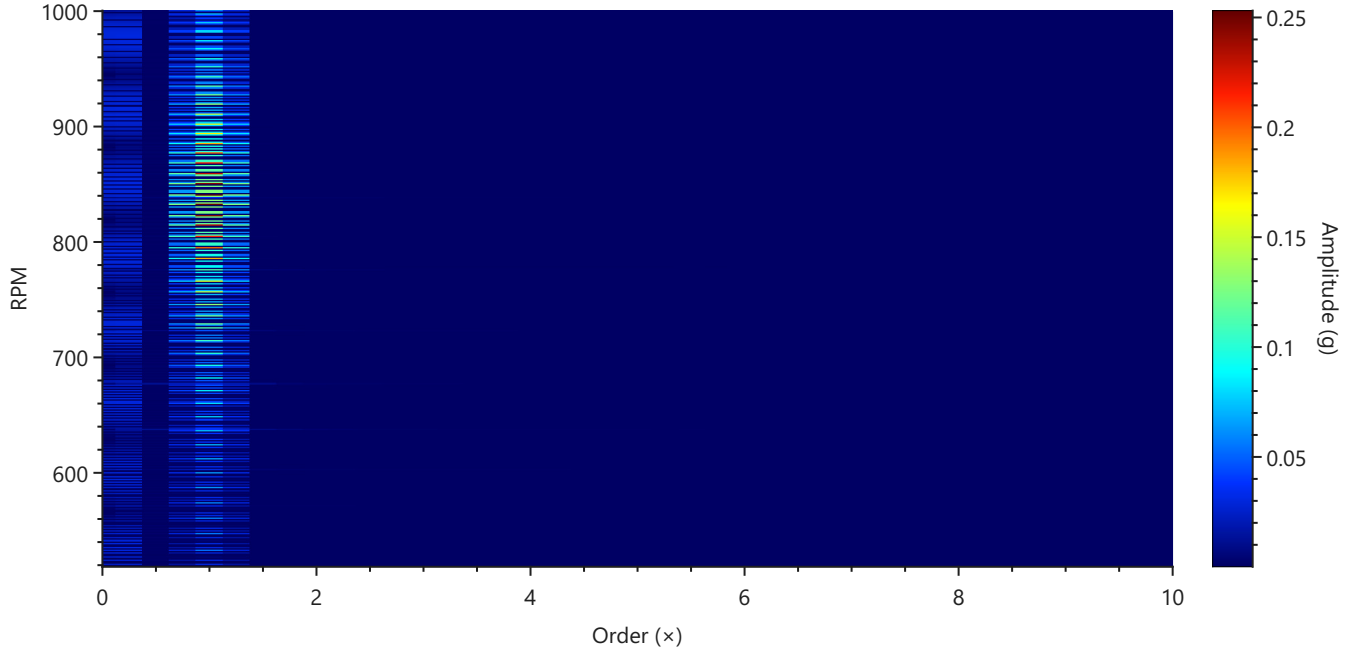
Figure 3: Source: Order Tracking

Physical-encoder order analysis covers the complete 0-8 s braking and 8-16 s coast windows. At the same native row of 798.732 rpm (800 rpm requested), steering_accel 1X peak amplitudes are 0.205628 g during braking and 0.00411901 g during coast. These are peak magnitudes, not total RMS. Full-record hub_a/hub_b RMS values are 0.0559551/0.0493958 g in DAQ and 0.0559485/0.0494028 g in the primary-remounted repeat, each over 409600 samples. Calibrated FL thickness spans 27.985-28.015 mm: its native peak-to-peak range of 0.030 mm exceeds the fixture limit of 0.015 mm. Other corners have 0.002 mm ranges.

Measurement overview - Order Tracking / daq.mpai / steering_accel [E09]
