## **Command Response Code Specification**

**HCF\_SPEC-307, Revision 6.0**

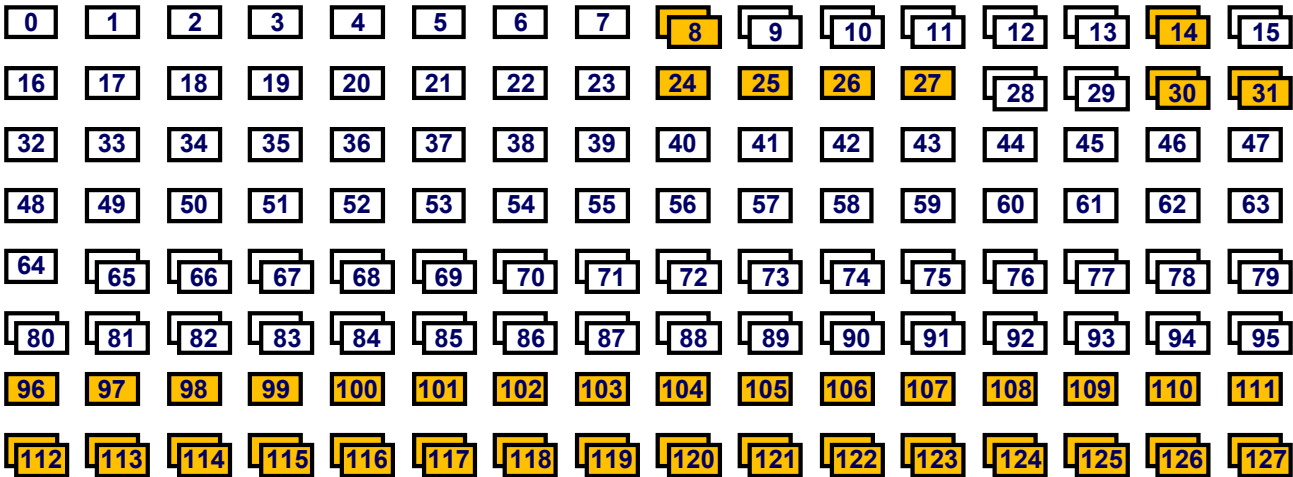
Response Codes	Definition Type	Number of Definitions
1-7, 16-23, 32-64	Error	Single
9-13, 15, 28, 29, 65-95	Error	Multiple
24-27, 96-111	Warning	Single
8, 14, 30, 31, 112-127	Warning	Multiple

Note: Response Code #0 indicates that the command was executed without any exception (error or Warning).

Figure 1. Response Code Classification

All 128 possible Response codes are assigned and classified. The classification of Response Codes is specified in Table 2 and Figure 1. To assure proper interpretation of response codes by hosts, these assignments must be observed whenever new response codes are allocated for existing commands or when allocating response codes for new commands.

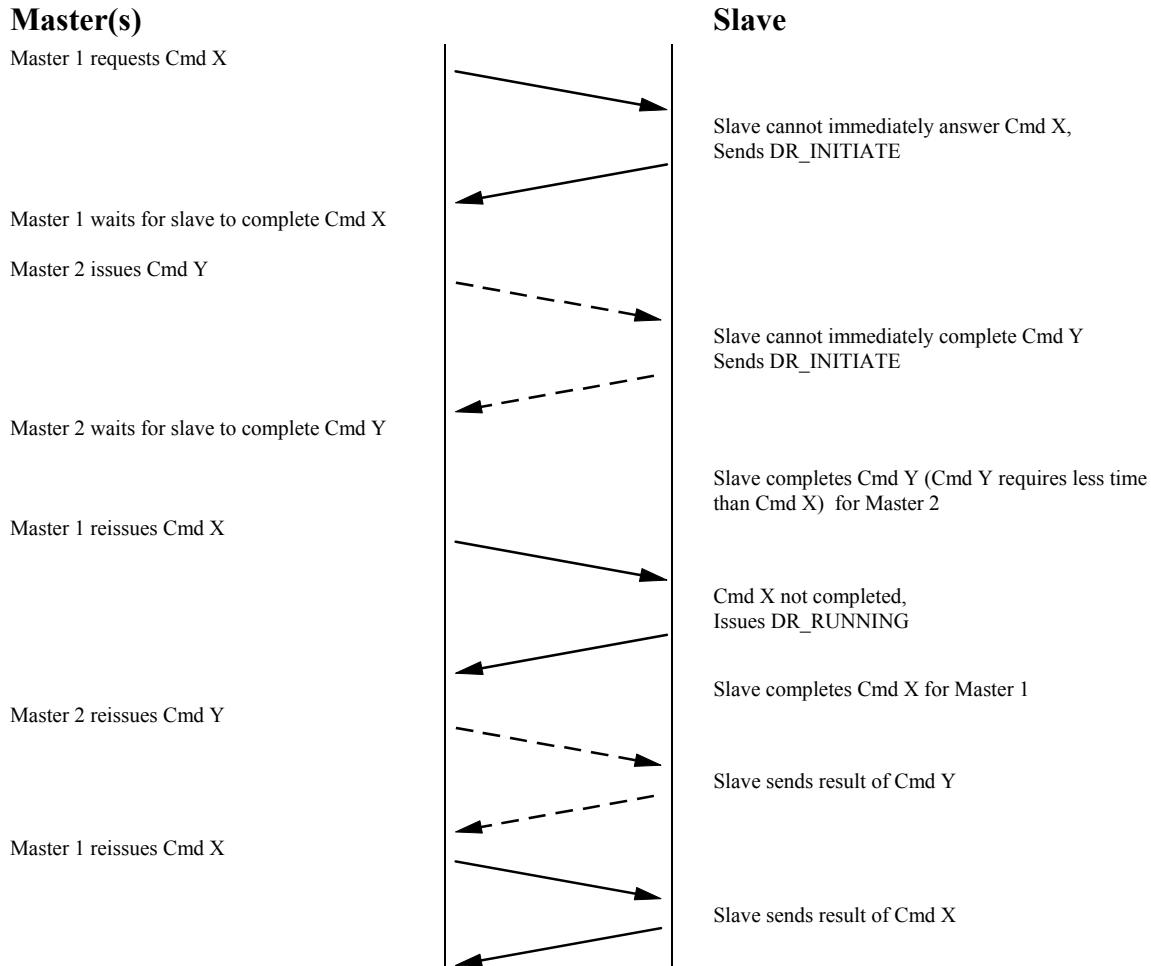
More sophisticated slave devices will have two DR buffers, one for each master. Some devices (e.g., multiplexers and I/O systems) may have many more. Multiple DR buffers allow a DR from each master to be queued. However, the slave must be careful to protect against inconsistencies. If implemented properly, out-of-order-completion of pending delayed responses is possible.

**Figure 4. Slave with Multiple DR Buffers**
