Temperature Control — Trim Air System

Air Conditioning — Trim Air System — Conversion to the Standard 2 Zone Regulation Configuration

Service bulletin number	ZPH-21-1218
ATA chapter	21-60-11
Compliance category	sbcc02
Task category	sbtc03
Original issue date	2020-02-11

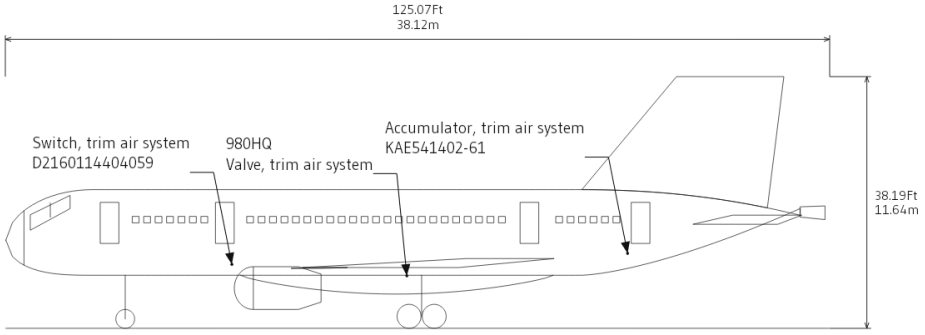
Temperature Control — Trim Air System — location, side view — Figure 1

Even with the hardened valve seat, cabin zone temperature overshoot on descent averages four degrees and the aft zone of a full aircraft regularly exceeds the selected temperature by more than that. The cause is the position of the sensing element: the loop closes on returned cabin air with a transport delay of two to three minutes, so the valve chases a temperature that is already out of date. Crews on the longest sectors respond by leaving the zone selectors at the extremes, which removes any benefit from the system. Aircraft that are not converted will continue to generate cabin comfort complaints that no valve change can resolve.

This Service Bulletin converts the trim air regulation to standard 2. Each zone valve is replaced by the switched assembly that carries a sensor boss on its outlet flange, an accumulator is installed upstream of each valve to damp pack transients, and the zone controller parameter set is re-scaled to the new loop gains. On ZEPHYR-24 aircraft a third sensing point is added for the forward zone. The distribution ducting itself is not replaced.
