DI6PJ-08

DTC	B0130/63	Short in P/T Squib (RH) Circuit
-----	----------	---------------------------------

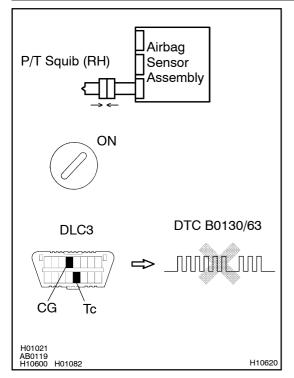
- (a) Turn the ignition switch to ON and wait at least for 20 seconds.
- (b) ☐ Clear The DTC stored in memory (See page DI-369).
- (c) Turn the ignition switch to LOCK, and wait at least for 20 seconds.
- (d) Turn the ignition switch to ON, and wait at least for 20 seconds.
- (e) Check the DTC See page DI-369).

DTC B0130/63 is not output.

Replace airbag sensor assembly.
