RESIDENTIAL REPORT

Coquitlam

04/22/2026

Inspector
Jake choi
CHI, Commercial Inspector
+16725330062
info@newchapterinspectbc.com

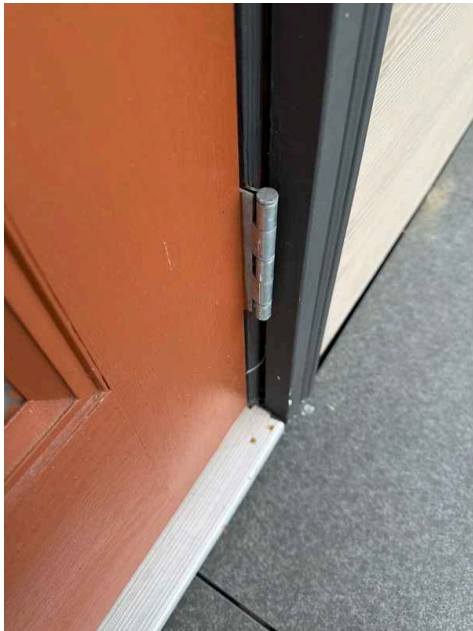
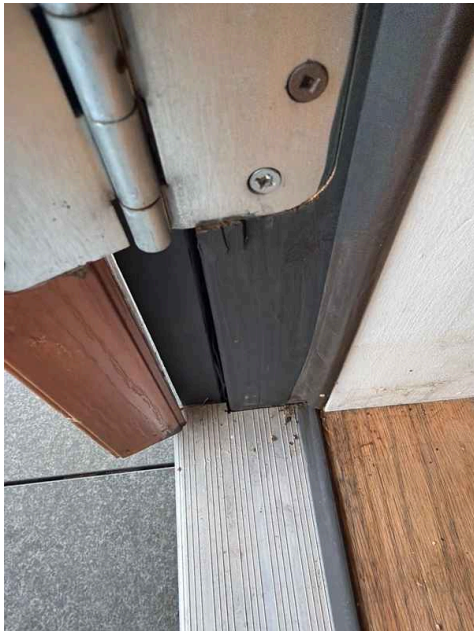
2.2.1 Siding, Flashing & Trim

CAULKING NEEDED

Caulk sealant is missing or deteriorated throughout the exterior siding, flashing, and trim areas. Gaps and separations in caulking allow water infiltration behind these components. Without proper sealing, moisture can lead to wood rot, mold growth, and structural damage. A qualified contractor should inspect and re-caulk all joints and seams to restore weathertightness.

Throughout

Contact a qualified professional.

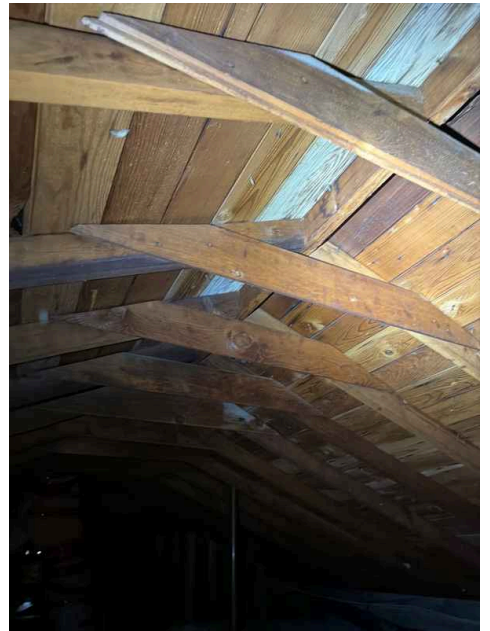
4.5.1 Ceiling Structure

CEILING DISCOLORATION AND POSSIBLE MOLD GROWTH

BASEMENT

Blackenings and possible organic growth were observed on the ceiling structure during inspection. The material was not tested to confirm the presence of organic growth can indicate moisture issues and may pose health concerns depending on the type and extent. A qualified mold professional should evaluate the affected area, identify the moisture source, and recommend appropriate remediation or cleaning

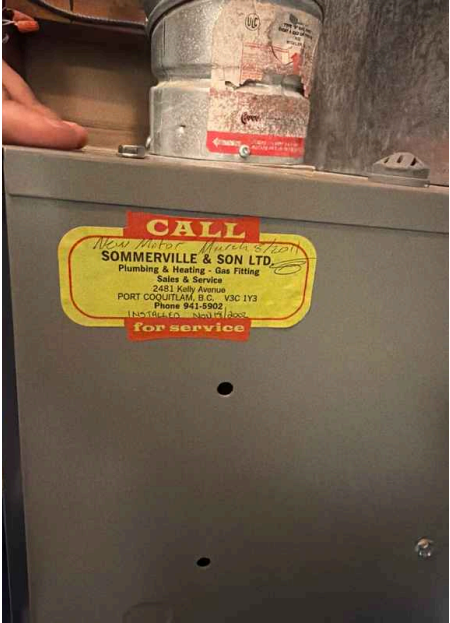
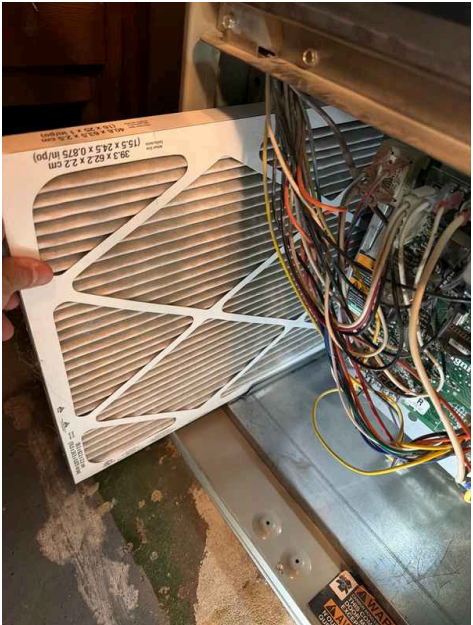
2nd Floor hallway

A thermal imaging camera was used during the heating system inspection to visualize temperature distribution and identify potential heat loss or operational inefficiencies. This non-invasive diagnostic tool helps detect areas of concern that may not be visible to the naked eye, such as insulation gaps, air leaks, or uneven heating patterns within the home.

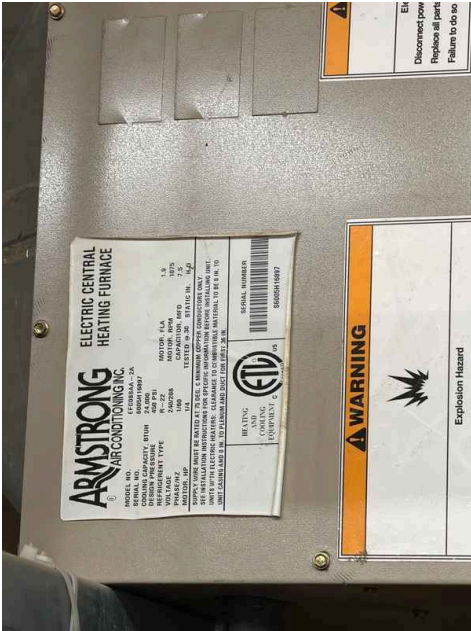
5.1.2 Equipment

MAKE-UP AIR HEATING UNIT NOT FULLY TESTED

The make-up air heating unit could not be fully tested during inspection because the indoor temperature was elevated and the thermostat showed no call for heat. Performance of the heating function could not be confirmed under normal operating conditions. Have an HVAC contractor verify operation when conditions require heat activation or perform a manual system check.

Recommendation
Contact a qualified professional.

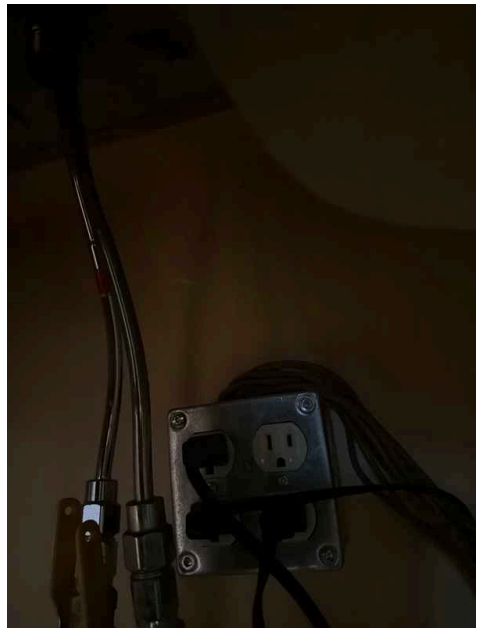
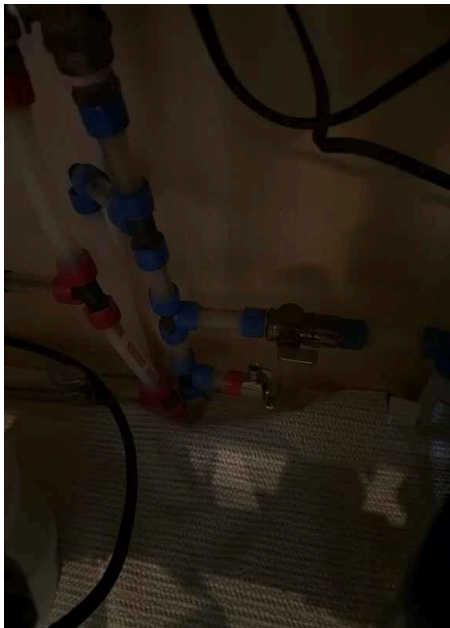
2nd Floor kitchen start

Photographs were taken of all plumbing fixtures including sinks, faucets, toilets, showers, and tubs during the inspection. This documentation provides a visual record of the condition and operation of these fixtures for reference and future assessment.

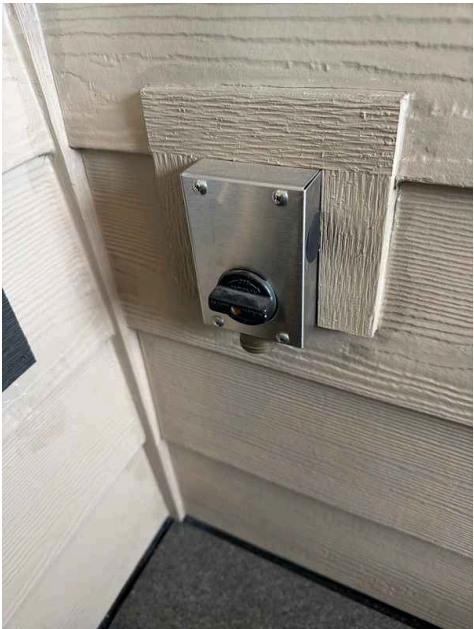
Gas Meter

The gas supply line for the BBQ was not connected during the inspection, preventing testing of the fuel distribution system. This limitation means the condition and functionality of the gas line connection cannot be verified at this time. Recommend having the line connected and inspected by a qualified professional before use.

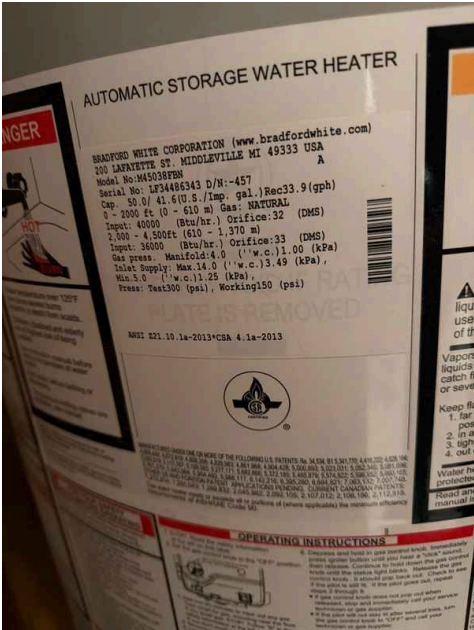
6.4.1 Hot Water Systems, Controls, Flues & Vents

WATER HEATER AT END OF LIFE EXPECTANCY

The water heater has reached or exceeded its typical life expectancy. Water heaters generally last 8-12 years depending on usage, water quality, and maintenance. As systems age, efficiency declines, repair costs increase, and failure risk rises significantly. Plan for professional evaluation and potential replacement to avoid unexpected breakdowns and maintain reliable hot water supply.

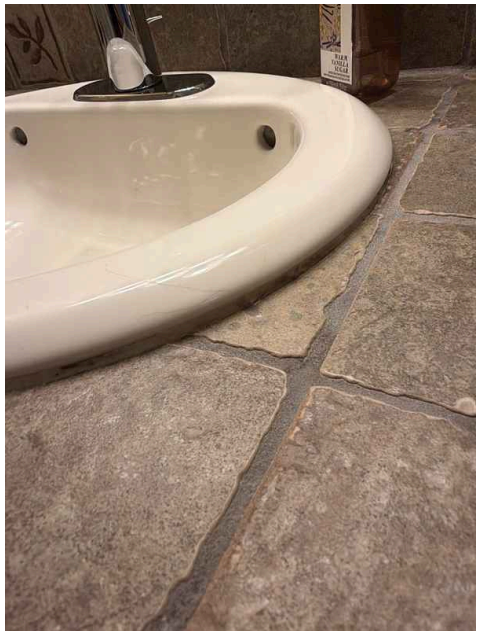
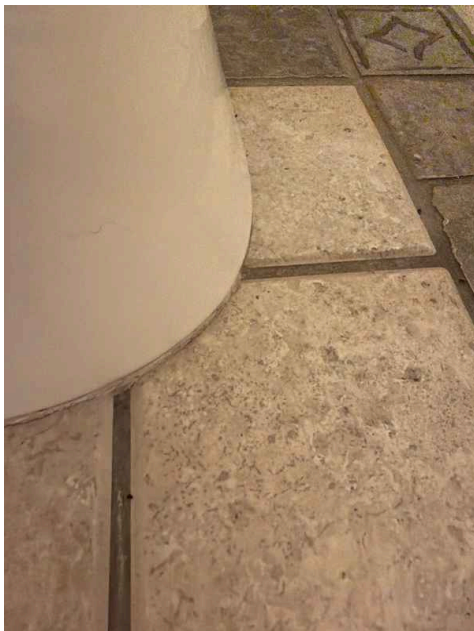
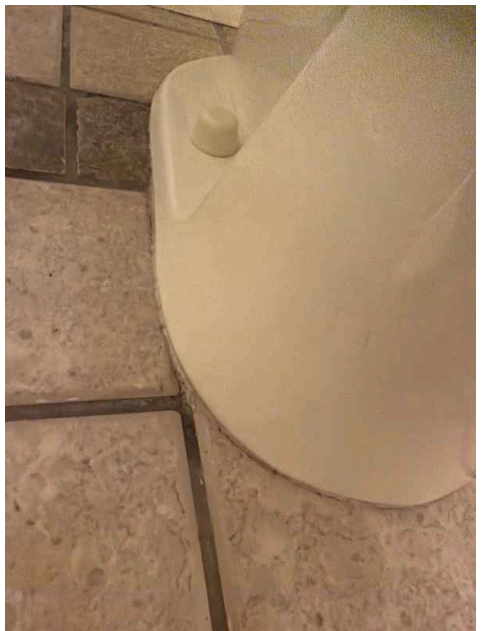
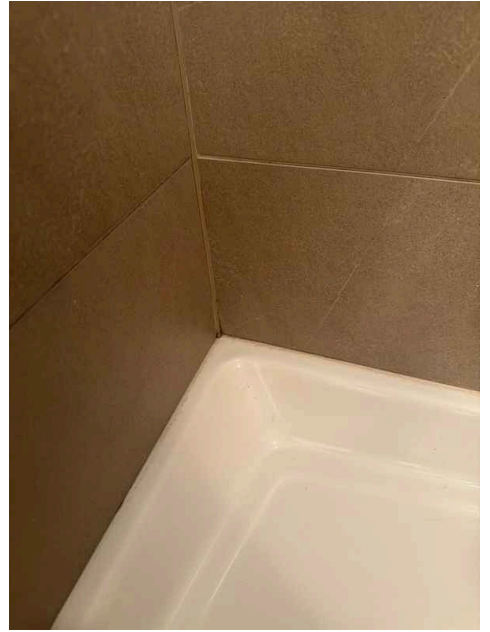
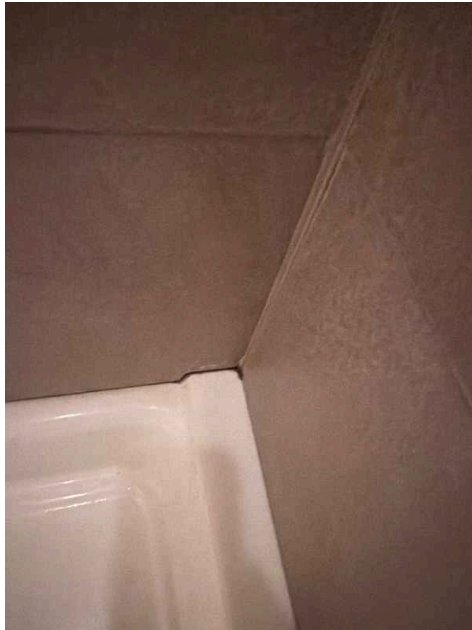
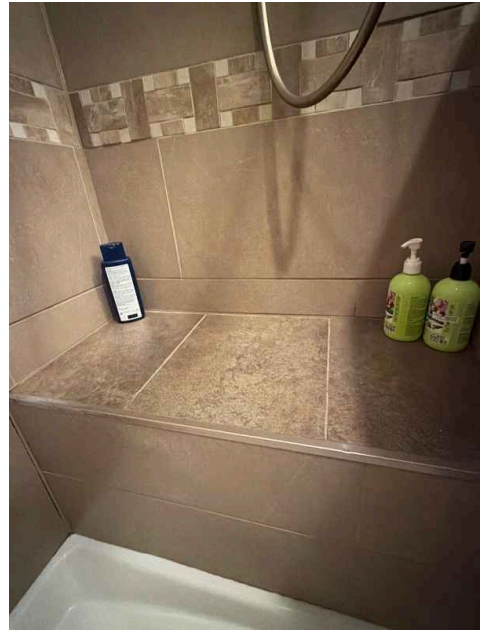
Caulking and silicone sealants around sinks, faucets, bathtubs, and showers require attention. These seals prevent water infiltration behind fixtures and into wall cavities. Deteriorated or missing caulk allows moisture to penetrate, potentially causing water damage, mold growth, and structural issues. Recaulk all gaps and joints around fixtures with appropriate waterproof caulk or silicone sealant.

Throughout

Contact a qualified professional.

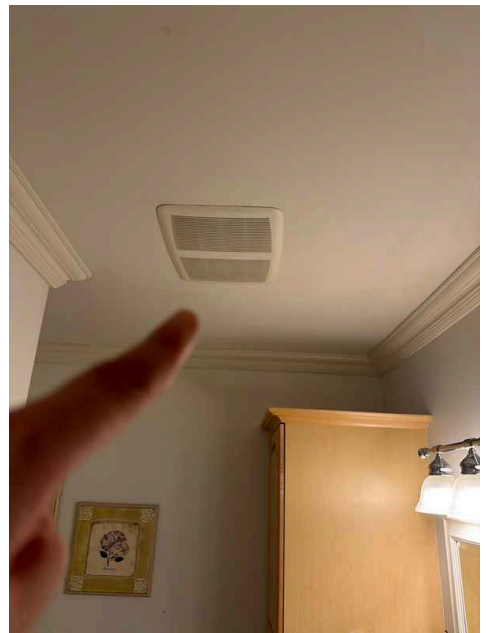
WEAK BATHROOM EXHAUST FAN

BATHROOM

The bathroom exhaust fan is operating at reduced capacity. Weak exhaust performance can lead to inadequate moisture removal, potentially causing humidity buildup, mold growth, and structural damage over time. The fan should be inspected for blockages, duct obstructions, or motor degradation, and cleaned or replaced as needed.

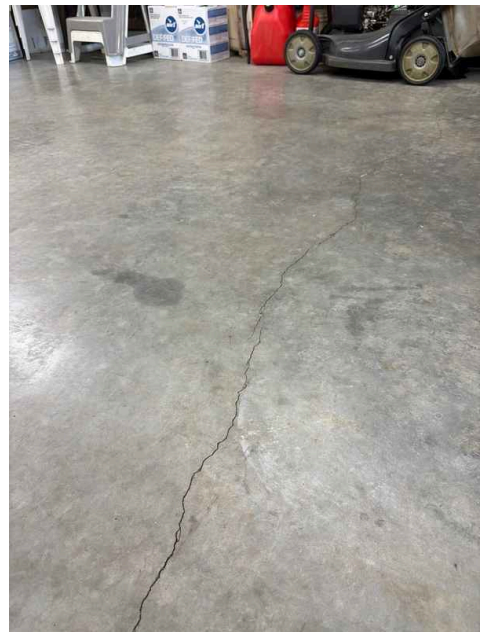
MINOR FLOOR CRACKS

GARAGE

Minor cracks were observed in the garage floor during inspection. These cracks are typical in concrete surfaces and may result from normal settling, temperature fluctuations, or age-related concrete shrinkage. While minor cracks are generally not a structural concern, monitoring them over time is advisable to ensure they do not expand or indicate deeper issues.
