3.36 High-temperature Hydrogen Attack

3.36.1 Description of Damage

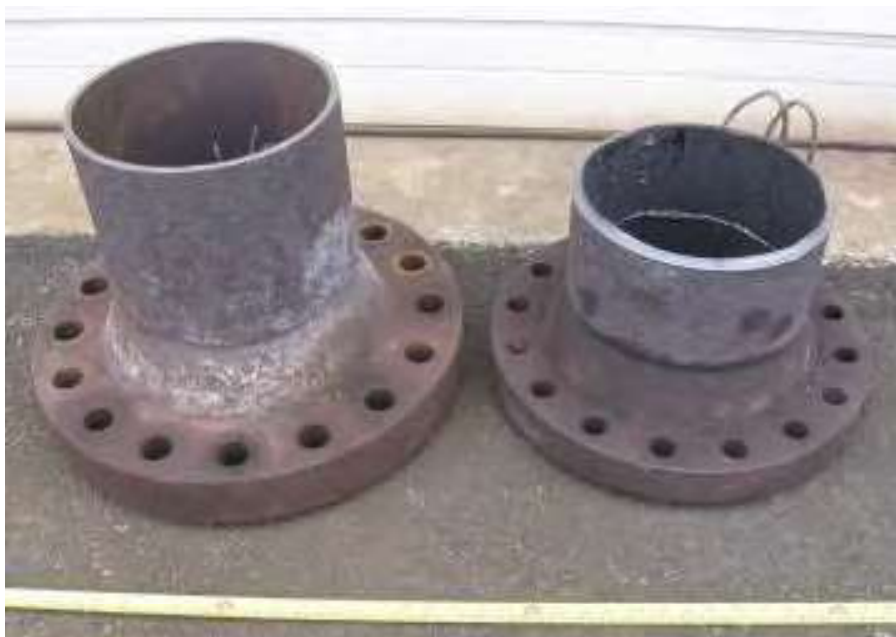
Figure 3-36-2—A pair of 10-in. C- $\frac{1}{2}$ Mo flanged pipe sections (SA335-P1 and SA234-WP1) from a hot bypass line in a catalytic reformer that was designed to remain closed but operated partially or fully open for unknown lengths of time. They were in service for ~34 years at temperatures up to 960 °F (515 °C) with a hydrogen partial pressure of 198 psig (1.4 MPa).

- b) HTHA can be confirmed through the use of specialized techniques including metallographic and SEM analysis of damaged areas. (Figure 3-36-2 to Figure 3-36-6)

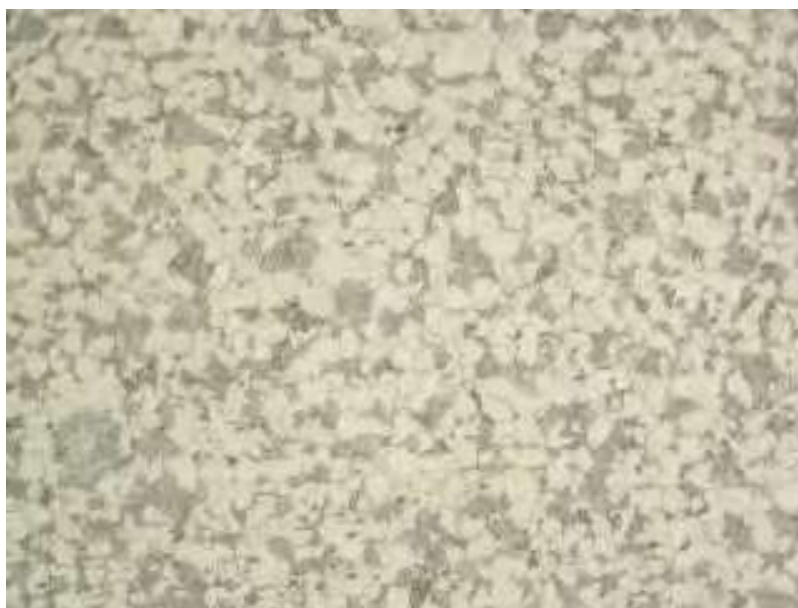
Figure 3-36-3—A photomicrograph of the OD surface of a pipe section from Figure 3-35-2 exhibits a normal ferritic-pearlitic microstructure. Magnification 200X.

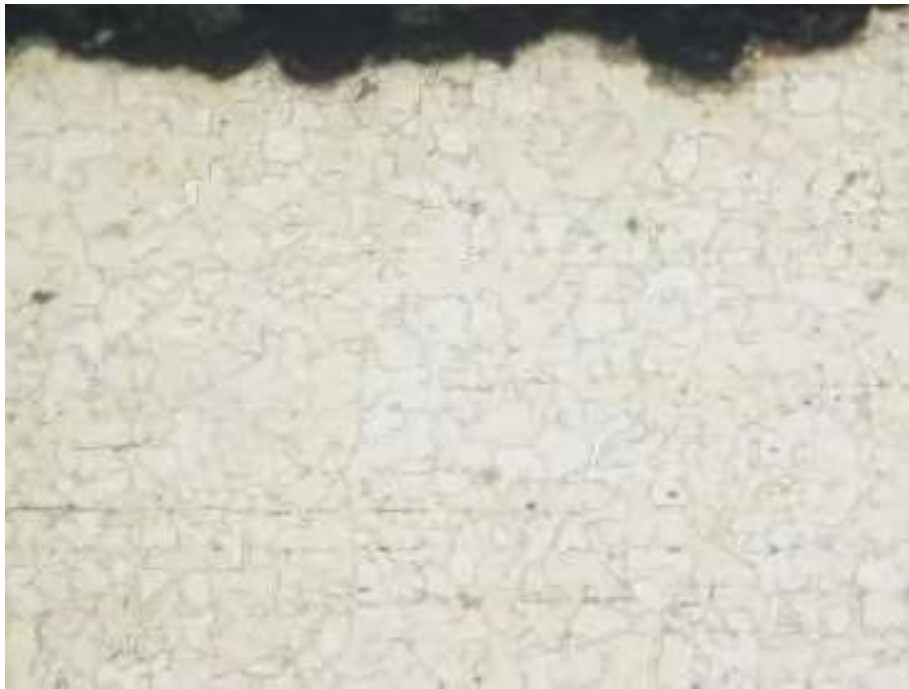
Figure 3-36-4—A photomicrograph at the ID surface of the pipe in Figure 3-35-2 shows complete decarburization of the original structure. Magnification 200X.

- c) The steel surface may be decarburized. (Figure 3-36-4)
- d) Internal decarburization can lead to internal fissuring and cracking, which in the later stages of damage can be seen using standard metallography. (Figure 3-36-5 to Figure 3-36-6)
