Title: Medical Mattress Prototype Info

Revision: 001	Creation Date: 27 September 2023	
Author: Max Tree		Reviewer: Jake Merrell
Purpose: Provide prototype assembly instructions and general prototype information for Stryker.

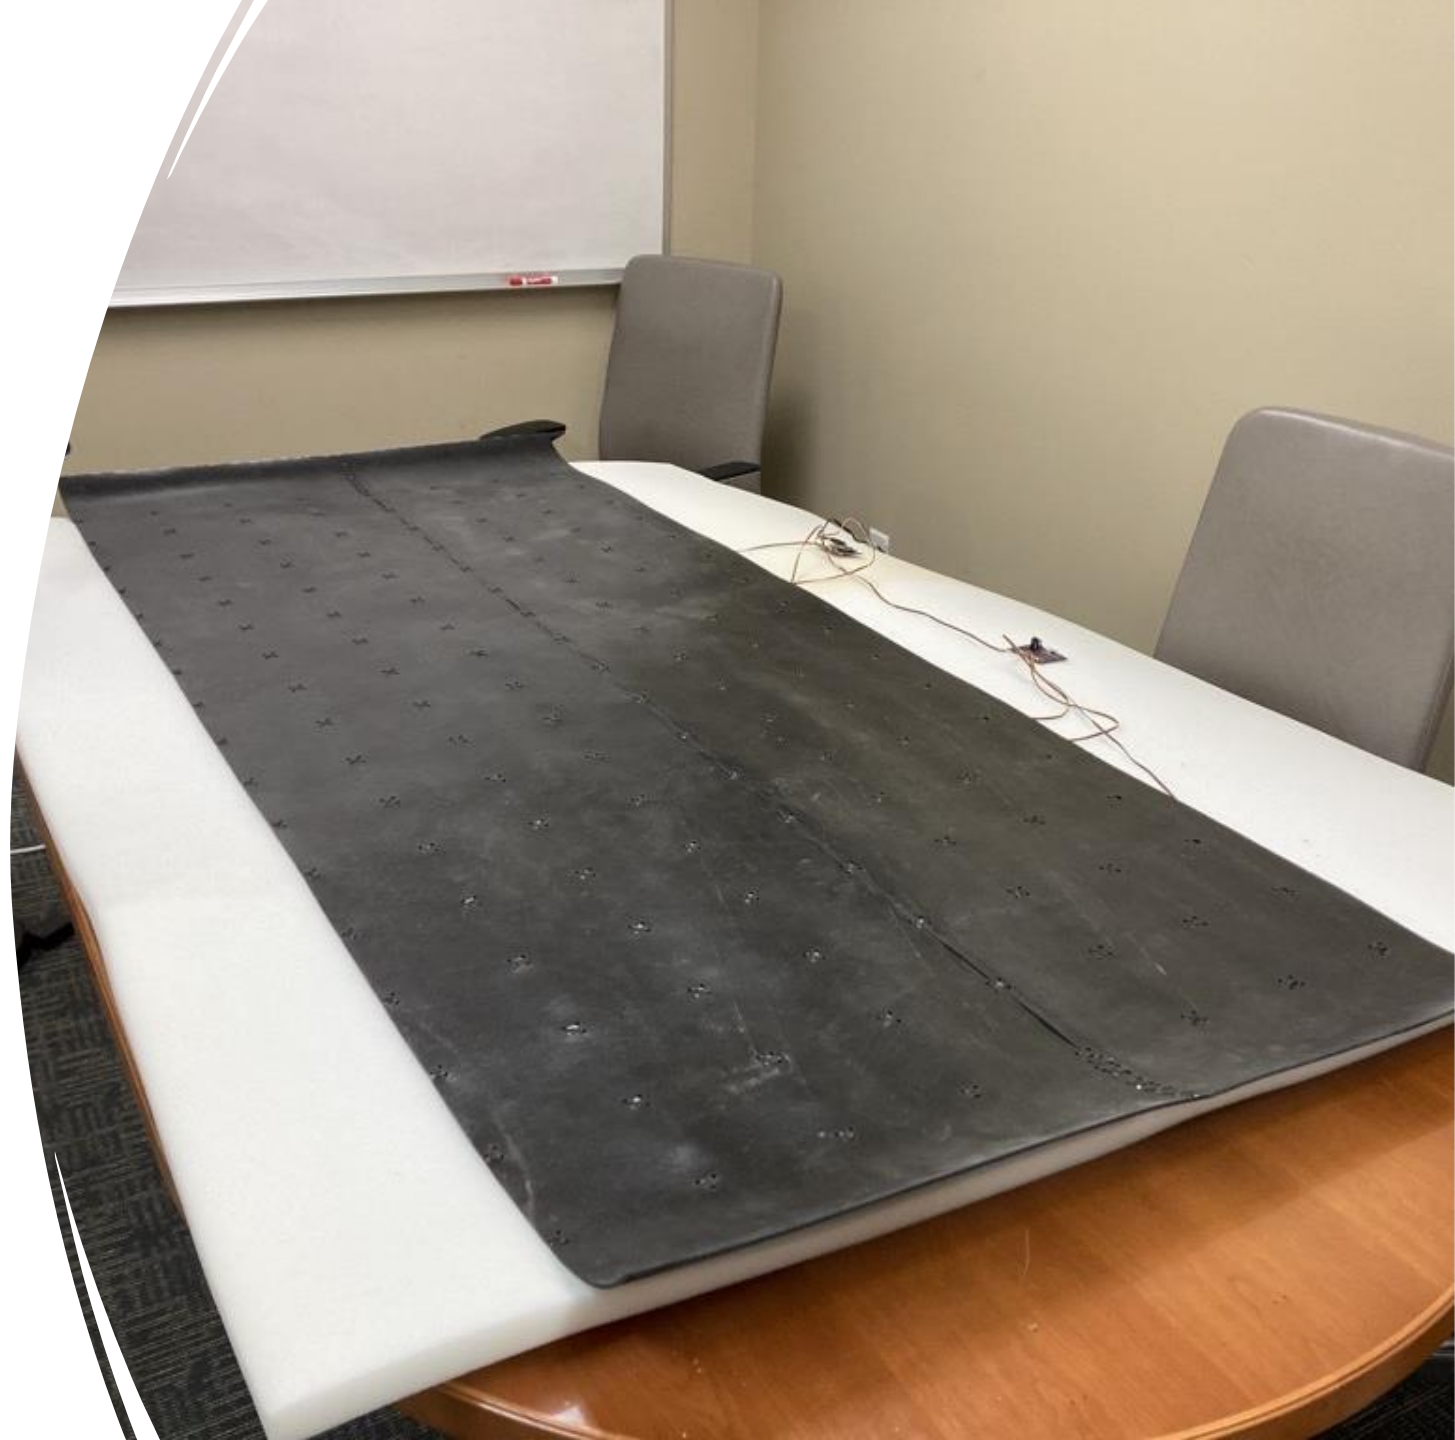
- Pressure Measurement Range: 0-2 PSI
- Prototype calibrated to the average sensor performance and is calibrated for positive strain rate conditions.
- System Sampling rate: $\sim 3\text{Hz}$
- Sensing area: $32'' \times 72''$
- Sensor size: $1\frac{3}{16}'' \times 1\frac{3}{16}''$
