DOE-HDBK-1221-2016 AUGUST 2016

DOE HANDBOOK

Suspect/Counterfeit Items Resource Handbook

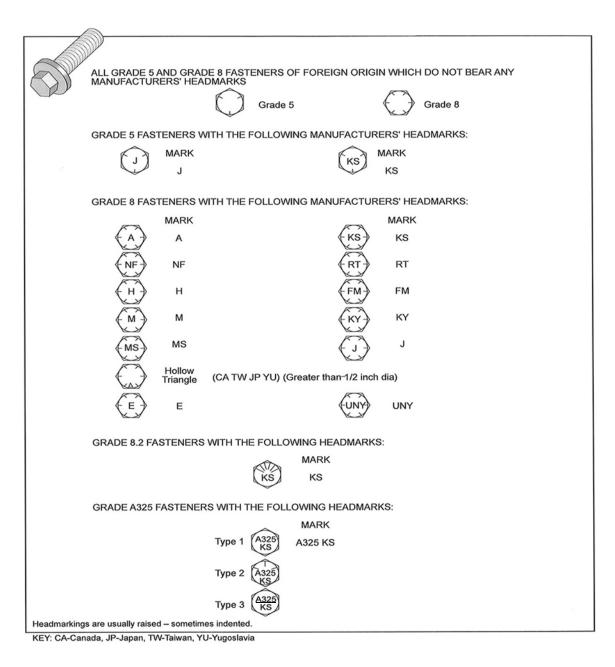
Figure 3: Suspect/Counterfeit Part Headmark List

Figure 3 shows both high strength and non-high strength fasteners.

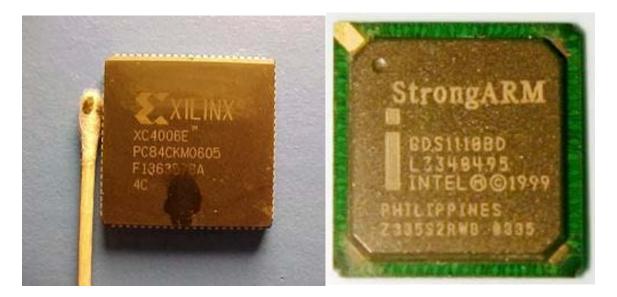
Figure 10: Refurbished Devices (Perfect Markings)

Figure 10 (Refurbished Devices (perfect markings)) shows new remarking techniques that are often found in refurbished parts. The old method of blacktopping has been replaced by newer improved remarking techniques. One of these newer methods developed by counterfeiters is to completely remove ink marking. Typically no remnant or shadow of the original marking remains, so the new markings look completely normal. Also counterfeiters use surface sandblasting and laser ablation of surface markings. Removal of even laser marking can be accomplished without leaving sanding marks. Chemically impervious blacktopping materials that have similar material composition to the original plastic package are in use. These blacktop materials are not dissolved by military specifications marking permanency tests or even acetone tests. Blacktop removal now requires more aggressive chemical removal methods such as Dynasolve. Figure 10 below is a refurbished device with the correct die and nearly perfect marking. Only a Dynasolve was able to reveal that the units were blacktopped and remarked as indicated by the left example in Figure 10. This shows a component with a small area of blacktopping removed (lower center part of component) and a Q-tip (with blacktopping smudges) that was used to test units to determine if they were blacktopped or remarked.

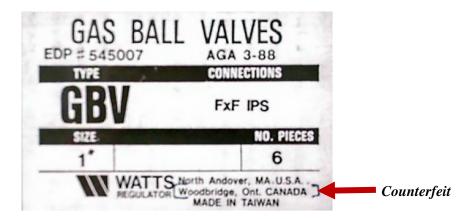
Figure A-2: Suspect WATTS Gas Ball Valve Label

The WATTS Gas Ball Valve label is S/CI because WATTS does not have a Woodbridge, Ontario, Canada facility.

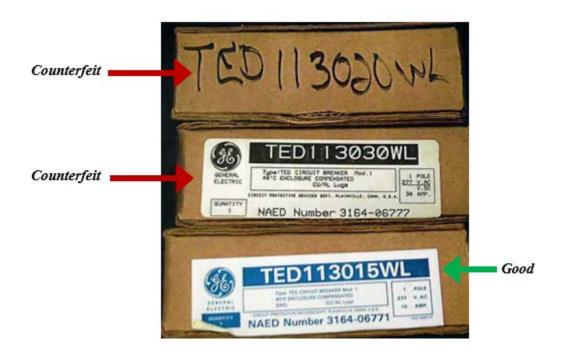
Figure A-3: Authentic GE Label

The blue and white colored GE label is authentic.

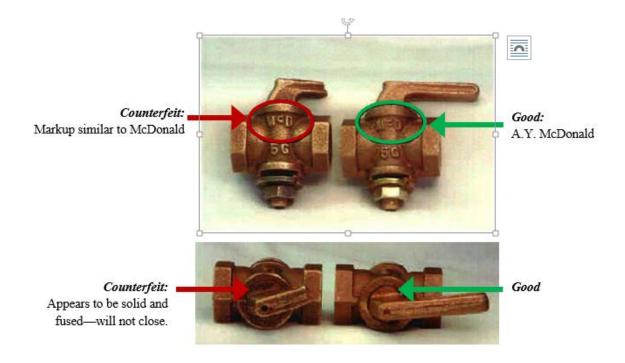
Figure A-6: Comparison of 1/2" Lever Handle with Check Low Pressure Gas Valve – Plug Style

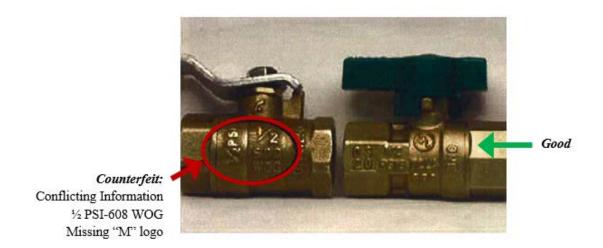
Figure A-7: Comparison between Two 1/2" Forged CSA Ball Gas Valves

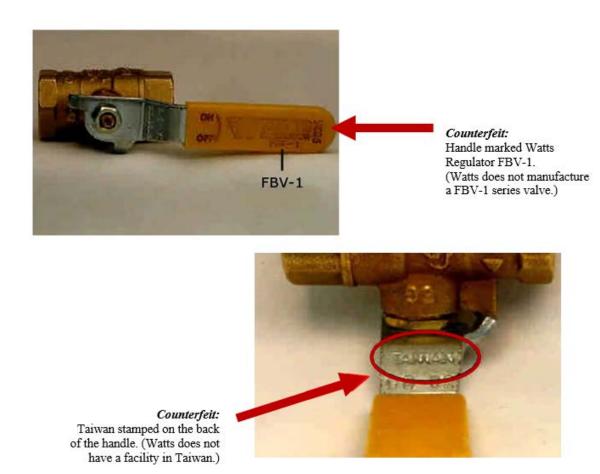
Figure A-8: 1/2" Forged Ball Gas Valves Counterfeit

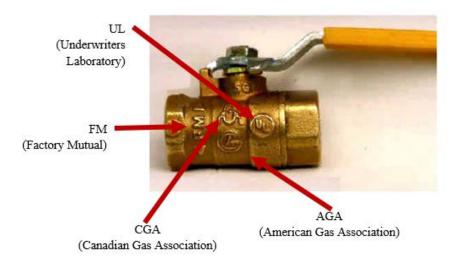
Note: Watts only Manufactures to UL and CGA

Figure A-9: 1/2" Forged Ball Gas Valves Counterfeit

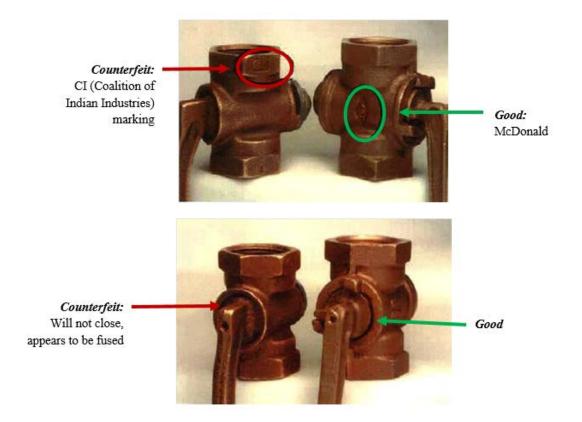
Figure A-10: Comparison of Two 1" Lever Handle with Check Low Pressure Gas Valves – Plug Style

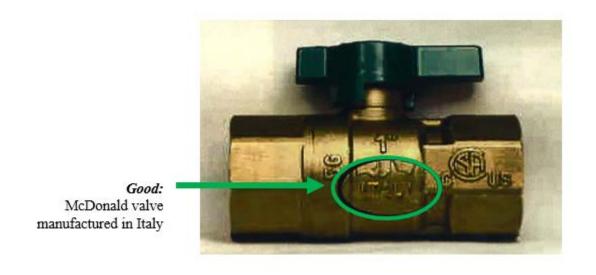
Figure A-12: 1" Forged Ball Gas Valve - Good

Figure A-13: 1" Forged Ball Gas Valve – Counterfeit

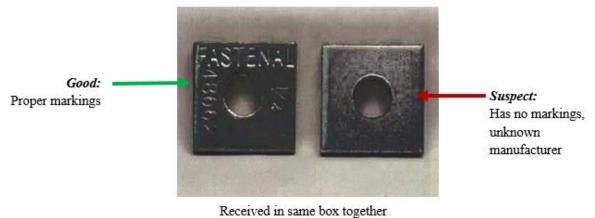
Figure A-21: Square Washers/Spacers

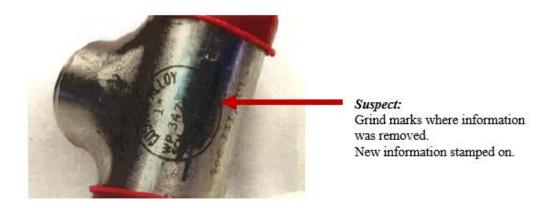
Figure A-22: Stainless Steel "T" Weldalet

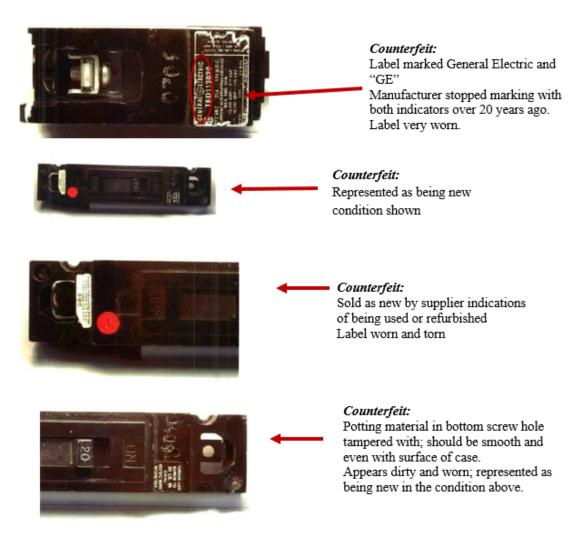
Figure A-23: GE Molded Case Circuit Breaker – Counterfeit

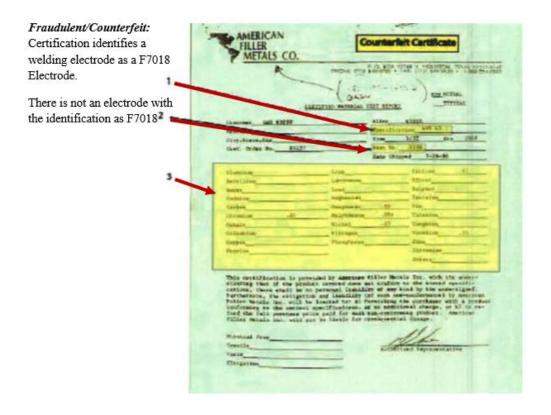
Figure A-26: Potential S/CI (Fraudulent Document)

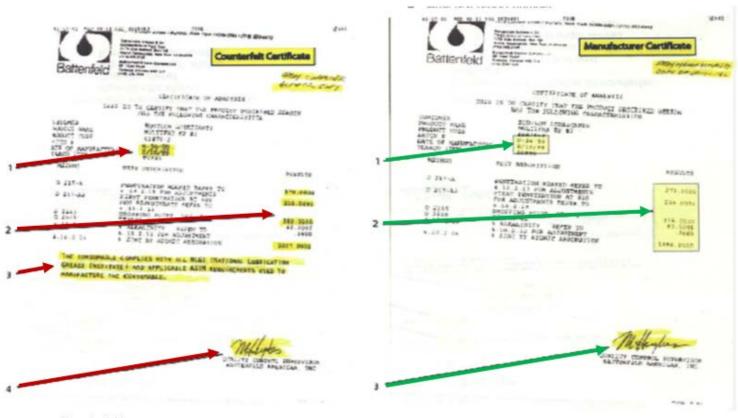
Counterfeit:

- 1. Info different font
- 2. Results altered
- Added information not on original
- 4. Signature forged

Good: Same font throughout

Figure A-27: Comparison of Counterfeit Certificate VS Authentic Certificate

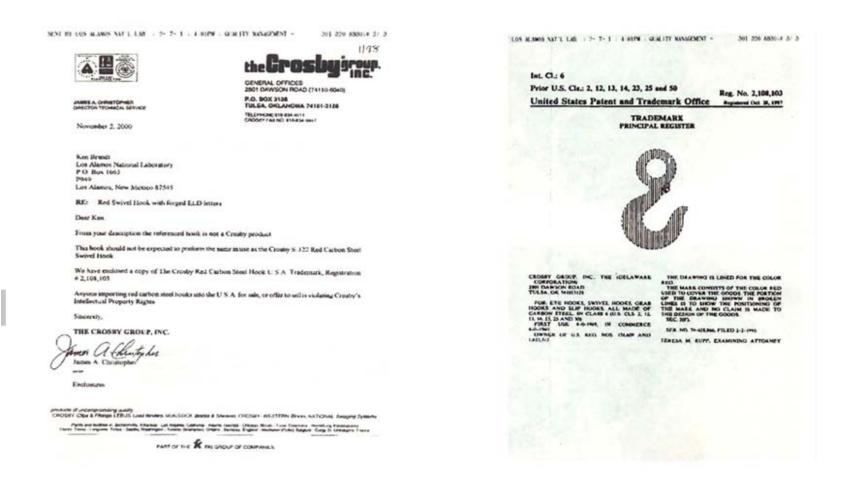
Figure A-28: Documentation from Crosby Inc. concerning the lifting hooks in Figure A-29 and 30

Fraudulent/Counterfeit: Inc. trademarkpatented color Represented as being new in condition Appearance very worn Red color is the Crosby Group

Figure A-29: Comparison of two Latching Eye Hooks – Both Fraudulent

If carbon-steel hooks are ordered (without specifying the Crosby brand) and hooks are received that are painted red but not identified as Crosby, consider the hooks suspect. The Crosby Group, Inc. has a trademark on painting its carbon-steel hooks red and does not license others to manufacture such hooks. If suspect hooks like the ones pictured above are discovered, it is suggested to calling the Crosby Group at (800) 772-1500 as a courtesy so that they can investigate and address the issue of potential trademark infringement. Further, the hooks should be evaluated according to hoisting and rigging guidelines to ensure they have all the proper certifications, the manufacturer is traceable, and the hooks meet specifications. If hooks were ordered new but show signs of wear, or if they appear to be improperly marked, consider the hooks suspect and counterfeit. Do not return the hooks to the source from which they were purchased.

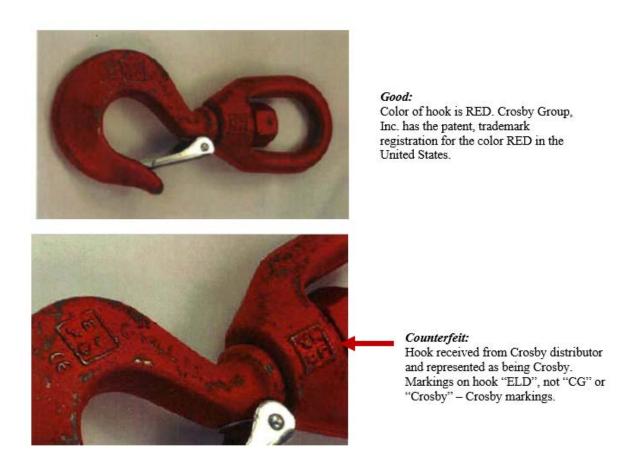
Figure A-30: Swivel Hook – Red Counterfeit
